NYC Department of Education
Building Condition Assessment Survey 2023 - 2024

Architectural Inspection

Asset: P.S. 1 - BROOKLYN, 309 47 STREET, New York, 11220

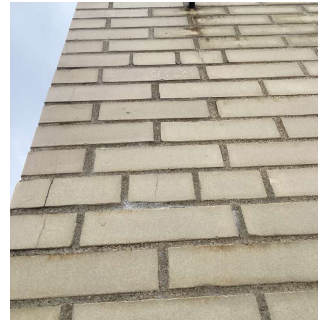
CH

BRICK: MINOR CRACKS AND SPALLING
 K001

30
 S.F.
 RESTITCH
 PRIORITY 3
 LEVEL 2

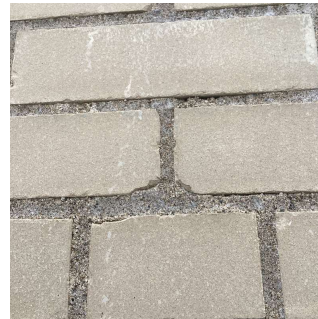
CH

BRICK: DETERIORATED JOINTS
K001

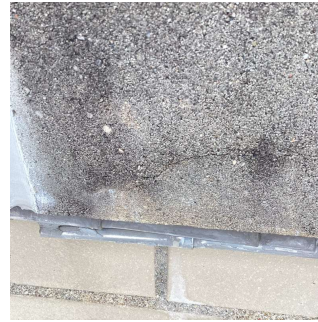
Roof 1

CAST STONE: CRACKED/BROKEN PIECES

REPLACE-IN-KIND

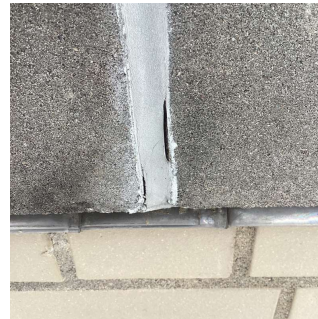
Roof 1

**CAST STONE: DETERIORATED TRANSVERSE JOINTS
K001**

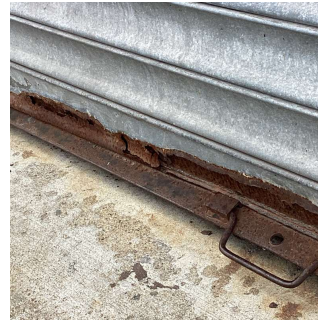
Facade B

ROLL-UP DOOR: DETERIORATED DOOR AND FRAME - MAJOR DETERIORATION

REPLACE

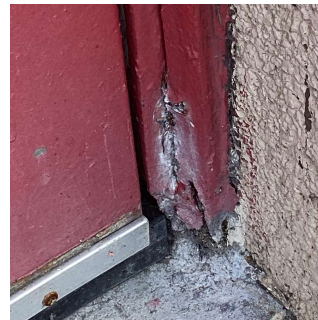
Facade B

METAL: DETERIORATED DOOR AND FRAME - MAJOR DETERIORATION

REPLACE

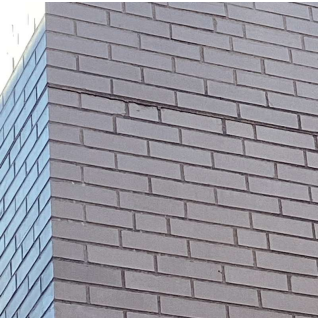
Question	Response
EXTERIOR	
EXTERIOR WALLS	Inspected
Material Type(s)	Concrete, Masonry
Replacement Quantity	35,000
Replacement Uom	S.F.
Instance on All Facades	Inspected
Instance Condition	3 - Fair
Instance Quantity	35,000
Instance Quantity Uom	S.F.
Deficiency	BRICK: DETERIORATED JOINTS
Roof Plan reference	K001
	<p align="center">46TH STREET</p>

Elevation	
Deficiency Quantity	10
Quantity Uom	S.F.
Potential Action	REPOINT
Urgency of Action	PRIORITY 3
Purpose of Action	LEVEL 2
Deficiency Photo1

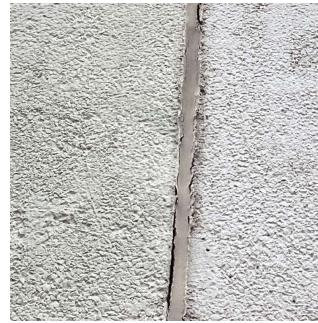
Facade B

CAST IN PLACE / PRE-CAST CONCRETE: DETERIORATED CONTROL/EXPANSION JOINTS

L.F.
MAINTENANCE
PRIORITY 3
LEVEL 2

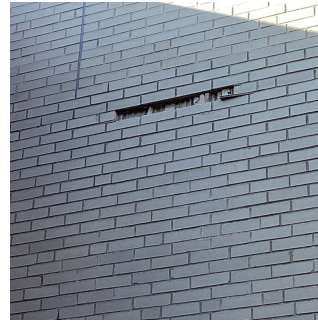
Facade D

BRICK: MAJOR / THRU CRACKS
K001

30
S.F.
REMOVE AND REBUILD
PRIORITY 4
LEVEL 2

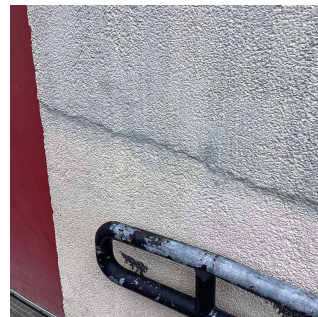
Facade B

**CAST IN PLACE / PRE-CAST CONCRETE: MAJOR
CRACKS/SPALLING**

REPLACE

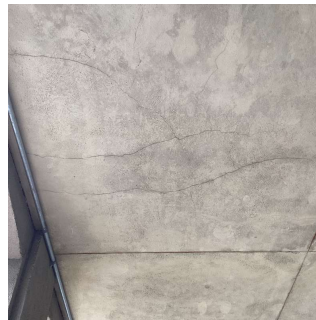
Facade B

STUCCO/PLASTER: MAJOR CRACKS/SPALLING

REPLACE

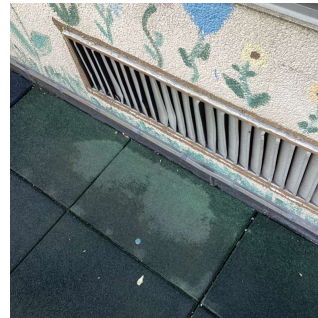
Facade E

BROKEN/ DENTED BLADES

REPLACE

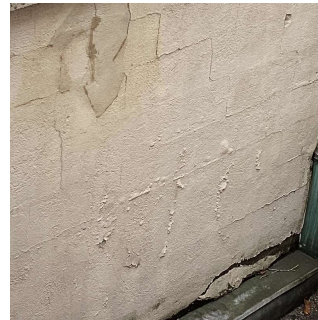
Roof 4

CONCRETE MASONRY UNITS: MINOR CRACKS, SPALLING

REPAIR

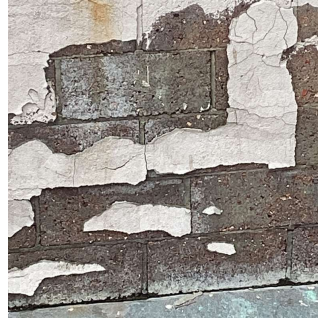
Roof 4

CONCRETE MASONRY UNITS: DETERIORATED JOINTS

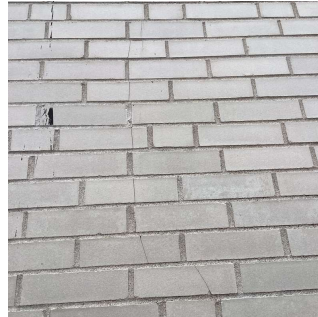
Roof 2

**BRICK: MAJOR DETERIORATION/CRACKS
K001**

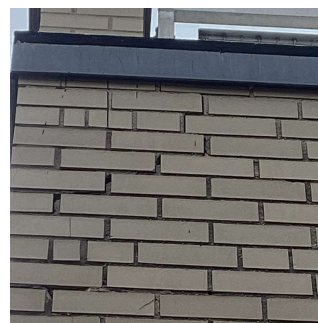
BRICK: DETERIORATED JOINTS

100
S.F.
REPOINT
PRIORITY 4
LEVEL 2

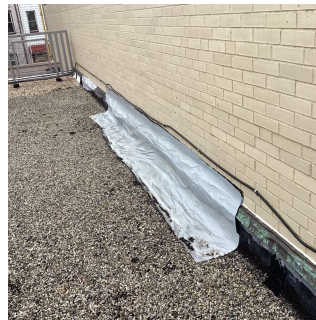
Deficiency Quantity	50
Quantity Uom	S.F.
Potential Action	INSTALL NEW GRAVEL
Urgency of Action	PRIORITY 3
Purpose of Action	LEVEL 2
Deficiency Photo1	 
Violations	Roof 4 No violations recorded.
Deficiency	BUILT-UP: FLASHING: BASE FLASHING DETERIORATED

K001
20
S.F.
REMOVE AND REPLACE
PRIORITY 4
LEVEL 2

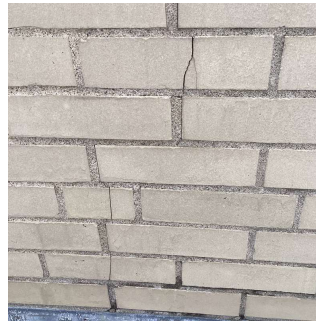
BH1

BULKHEAD/PENTHOUSE WALLS/EXTERIOR: MAJOR THRU CRACKS

K001
10
S.F.
REMOVE AND REBUILD

PRIORITY 4
 LEVEL 2

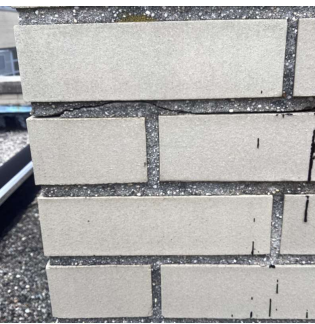
**BULKHEAD/PENTHOUSE WALLS/EXTERIOR: DETERIORATED
 JOINTS**

Deficiency Quantity	30
Quantity Uom	S.F.
Potential Action	REPOINT
Urgency of Action	PRIORITY 3
Purpose of Action	LEVEL 2
Deficiency Photo1

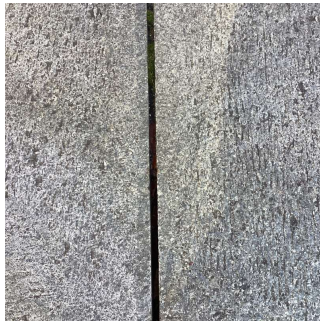
Question	Response
EXTERIOR	
STAIRS/RAMPS: EXTERIOR	
STAIRS/RAMPS	
Deficiency Photo1

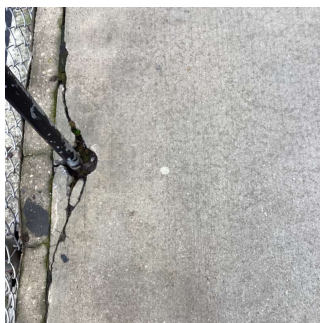
Violations	Facade C No violations recorded.
Deficiency	CONCRETE: CRACKS/SPALLING - MAJOR
Roof Plan reference	K001

<p align="center">46TH STREET</p> <p align="center">47TH STREET</p>
Deficiency Quantity	20
Quantity Uom	S.F.
Potential Action	REPLACE
Urgency of Action	PRIORITY 4
Purpose of Action	LEVEL 2
Deficiency Photo1

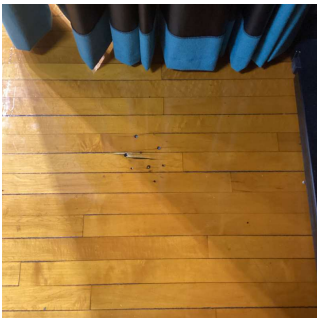
Question	Response
INTERIOR	
AUDITORIUM	
Stage	
Stage	Inspected
Instance on 1st Floor (459 Seats)	Inspected
Condition	3 - Fair
Deficiency	DAMAGED FLOOR
Deficiency Location/Instance	Right Side
Deficiency Quantity	10
Quantity Uom	S.F.
Potential Action	REPLACE
Urgency of Action	PRIORITY 3
Purpose of Action	LEVEL 2
Deficiency Photo1

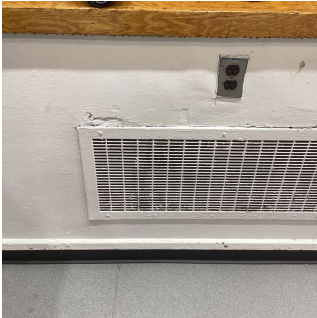
Right Side
Violations	No violations recorded.
Deficiency	DAMAGED FASCIA
Deficiency Location/Instance	Right Side
Deficiency Quantity	10
Quantity Uom	S.F.
Potential Action	REPLACE
Urgency of Action	PRIORITY 3
Purpose of Action	LEVEL 2
Deficiency Photo1

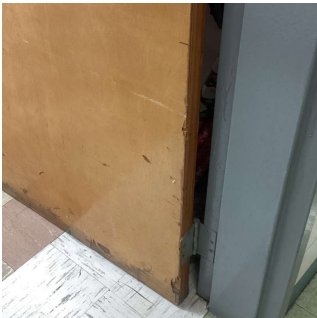
Question	Response
INTERIOR	
CLASSROOMS/CORRIDORS/ADMIN SPACES	
Ceiling	
Deficiency	ACOUSTIC TILES ON PLASTER: DAMAGED/MISSING
Deficiency Location/Instance	Corridor near Room B15, By Courtyard
Deficiency Quantity	20
Quantity Uom	S.F.
Potential Action	REPLACE
Urgency of Action	PRIORITY 3
Purpose of Action	LEVEL 2
Deficiency Photo1	 
Violations	Corridor near Room B15 No violations recorded.
Door(s)	Inspected
Condition	5 - Poor
Deficiency	WOOD: DETERIORATED DOOR
Deficiency Location/Instance	Rooms 133, 134, 135, 135A, 137 and others
Deficiency Quantity	20
Quantity Uom	EACH
Potential Action	MAINTENANCE
Urgency of Action	PRIORITY 3
Purpose of Action	LEVEL 2
Deficiency Photo1

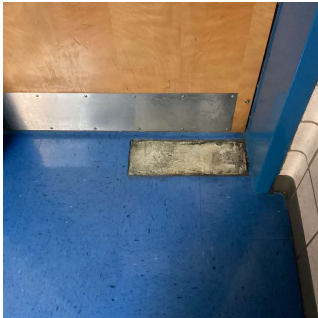
Corridor near Courtyard Entrance No violations recorded.
Deficiency Deficiency Location/Instance Deficiency Quantity Quantity Uom Potential Action Urgency of Action Purpose of Action Deficiency Photo1 Violations	VINYL TILES: BROKEN/DETERIORATED/MISSING TILES Corridor near Room 232 10 S.F. REPLACE PRIORITY 3 LEVEL 2

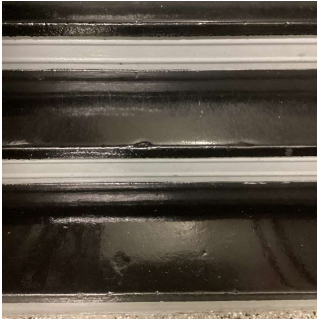
Violations	Stair A/1 No violations recorded.

Violations	Corridor near Gymnasium No violations recorded.
Deficiency	STONE: BROKEN/MISSING
Deficiency Location/Instance	Stairs A/1, B/Basement, 1, C/3, 12/1 and others
Deficiency Quantity	130
Quantity Uom	S.F.
Potential Action	REPLACE
Urgency of Action	PRIORITY 3
Purpose of Action	LEVEL 2
Deficiency Photo1

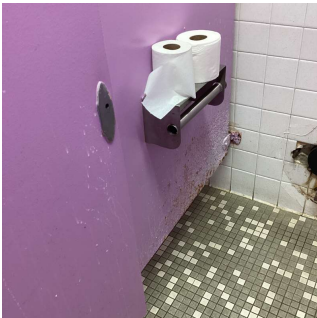
Room 7
Violations	No violations recorded.
Stalls	Inspected
Condition	5 - Poor
Deficiency	RUST - MAJOR
Deficiency Location/Instance	In Kitchen Locker Room
Deficiency Quantity	1
Quantity Uom	EACH
Potential Action	REPLACE
Urgency of Action	PRIORITY 3
Purpose of Action	LEVEL 2
Deficiency Photo1

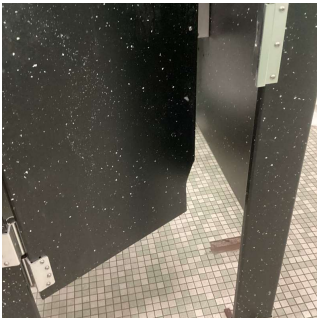
Violations	Girls Toilet Room - 2nd Floor No violations recorded.
Deficiency	BROKEN/MISSING
Deficiency Location/Instance	Room B05
Deficiency Quantity	1
Quantity Uom	EACH
Potential Action	REPLACE
Urgency of Action	PRIORITY 3
Purpose of Action	LEVEL 2
Deficiency Photo1

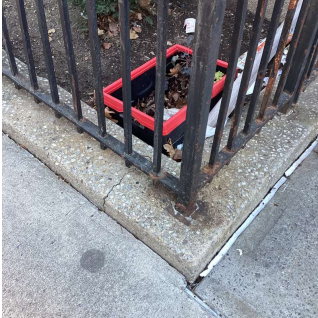
Question	Response
SITE	
FENCES	
Deficiency	CONCRETE CURB: DAMAGED/DETERIORATED
Deficiency Location/Instance	46th Street, near Mini Building
Deficiency Quantity	30
Quantity Uom	S.F.
Potential Action	REPLACE
Urgency of Action	PRIORITY 3
Purpose of Action	LEVEL 2
Deficiency Photo1
