NYC Department of Education
Building Condition Assessment Survey 2023 - 2024

Architectural Inspection

Asset: I.S. 2 - BROOKLYN, 655 PARKSIDE AVE, New York, 11226

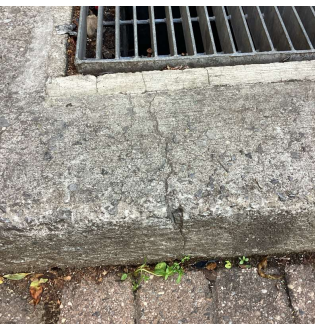
Violations	AW2 No violations recorded.
AWNINGS AND CANOPIES	Does not Exist
CHIMNEY	Inspected
Material Type(s)	Masonry
Condition	2 - Between Good and Fair
Deficiency	No deficiencies recorded
COPING	Inspected
Condition	3 - Fair
Deficiency	CAST STONE: CRACKED/BROKEN PIECES
Roof Plan reference

Question	Response
Architectural	
EXTERIOR	Inspected
AREAWAY	Inspected
Instance on AW1 - AW3	Inspected
Instance Condition	2 - Between Good and Fair
Instance Quantity	3
Instance Quantity Uom	EACH
Deficiency	AREAWAY WALLS: CRACKS AND SPALLING
Roof Plan reference

Deficiency Quantity	20
Quantity Uom	S.F.
Potential Action	REPAIR
Urgency of Action	PRIORITY 3
Purpose of Action	LEVEL 2
Deficiency Photo1

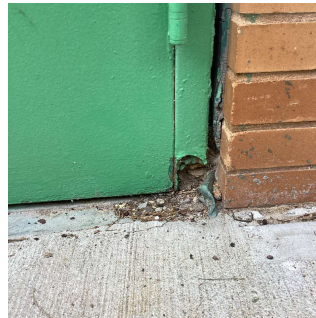
Facade C

METAL: DETERIORATED DOOR AND FRAME - MAJOR DETERIORATION

REPLACE

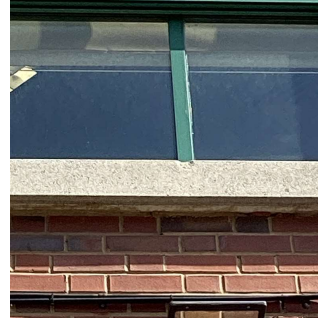
Facade A - 2nd Floor

Question	Response
EXTERIOR	
DOORS	
DOORS AND FRAMES	
Deficiency Quantity	3
Quantity Uom	EACH
Potential Action	MAINTENANCE
Urgency of Action	PRIORITY 3
Purpose of Action	LEVEL 2
Deficiency Photo1	No photo recorded
Violations	No violations recorded.
DOOR HARDWARE	
Condition	Inspected
Deficiency	3 - Fair
LINTELS	
Condition	Inspected
Deficiency	2 - Between Good and Fair
TRANSOM/SIDE LIGHT	
Condition	Inspected
Deficiency	2 - Between Good and Fair
EXTERIOR WALLS	
Material Type(s)	Inspected
Replacement Quantity	Concrete, Masonry
Replacement Uom	34,000
Instance on All Facades	S.F.
Instance Condition	Inspected
Instance Quantity	3 - Fair
Instance Quantity Uom	34,000
Deficiency	S.F.
Roof Plan reference	BRICK: DETERIORATED MASONRY SILLS - MINOR
Elevation	
Deficiency Quantity	10
Quantity Uom	L.F.
Potential Action	REPAIR
Urgency of Action	PRIORITY 3
Purpose of Action	LEVEL 2

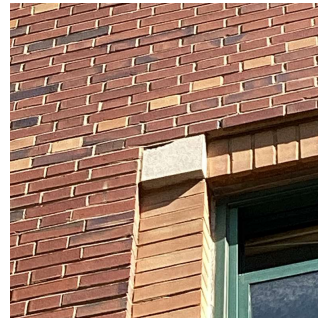
Facade A

CAST IN PLACE / PRE-CAST CONCRETE: MINOR CRACKS/SPALLING

REPAIR

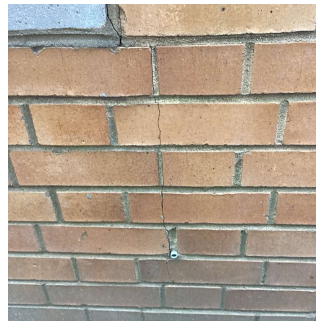
Facade C

BRICK: MINOR CRACKS AND SPALLING

60
 S.F.
 RESTITCH
 PRIORITY 3
 LEVEL 2

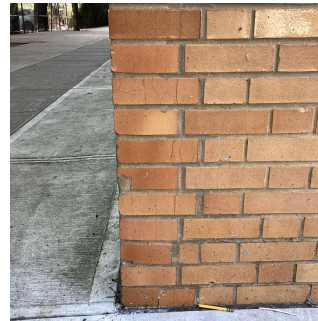
Facade B

BRICK: CRACKS/DISPLACED/SPALLED BRICK AT BUILDING CORNERS

S.F.
 REMOVE AND REBUILD
 PRIORITY 4
 LEVEL 2

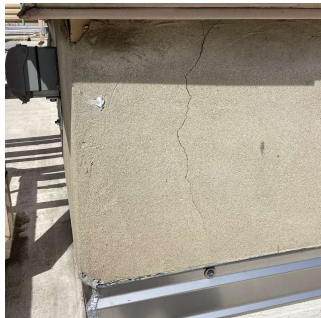
PH4
Violations	No violations recorded.

Roof 9
Instance Quantity	10,000
Instance Quantity Uom	S.F.
Does the roof have major mechanical equipment sitting on Dunnage Steel less than 18" above the Roofing?	No
Does this roof instance have a Sustainable Roof System?	No
Do solar panels exist on these roofs?	No
Is/Are the roof(s) suitable for Solar Panel installation?	No
Installation Year	1994
Source of Installation	Custodial Staff
Deficiency	No deficiencies recorded
ROOFING DRAINS	
	Inspected
Condition	2 - Between Good and Fair
Deficiency	No deficiencies recorded
Specialties	
	Inspected
BULKHEAD/PENTHOUSE	
	Inspected
Condition	3 - Fair
Deficiency	BULKHEAD/PENTHOUSE WALLS/EXTERIOR: CRACKS/SPALLING - MINOR
Roof Plan reference

Deficiency Quantity	80
Quantity Uom	S.F.
Potential Action	REPAIR
Urgency of Action	PRIORITY 3
Purpose of Action	LEVEL 2
Deficiency Photo1

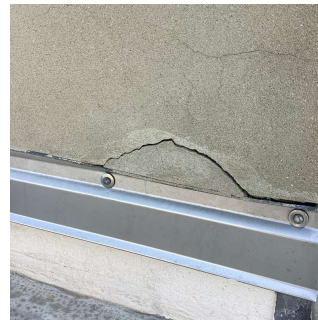
PH5

**BULKHEAD/PENTHOUSE WALLS/EXTERIOR:
 CRACKS/SPALLING - MAJOR**

REPLACE

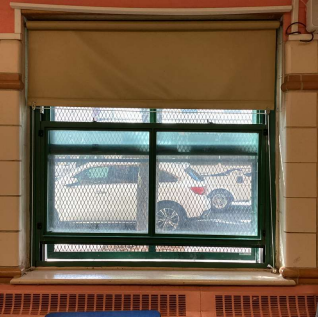
Question	Response
EXTERIOR	
WINDOWS	
WINDOWS	
Deficiency	ALUMINUM - DOUBLE HUNG: INOPERABLE BALANCE
Roof Plan reference

Violations	Facade C - Cafeteria (similar throughout) No violations recorded.
Instance on Aluminum - Other: Stairwell, Kitchen	Inspected
Instance Condition	3 - Fair
Instance Quantity	500
Instance Quantity Uom	S.F.
Are these windows insulated	No
Installation Year	1994
Source of Installation	Custodial Staff
Deficiency	No deficiencies recorded
INTERIOR	Inspected
POOLS	Does not Exist
STRUCTURAL	Inspected
COLUMNS/BEAMS/BEARING WALLS	Inspected
Condition	2 - Between Good and Fair
Deficiency	No deficiencies recorded
FLOOR STRUCTURE	Inspected

Deficiency Quantity	30
Quantity Uom	EACH
Potential Action	REPLACE BALANCES
Urgency of Action	PRIORITY 3
Purpose of Action	LEVEL 2
Deficiency Photo1

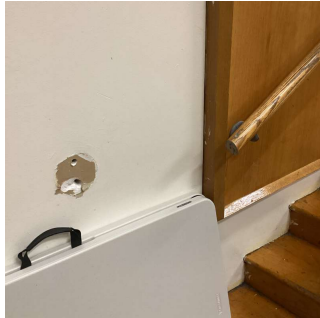
Left Side
Violations	No violations recorded.
Deficiency	RAILINGS/DAMAGED
Deficiency Location/Instance	Right Side
Deficiency Quantity	10
Quantity Uom	L.F.
Potential Action	REPLACE
Urgency of Action	PRIORITY 3
Purpose of Action	LEVEL 2
Deficiency Photo1

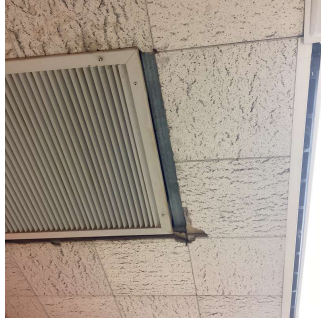
Deficiency	ACOUSTIC TILES ON PLASTER: DAMAGED/MISSING
Deficiency Location/Instance	Left Side
Deficiency Quantity	10
Quantity Uom	S.F.
Potential Action	REPLACE
Urgency of Action	PRIORITY 3
Purpose of Action	LEVEL 2
Deficiency Photo1

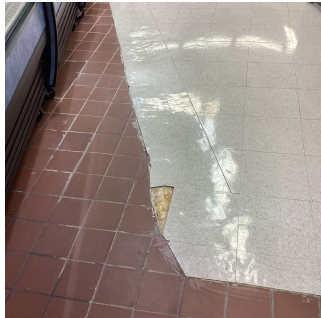
Instance on 1st Floor - Students	Inspected
Condition	2 - Between Good and Fair
Deficiency	VINYL TILES: BROKEN/DETERIORATED/MISSING TILES
Deficiency Location/Instance	Near Serving Area, Near Center
Deficiency Quantity	20
Quantity Uom	S.F.
Potential Action	REPLACE
Urgency of Action	PRIORITY 3
Purpose of Action	LEVEL 2
Deficiency Photo1

Violations	Near Serving Area No violations recorded.
------------	--

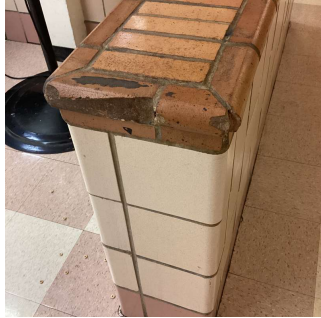
Instance on 1st Floor - Students	Inspected
Condition	2 - Between Good and Fair
Deficiency	GLAZED BLOCK: CRACKS/SPALLING
Deficiency Location/Instance	Near Main Entrance
Deficiency Quantity	10
Quantity Uom	S.F.
Potential Action	REPLACE
Urgency of Action	PRIORITY 3
Purpose of Action	LEVEL 2
Deficiency Photo1

Violations	Near Main Entrance No violations recorded.
------------	---

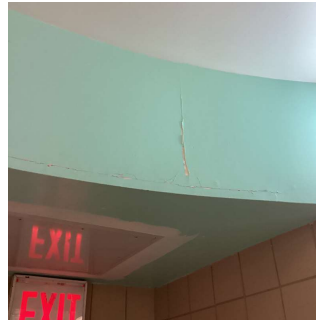
Condition	Inspected 2 - Between Good and Fair
Deficiency	GYPSUM BOARD: DAMAGED/DETERIORATED
Deficiency Location/Instance	Corridor near Stair A/3
Deficiency Quantity	10
Quantity Uom	S.F.
Potential Action	REPLACE
Urgency of Action	PRIORITY 3
Purpose of Action	LEVEL 2

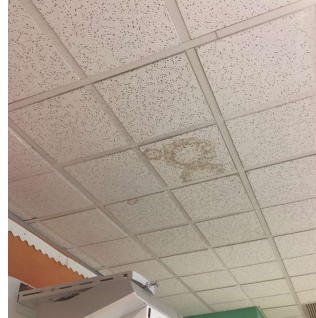
Room B410

ACOUSTIC TILES: DAMAGED/MISSING

REPLACE

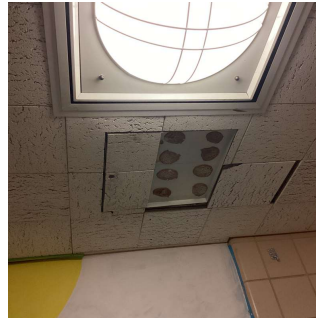
Corridor near Room A410

ACOUSTIC TILES ON PLASTER: DAMAGED/MISSING

REPLACE

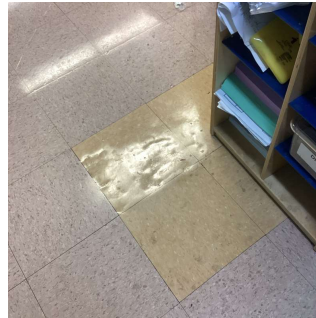
Room B412

VINYL TILES: DETERIORATED SUBSTRATE

REPLACE

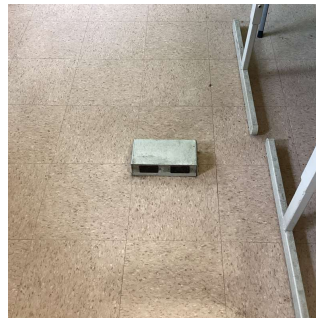
Room B212

VINYL TILES: TRIPPING HAZARD - ELECTRICAL OUTLET

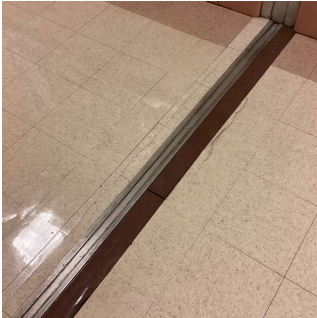
Question	Response
INTERIOR	
CLASSROOMS/CORRIDORS/ADMIN SPACES	
Floor Finish	
Deficiency	VINYL TILES: BROKEN/DETERIORATED/MISSING TILES
Deficiency Location/Instance	Corridor near Stair L/2
Deficiency Quantity	10
Quantity Uom	S.F.
Potential Action	REPLACE
Urgency of Action	PRIORITY 3
Purpose of Action	LEVEL 2
Deficiency Photo1

Violations	Corridor near Stair L/2 No violations recorded.
Deficiency	WOOD: DAMAGED/DETERIORATED
Deficiency Location/Instance	Room A320
Deficiency Quantity	20
Quantity Uom	S.F.
Potential Action	REPLACE
Urgency of Action	PRIORITY 3
Purpose of Action	LEVEL 2
Deficiency Photo1

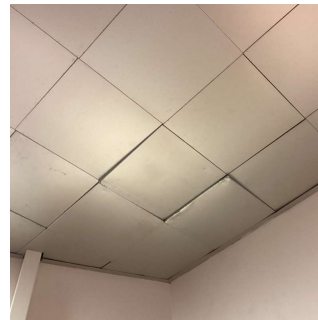
METAL PAN: DAMAGED/MISSING
Students Serving Area
10
S.F.
REPLACE
PRIORITY 3
LEVEL 2

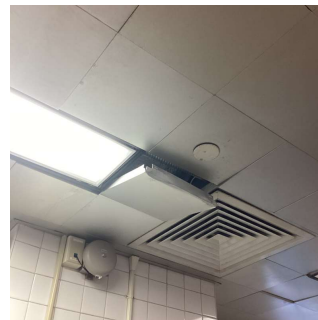
METAL PAN: DAMAGED/MISSING
Near Windows
10
S.F.
REPLACE
PRIORITY 5
LEVEL 6

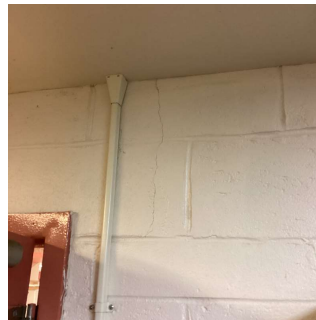
Deficiency	MASONRY: CRACKS/SPALLING
Deficiency Location/Instance	Store Room A101 in Cafeteria
Deficiency Quantity	10
Quantity Uom	S.F.
Potential Action	REPLACE
Urgency of Action	PRIORITY 3
Purpose of Action	LEVEL 2

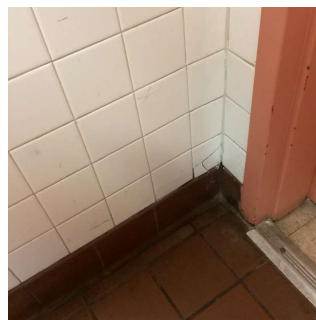
Deficiency	CERAMIC TILE: BROKEN/ MISSING
Deficiency Location/Instance	Near Exit to Staff Cafeteria
Deficiency Quantity	10
Quantity Uom	S.F.
Potential Action	REPLACE
Urgency of Action	PRIORITY 3
Purpose of Action	LEVEL 2

Question	Response
INTERIOR	
KITCHEN	Inspected
Walls	
Violations	Near Exit to Staff Cafeteria No violations recorded.
LIBRARY	Inspected
Instance on Room A225	Inspected
Built-in Furnishing	
Instance on Room A225	Inspected
Condition	2 - Between Good and Fair
Deficiency	No deficiencies recorded
Ceiling	
Instance on Room A225	Inspected
Condition	2 - Between Good and Fair
Deficiency	ACOUSTIC TILES: DAMAGED/MISSING
Deficiency Location/Instance	Room A225B
Deficiency Quantity	10
Quantity Uom	S.F.
Potential Action	REPLACE
Urgency of Action	PRIORITY 3
Purpose of Action	LEVEL 2
Deficiency Photo1

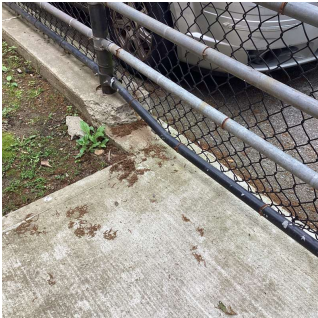
Question	Response
SITE	
FENCES	
Deficiency Location/Instance	Rear of Building, Parking Lot, West Schoolyard
Deficiency Quantity	120
Quantity Uom	L.F.
Potential Action	REPLACE
Urgency of Action	PRIORITY 3
Purpose of Action	LEVEL 2
Deficiency Photo1

Violations	Rear of Building No violations recorded.
IRRIGATION SYSTEM	Does not Exist
PAVING	Inspected
Student Non-Use	Inspected
Gravel Exists?	No
Asphalt	Inspected
Condition	4 - Between Fair and Poor
Deficiency	LOCALIZED SINK AREA
Deficiency Location/Instance	Near Containers on Parkside Avenue
Deficiency Quantity	50
Quantity Uom	S.F.
Potential Action	REPAIR
Urgency of Action	PRIORITY 5
Purpose of Action	LEVEL 6
Deficiency Photo1

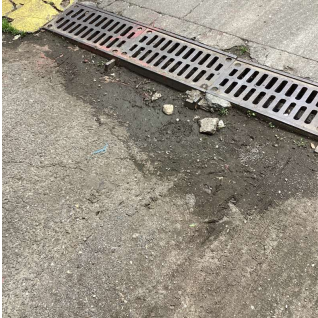
Violations	Near Containers on Parkside Avenue No violations recorded.
Deficiency	CRACKS - MAJOR
Deficiency Location/Instance	Parking Lot, Near Containers
Deficiency Quantity	1,000
Quantity Uom	S.F.
Potential Action	REPLACE
Urgency of Action	PRIORITY 3

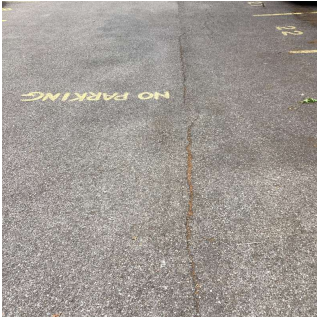
Violations	Parking Lot No violations recorded.
Concrete	Inspected
Condition	2 - Between Good and Fair
Deficiency	No deficiencies recorded
Pavers	Does not Exist
Student Use	Inspected
Gravel Exists?	No
Asphalt	Inspected
Condition	4 - Between Fair and Poor
Deficiency	CRACKS - MAJOR
Deficiency Location/Instance	West Schoolyard
Deficiency Quantity	1,400
Quantity Uom	S.F.
Potential Action	REPLACE
Urgency of Action	PRIORITY 3
Purpose of Action	LEVEL 2
Deficiency Photo1

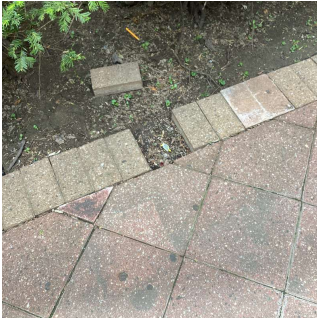
Violations	East Side of Building No violations recorded.
Pavers	Inspected
Condition	2 - Between Good and Fair
Deficiency	DAMAGED/MISSING
Deficiency Location/Instance	Parkside Avenue
Deficiency Quantity	10
Quantity Uom	S.F.
Potential Action	REPLACE
Urgency of Action	PRIORITY 3
Purpose of Action	LEVEL 2
Deficiency Photo1

Violations	Parkside Avenue No violations recorded.
Deficiency	HEAVING
Deficiency Location/Instance	Parkside Avenue - Exit 2
Deficiency Quantity	10
Quantity Uom	S.F.
Potential Action	REPLACE
Urgency of Action	PRIORITY 5
Purpose of Action	LEVEL 6

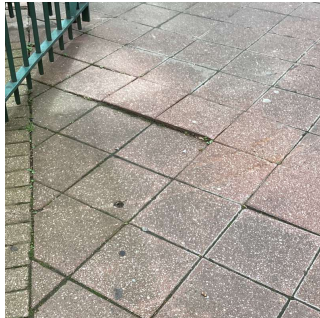
Violations	Parkside Avenue - Exit 2 No violations recorded.
DOT Sidewalk	Inspected
Asphalt	Does not Exist
Concrete	Inspected
Condition	4 - Between Fair and Poor
Deficiency	HEAVING
Deficiency Location/Instance	Parkside Avenue
Deficiency Quantity	650
Quantity Uom	S.F.
Potential Action	REPLACE
Urgency of Action	PRIORITY 5
Purpose of Action	LEVEL 6
Deficiency Photo1

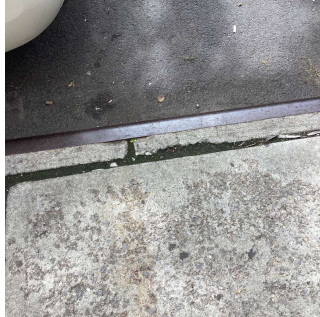
Question	Response
SITE	
PAVING	
DOT Sidewalk	Inspected
Concrete	
Deficiency Photo1

Violations	Parkside Avenue No violations recorded.
Deficiency	DAMAGED/DETERIORATED/MISSING SECTIONS
Deficiency Location/Instance	Winthrop Street, Nostrand Avenue, Parkside Avenue
Deficiency Quantity	675
Quantity Uom	S.F.
Potential Action	REPLACE
Urgency of Action	PRIORITY 3
Purpose of Action	LEVEL 2
Deficiency Photo1

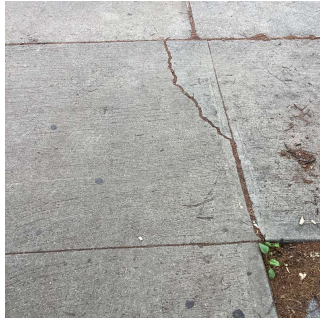
Violations	Winthrop Street No violations recorded.
Pavers	Inspected
Condition	3 - Fair
Deficiency	HEAVING
Deficiency Location/Instance	Parkside Avenue
Deficiency Quantity	10
Quantity Uom	S.F.
Potential Action	REPLACE
Urgency of Action	PRIORITY 3
Purpose of Action	LEVEL 2

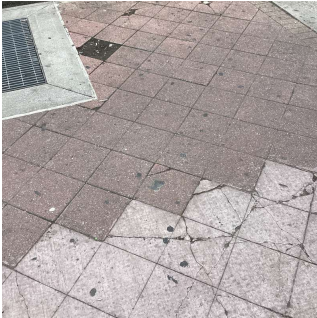
Violations	Parkside Avenue No violations recorded.
Deficiency	DAMAGED/MISSING
Deficiency Location/Instance	Nostrand Avenue, Parkside Avenue
Deficiency Quantity	85
Quantity Uom	S.F.
Potential Action	REPLACE
Urgency of Action	PRIORITY 3
Purpose of Action	LEVEL 2
Deficiency Photo1

Violations	Nostrand Avenue No violations recorded.
PLAYGROUNDS	Does not Exist
PLAYING SURFACE	Does not Exist
RETAINING WALLS	Does not Exist
SEATING	Does not Exist
SITE WALLS (NOT RETAINING WALLS)	Inspected
Condition	3 - Fair
Deficiency	BRICK: CRACKS/SPALLING - MAJOR
Deficiency Location/Instance	Parkside Avenue
Deficiency Quantity	30
Quantity Uom	S.F.
Potential Action	REPLACE
Urgency of Action	PRIORITY 3
Purpose of Action	LEVEL 2
