NYC Department of Education
Building Condition Assessment Survey 2023 - 2024

Architectural Inspection

Asset: P.S. 6 - BROOKLYN, 43 SNYDER AVENUE, New York, 11226

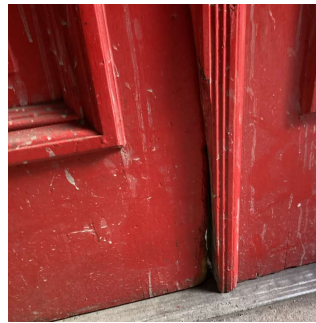
Facade F

Question	Response
Architectural	
EXTERIOR	Inspected
AREAWAY	Inspected
Instance on AW1	Inspected
Instance Condition	2 - Between Good and Fair
Instance Quantity	1
Instance Quantity Uom	EACH
Deficiency	No deficiencies recorded
AWNINGS AND CANOPIES	Inspected
Condition	2 - Between Good and Fair
Deficiency	No deficiencies recorded
CHIMNEY	Inspected
Material Type(s)	Masonry
Condition	2 - Between Good and Fair
Deficiency	No deficiencies recorded
COPING	Under Construction
CORNICE	Does not Exist
DOORS	Inspected
DOORS AND FRAMES	Inspected
Condition	5 - Poor
Deficiency	WOOD: DETERIORATED DOOR AND FRAME - MAJOR DETERIORATION

2
EACH
REPLACE
PRIORITY 4
LEVEL 2

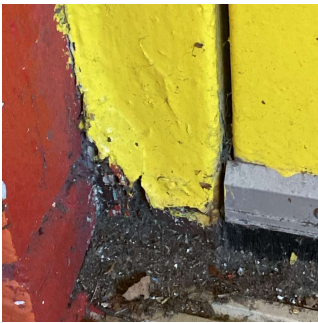
METAL: DETERIORATED DOOR AND FRAME - MAJOR DETERIORATION

5
EACH
REPLACE
PRIORITY 4
LEVEL 2

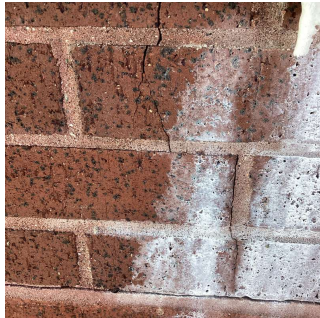
Question	Response
EXTERIOR	
PARAPETS	
Roof Plan reference	
Deficiency Quantity	30
Quantity Uom	S.F.
Potential Action	MAINTENANCE
Urgency of Action	PRIORITY 3
Purpose of Action	LEVEL 2
Deficiency Photo1	No photo recorded
Violations	No violations recorded.
Deficiency	BRICK: MINOR CRACKS, SPALLING
Roof Plan reference	
Deficiency Quantity	30
Quantity Uom	S.F.
Potential Action	REPAIR
Urgency of Action	PRIORITY 3
Purpose of Action	LEVEL 2
Deficiency Photo1

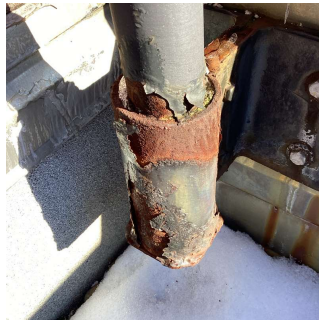
Deficiency	RAILINGS/PANELS: DETERIORATED, MAJOR RUSTING
------------	--

Deficiency Quantity	100
Quantity Uom	S.F.
Potential Action	REPLACE
Urgency of Action	PRIORITY 4
Purpose of Action	LEVEL 2
Deficiency Photo1

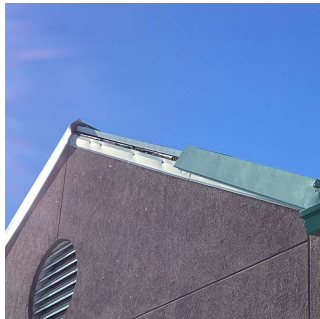
Question	Response
EXTERIOR	
ROOF	
Roofing	
ROOFING	
Roof Plan reference	
Deficiency Quantity	20
Quantity Uom	L.F.
Potential Action	REMOVE AND REPLACE
Urgency of Action	PRIORITY 4
Purpose of Action	LEVEL 2
Deficiency Photo1

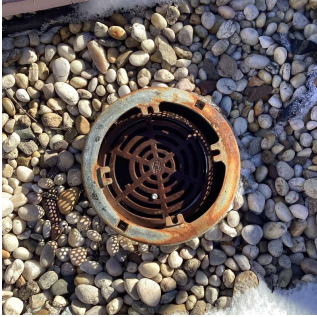
Violations	PH2 No violations recorded.
ROOFING DRAINS	
Condition	Inspected
Deficiency	5 - Poor
Roof Plan reference	DETERIORATED
Deficiency Quantity	9
Quantity Uom	EACH
Potential Action	REPLACE
Urgency of Action	PRIORITY 4
Purpose of Action	LEVEL 2

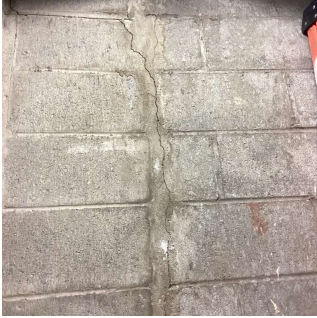
Violations	Roof 1 No violations recorded.
Specialties	Inspected
BULKHEAD/PENTHOUSE	Inspected
Condition	3 - Fair
Deficiency	BULKHEAD/PENTHOUSE WALLS/INTERIOR: CMU CRACKS/SPALLING
Roof Plan reference	
Deficiency Quantity	20
Quantity Uom	S.F.
Potential Action	REPLACE
Urgency of Action	PRIORITY 3
Purpose of Action	LEVEL 2
Deficiency Photo1

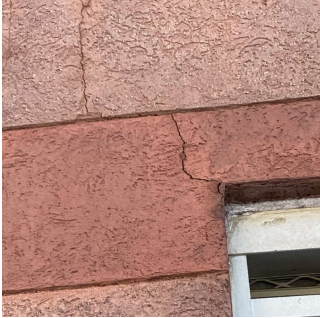
Violations	BH3 No violations recorded.
Deficiency	BULKHEAD/PENTHOUSE WALLS/EXTERIOR: MAJOR THRU CRACKS

Question	Response
EXTERIOR	
ROOF	
Specialties	
BULKHEAD/PENTHOUSE	
Roof Plan reference	
Deficiency Quantity	20
Quantity Uom	S.F.
Potential Action	REMOVE AND REBUILD
Urgency of Action	PRIORITY 4
Purpose of Action	LEVEL 2
Deficiency Photo1

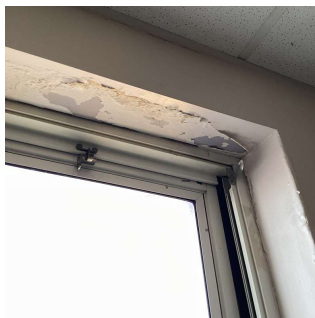
Question	Response
EXTERIOR	
WINDOWS	
Replacement Quantity	7,000
Replacement Uom	S.F.
EXTERIOR GUARDS	Inaccessible
LINTELS	Inaccessible
WINDOWS	Inspected
Material Type(s)	Aluminum
Instance on Aluminum - Double Hung: All Facades	Inspected
Instance Condition	3 - Fair
Instance Quantity	6,900
Instance Quantity Uom	S.F.
Are these windows insulated	No
Installation Year	1993
Source of Installation	Custodial Staff
Deficiency	ALUMINUM - DOUBLE HUNG: AIR/WATER INFILTRATION, DETERIORATED JOINTS WITH DAMAGED CAULKING
Roof Plan reference

900
L.F.
MAINTENANCE
PRIORITY 3
LEVEL 2

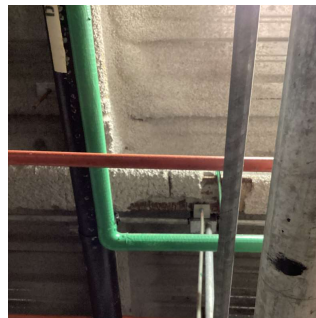
Basement - Room 004

Deficiency	STEEL COLUMNS/BEAMS: DETERIORATED/MISSING SPRAY-ON FIREPROOFING
------------	---

Deficiency Location/Instance	Basement - Rooms 004, 005, 006
Deficiency Quantity	30
Quantity Uom	S.F.
Potential Action	REPLACE
Urgency of Action	PRIORITY 4
Purpose of Action	LEVEL 5
Deficiency Photo1

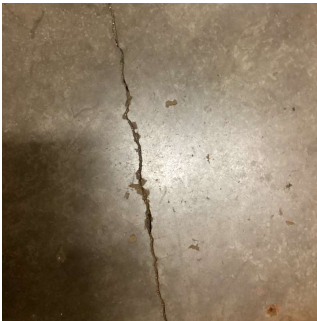
Deficiency	CONCRETE SLAB ON GRADE: THRU CRACKS
Deficiency Location/Instance	Basement - Boiler Room, Corridor, Rooms 004, 006
Deficiency Quantity	180
Quantity Uom	S.F.
Potential Action	REPLACE
Urgency of Action	PRIORITY 4
Purpose of Action	LEVEL 5

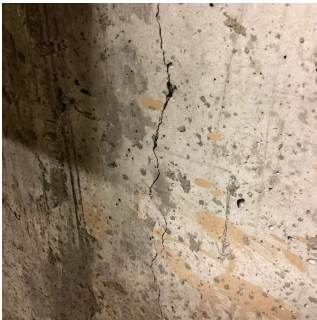
Violations	Rooms 004 No violations recorded.
FOUNDATION WALLS	
Material Type(s)	Inspected Concrete
Condition	3 - Fair
Deficiency	CONCRETE: CRACKED/SPALLED/REINFORCEMENT EXPOSED
Deficiency Location/Instance	Basement - Boiler Room
Deficiency Quantity	30
Quantity Uom	S.F.
Potential Action	REPAIR
Urgency of Action	PRIORITY 4
Purpose of Action	LEVEL 5
Deficiency Photo1

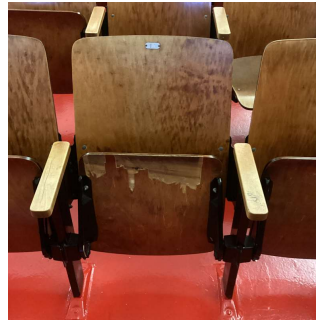
Seat B/14

DAMAGED/BROKEN/INOPERABLE

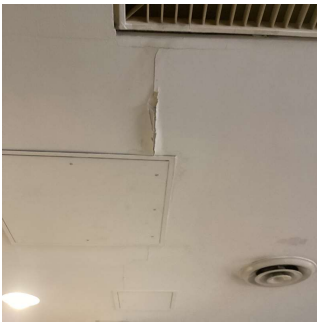
Question	Response
INTERIOR	
CLASSROOMS/CORRIDORS/ADMIN SPACES	
Ceiling	
Deficiency	GYPSUM BOARD: DAMAGED/DETERIORATED - ACTIVE LEAK
Deficiency Location/Instance	Rooms 308, 410, 404, Corridor near Stair B/4
Deficiency Quantity	40
Quantity Uom	S.F.
Potential Action	REPLACE
Urgency of Action	PRIORITY 5
Purpose of Action	LEVEL 2
Deficiency Photo1

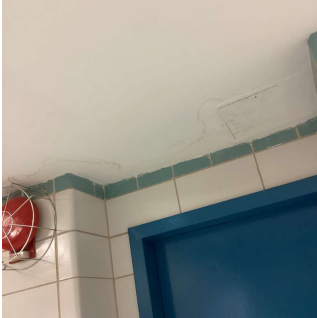
Room 404
Violations	No violations recorded.
Deficiency	GYPSUM BOARD: DAMAGED/DETERIORATED
Deficiency Location/Instance	Rooms 404, 308, 124, Corridor near Rooms 417, 124 and others
Deficiency Quantity	180
Quantity Uom	S.F.
Potential Action	REPLACE
Urgency of Action	PRIORITY 3
Purpose of Action	LEVEL 2
Deficiency Photo1

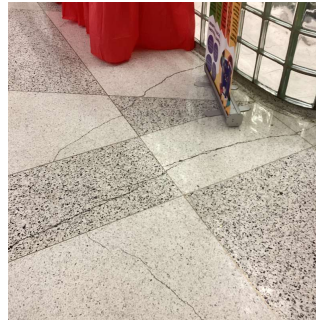
Corridor by Cafeteria

VINYL TILES: DETERIORATED SUBSTRATE

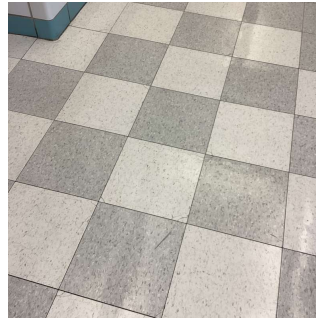
Corridor near Stair B/4

VINYL TILES: BROKEN/DETERIORATED/MISSING TILES

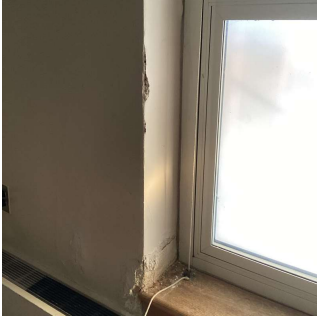
Question	Response
INTERIOR	
CLASSROOMS/CORRIDORS/ADMIN SPACES	
Walls	Inspected
Condition	2 - Between Good and Fair
Deficiency	GYPSUM BOARD: DETERIORATED
Deficiency Location/Instance	Room 112
Deficiency Quantity	20
Quantity Uom	S.F.
Potential Action	REPLACE
Urgency of Action	PRIORITY 3
Purpose of Action	LEVEL 2
Deficiency Photo1	 
Violations	Room 112 No violations recorded.
Deficiency	PLASTER: CRACKS/SPALLING - ACTIVE LEAK
Deficiency Location/Instance	Rooms 208, 404, 406, 409, 410, 419B, 419C
Deficiency Quantity	80
Quantity Uom	S.F.
Potential Action	REPLACE
Urgency of Action	PRIORITY 5
Purpose of Action	LEVEL 2
Deficiency Photo1

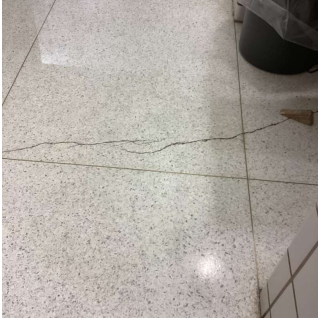
Deficiency	TERRAZZO: CRACKS

Question	Response
INTERIOR	
GYMNASIUM	
Floor Finish	
Deficiency Location/Instance	Near Main Entrance, By Exit 10 - Vestibule
Deficiency Quantity	50
Quantity Uom	S.F.
Potential Action	REPLACE
Urgency of Action	PRIORITY 3
Purpose of Action	LEVEL 2
Deficiency Photo1

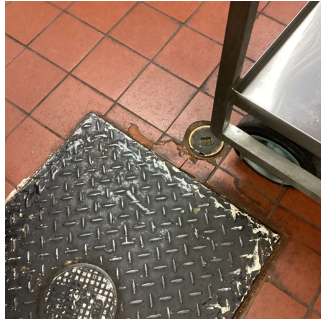
Violations	Preparation Area No violations recorded.

Floor Finish	
Instance on 1st Floor	Inspected
Condition	2 - Between Good and Fair
Deficiency	QUARRY TILE: BROKEN/MISSING TILES
Deficiency Location/Instance	Preparation Area
Deficiency Quantity	10
Quantity Uom	S.F.
Potential Action	REPLACE
Urgency of Action	PRIORITY 3
Purpose of Action	LEVEL 2
Deficiency Photo1

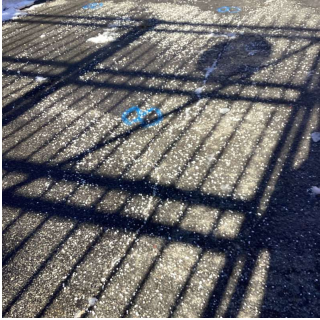
Question	Response
SITE	Inspected
PAVING	
Student Use	
Asphalt	
Condition	4 - Between Fair and Poor
Deficiency	CRACKS - MAJOR
Deficiency Location/Instance	Schoolyard
Deficiency Quantity	500
Quantity Uom	S.F.
Potential Action	REPLACE
Urgency of Action	PRIORITY 3
Purpose of Action	LEVEL 2
Deficiency Photo1

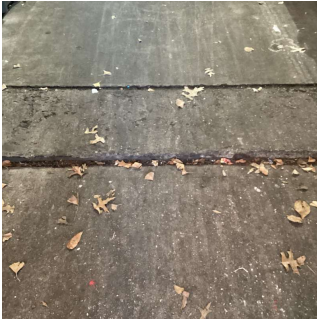
Question	Response
SITE	
PAVING	
Site Sidewalks & Walkways	
Concrete	
Deficiency	HEAVING
Deficiency Location/Instance	Bedford Avenue, Snyder Avenue
Deficiency Quantity	150
Quantity Uom	S.F.
Potential Action	REPLACE
Urgency of Action	PRIORITY 3
Purpose of Action	LEVEL 2
Deficiency Photo1

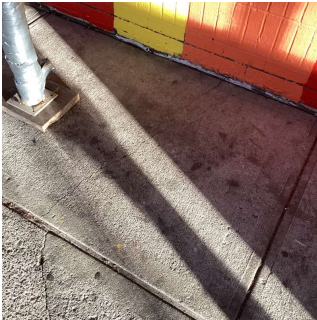
Violations	Bedford Avenue No violations recorded.
Deficiency	DAMAGED/DETERIORATED/MISSING SECTIONS
Deficiency Location/Instance	Bedford Avenue, Snyder Avenue
Deficiency Quantity	125
Quantity Uom	S.F.
Potential Action	REPLACE
Urgency of Action	PRIORITY 3
Purpose of Action	LEVEL 2
Deficiency Photo1

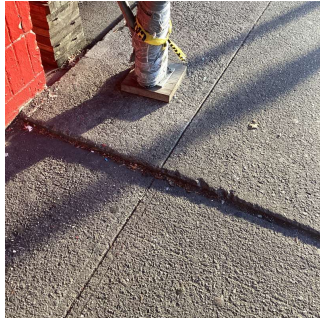
Bedford Avenue
Violations	No violations recorded.
Deficiency	HEAVING
Deficiency Location/Instance	Bedford Avenue
Deficiency Quantity	150
Quantity Uom	S.F.
Potential Action	REPLACE
Urgency of Action	PRIORITY 3
Purpose of Action	LEVEL 2
Deficiency Photo1
