**NYC Department of Education**  
**Building Condition Assessment Survey 2023 - 2024**

Architectural Inspection

**Asset: P.S. 7 - BROOKLYN, 858 JAMAICA AVENUE, New York, 11208**

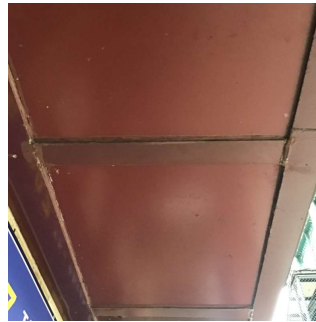
Facade A - Main Entrance

METAL: DETERIORATION/DAMAGED/MISSING PIECES

40  
S.F.  
REPAIR  
PRIORITY 3  
LEVEL 2

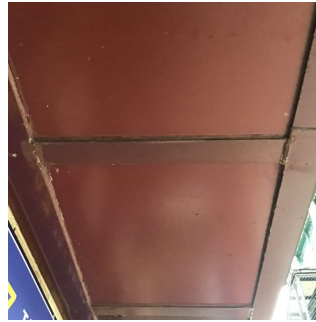
Facade A - Main Entrance

**METAL: WATER PENETRATION**

30  
S.F.  
REPLACE  
PRIORITY 5  
LEVEL 2

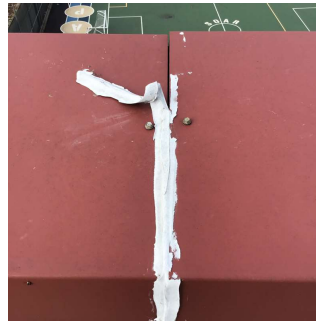
Roof 1

METAL: DETERIORATED TRANSVERSE JOINTS

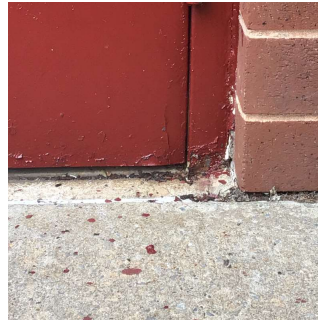
Facade C - Exit 10

METAL CLAD: DETERIORATED DOOR AND FRAME - MINOR DETERIORATION

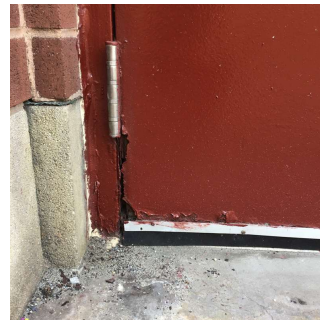
Facade E - Exit 3

**METAL CLAD: DETERIORATED DOOR - MAJOR DETERIORATION**

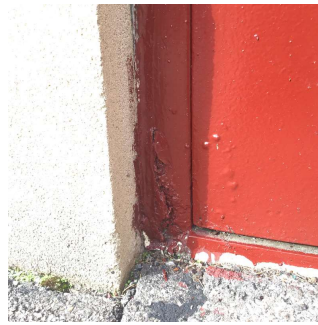
Facade D

**METAL: DETERIORATED DOOR AND FRAME - MAJOR DETERIORATION**

3  
 EACH  
 REPLACE  
 PRIORITY 4  
 LEVEL 2

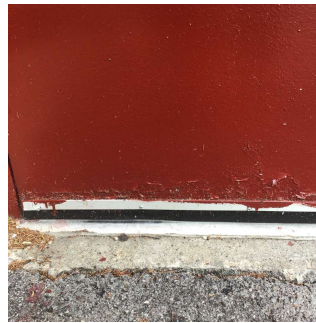
Facade C

Deficiency METAL CLAD: DETERIORATED DOOR - MINOR DETERIORATION

4  
 EACH  
 MAINTENANCE  
 PRIORITY 3  
 LEVEL 2

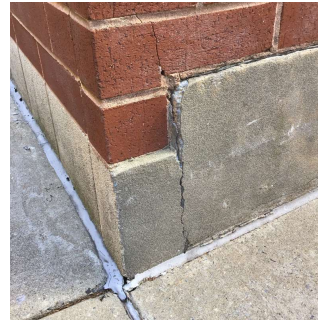
Facade C

CAST IN PLACE / PRE-CAST CONCRETE: MAJOR CRACKS/SPALLING

10  
S.F.  
REPLACE  
PRIORITY 4  
LEVEL 2

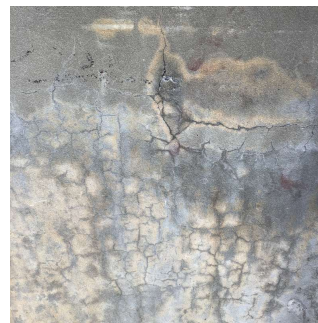
Facade C

CAST IN PLACE / PRE-CAST CONCRETE: MINOR CRACKS/SPALLING

REPAIR

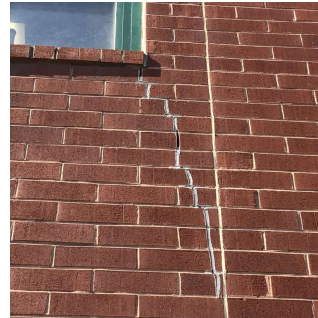
Facade D

BRICK: MAJOR / THRU CRACKS

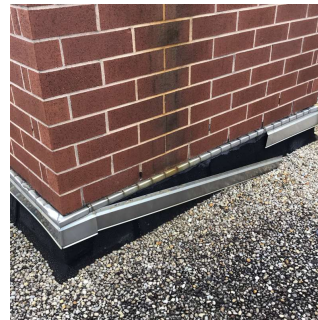
Roof 1 - CH

**BUILT-UP: FLASHING: CAP FLASHING DAMAGED**

20  
L.F.  
REPLACE  
PRIORITY 4  
LEVEL 2

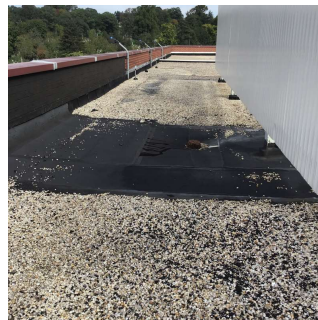
Roof 1

**BUILT-UP: ROOFING: LOSS OF GRAVEL**

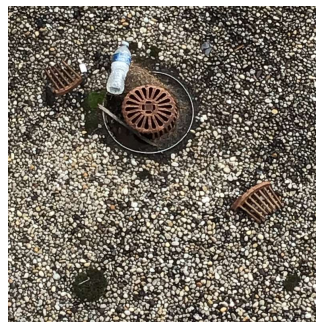
Roof 2  
No violations recorded.

DETERIORATED

1  
EACH  
REPLACE  
PRIORITY 4  
LEVEL 2

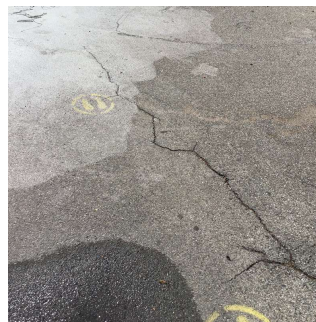
Near Exit 2

Instance on Schoolyard	Inspected
Condition	3 - Fair
Deficiency	ASPHALT: CRACKS - MAJOR
Deficiency Location/Instance	Near Exit 2, Near Gate to Schoolyard
Deficiency Quantity	75
Quantity Uom	S.F.
Potential Action	REPLACE
Urgency of Action	PRIORITY 3
Purpose of Action	LEVEL 2
Deficiency Photo1
