NYC Department of Education
Building Condition Assessment Survey 2023 - 2024

Architectural Inspection

Asset: P.S. 11 - BROOKLYN, 419 WAVERLY AVENUE, New York, 11238

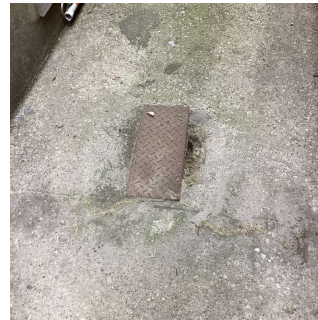
AW3
No violations recorded.

Question	Response
Architectural	
EXTERIOR	Inspected
AREAWAY	Inspected
Instance on AW1 - AW4	Inspected
Instance Condition	3 - Fair
Instance Quantity	4
Instance Quantity Uom	EACH
Deficiency	AREAWAY DRAINS: DETERIORATED

1
EACH
REPLACE
PRIORITY 4
LEVEL 2

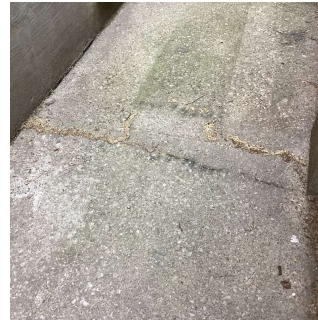
AW3

AREAWAY SLAB: CRACKS AND SPALLING

10
S.F.
REPAIR
PRIORITY 3
LEVEL 2

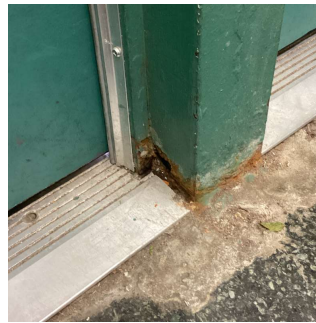
Facade A - Main Entrance

Question	Response
EXTERIOR	
CORNICE	Does not Exist
DOORS	Inspected
DOORS AND FRAMES	Inspected
Condition	5 - Poor
Deficiency	METAL: DETERIORATED DOOR AND FRAME - MINOR DETERIORATION
Roof Plan reference	
Deficiency Quantity	2
Quantity Uom	EACH
Potential Action	MAINTENANCE
Urgency of Action	PRIORITY 3
Purpose of Action	LEVEL 2
Deficiency Photo1	
Violations	Facade E - Exit 5 No violations recorded.
Deficiency	METAL: DETERIORATED DOOR AND FRAME - MAJOR DETERIORATION
Roof Plan reference	
Deficiency Quantity	8
Quantity Uom	EACH
Potential Action	REPLACE
Urgency of Action	PRIORITY 4
Purpose of Action	LEVEL 2

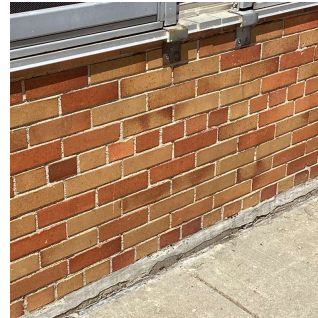
Facade E

BRICK: DETERIORATED JOINTS

PRIORITY 3
LEVEL 2

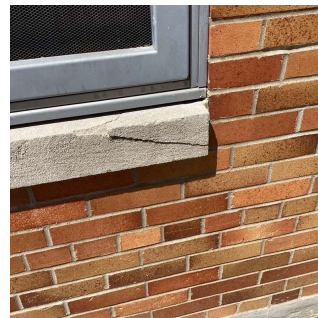
Facade E

BRICK: DETERIORATED MASONRY SILLS - MAJOR

REMOVE AND REPLACE

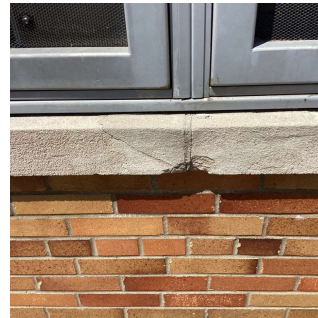
Facade E

BRICK: DETERIORATED MASONRY SILLS - MINOR

REPAIR

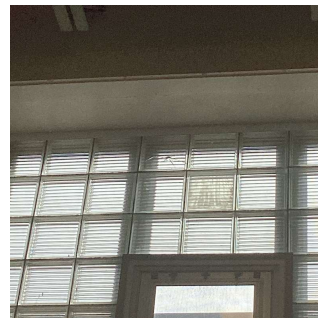
Facade D - Gymnasium

GLASS BLOCK: CHIPPED/ BROKEN PIECES

REPLACE-IN-KIND

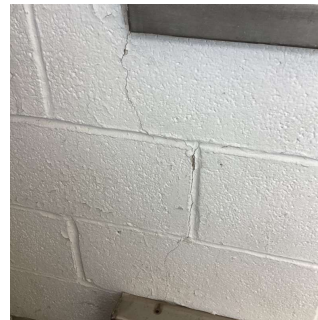
BH2
No violations recorded.

Do solar panels exist on these roofs?	No
Is/Are the roof(s) suitable for Solar Panel installation?	No
Installation Year	2022
Source of Installation	Custodial Staff
Deficiency	No deficiencies recorded
ROOFING DRAINS	Inspected
Condition	1 - Good
Deficiency	No deficiencies recorded
Specialties	Inspected
BULKHEAD/PENTHOUSE	Inspected
Condition	3 - Fair
Deficiency	BULKHEAD/PENTHOUSE WALLS/INTERIOR: CMU CRACKS/SPALLING

20
S.F.
REPLACE
PRIORITY 3
LEVEL 2

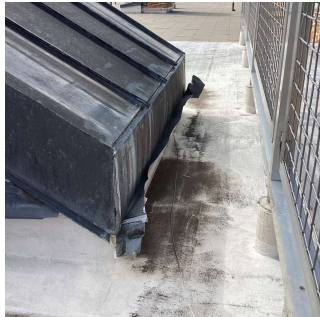
BULKHEAD/PENTHOUSE ROOF: DETERIORATED

20
S.F.
REPLACE
PRIORITY 4
LEVEL 2

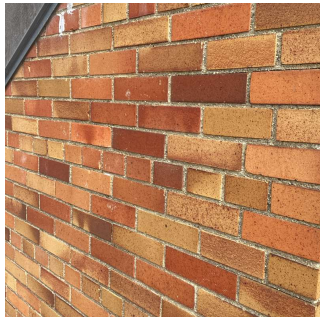
Violations	BH1 No violations recorded.
Deficiency	BULKHEAD/PENTHOUSE WALLS/EXTERIOR: DETERIORATED JOINTS
Roof Plan reference

Deficiency Quantity	200
Quantity Uom	S.F.
Potential Action	REPOINT
Urgency of Action	PRIORITY 3
Purpose of Action	LEVEL 2
Deficiency Photo1

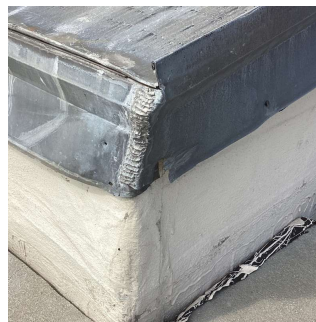
SK
 No violations recorded.

Violations	BH2 No violations recorded.
CUPOLA/ SPIRES/ TOWERS	Does not Exist
DORMER	Does not Exist
DUNNAGE STEEL	Does not Exist
SKYLIGHT/ROOF VENT	Inspected
Material Type(s)	Other
Condition	2 - Between Good and Fair
Deficiency	DAMAGED FLASHING

10
 L.F.
 MAINTENANCE
 PRIORITY 3
 LEVEL 2

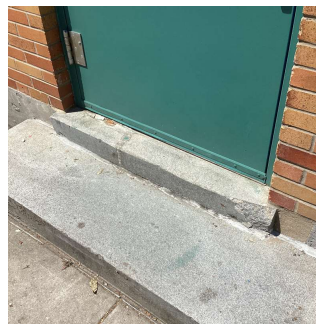
Facade E - Exit 4
No violations recorded.

STONE: CRACKS/SPALLING - MAJOR

10
S.F.
REPLACE
PRIORITY 4
LEVEL 2

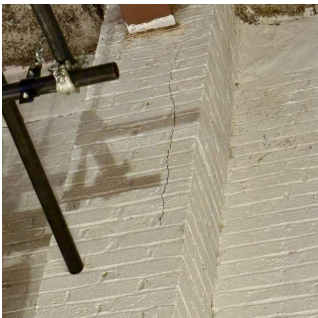
Question	Response
INTERIOR	
STRUCTURAL	Inspected
COLUMNS/BEAMS/BEARING WALLS	Inspected
Condition	2 - Between Good and Fair
Deficiency	STEEL COLUMNS/BEAMS: DETERIORATED MASONRY FIREPROOFING
Deficiency Location/Instance	Ground Floor - Auditorium Stage
Deficiency Quantity	10
Quantity Uom	S.F.
Potential Action	REPLACE
Urgency of Action	PRIORITY 3
Purpose of Action	LEVEL 5
Deficiency Photo1

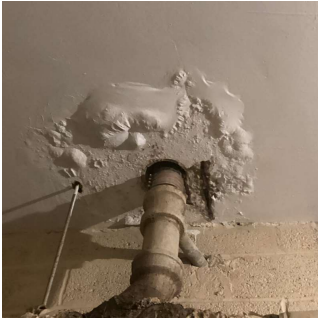
Violations	Auditorium Stage No violations recorded.
FLOOR STRUCTURE	Inspected
Condition	3 - Fair
Deficiency	CONCRETE: CRACKS/SPALLED/REINFORCEMENT EXPOSED
Deficiency Location/Instance	Basement - Room C2
Deficiency Quantity	10
Quantity Uom	S.F.
Potential Action	REPAIR
Urgency of Action	PRIORITY 4
Purpose of Action	LEVEL 5
Deficiency Photo1

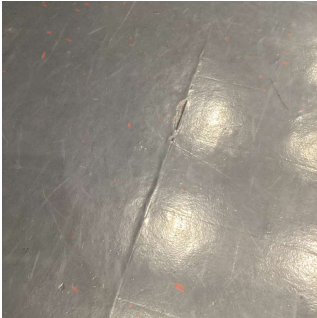
Question	Response
INTERIOR	
AUDITORIUM	
Floor Finish	
Deficiency	SHEET VINYL: BROKEN/DETERIORATED
Deficiency Location/Instance	Front Stage
Deficiency Quantity	10
Quantity Uom	S.F.
Potential Action	REPLACE
Urgency of Action	PRIORITY 3
Purpose of Action	LEVEL 2
Deficiency Photo1

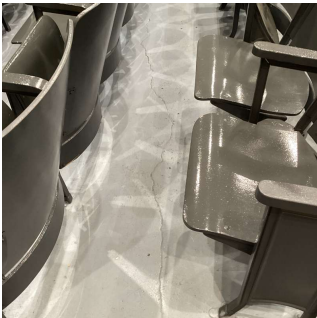
Violations	Front Stage No violations recorded.
Deficiency	CONCRETE: CRACKS
Deficiency Location/Instance	Near Row F, Balcony
Deficiency Quantity	45
Quantity Uom	S.F.
Potential Action	REPLACE
Urgency of Action	PRIORITY 3
Purpose of Action	LEVEL 2
Deficiency Photo1

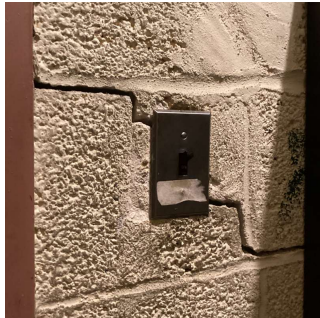
Violations	Left Side Room near Stage No violations recorded.
Deficiency	MASONRY: CRACKS/SPALLING
Deficiency Location/Instance	Right and Left Side, Left Side Room near Stage
Deficiency Quantity	40
Quantity Uom	S.F.
Potential Action	REPLACE
Urgency of Action	PRIORITY 3
Purpose of Action	LEVEL 2
Deficiency Photo1

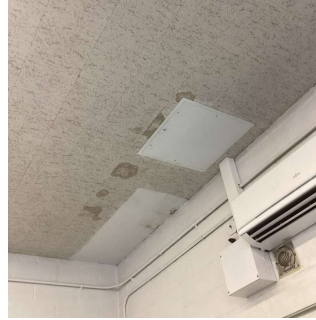
Near Right Side Windows
Violations	No violations recorded.
Deficiency	ACOUSTIC TILES ON PLASTER: DAMAGED/MISSING
Deficiency Location/Instance	Near Main Entrance
Deficiency Quantity	20
Quantity Uom	S.F.

Potential Action	REPLACE
Urgency of Action	PRIORITY 3
Purpose of Action	LEVEL 2
Deficiency Photo1

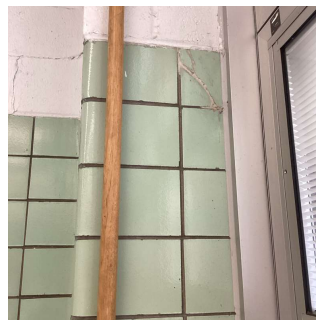
Instance on Ground Floor	Inspected
Condition	2 - Between Good and Fair
Deficiency	GLAZED BLOCK: CRACKS/SPALLING
Deficiency Location/Instance	Near Right Side Windows
Deficiency Quantity	10
Quantity Uom	S.F.
Potential Action	REPLACE
Urgency of Action	PRIORITY 3
Purpose of Action	LEVEL 2
Deficiency Photo1

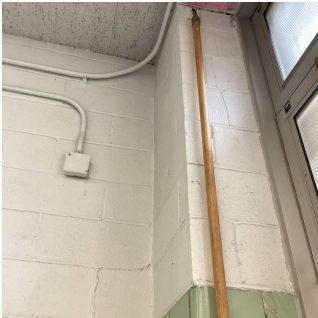
Question	Response
INTERIOR	
CAFETERIA	
Walls	
Violations	Near Right Side Windows No violations recorded.
Deficiency	MASONRY: CRACKS/SPALLING
Deficiency Location/Instance	Near Right Side Windows, by Rolling Door
Deficiency Quantity	30
Quantity Uom	S.F.
Potential Action	REPLACE
Urgency of Action	PRIORITY 3
Purpose of Action	LEVEL 2
Deficiency Photo1

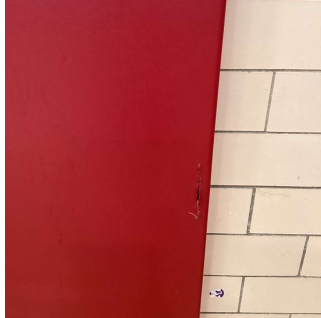
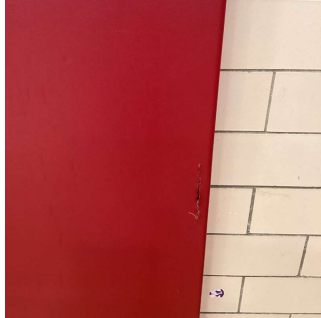
Near Left Side Windows

Deficiency	WALL PADDING: DETERIORATED
Deficiency Location/Instance	Near Left Side Windows, by Rear Basketball Hoop
Deficiency Quantity	40
Quantity Uom	S.F.
Potential Action	REPLACE
Urgency of Action	PRIORITY 3
Purpose of Action	LEVEL 2
Deficiency Photo1

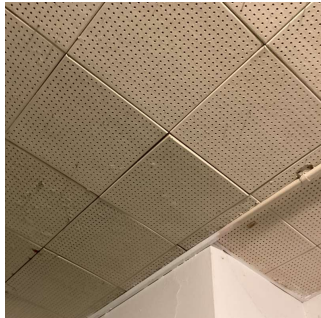
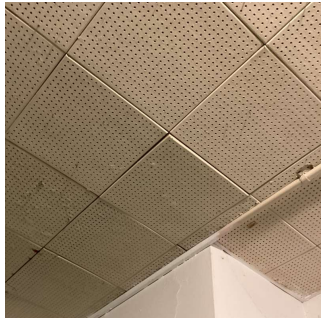
Instance on Ground Floor	Inspected
Condition	3 - Fair
Deficiency	ACOUSTIC TILES ON PLASTER: DAMAGED/MISSING
Deficiency Location/Instance	Kitchen Locker Room, Fridges Room
Deficiency Quantity	20
Quantity Uom	S.F.
Potential Action	REPLACE
Urgency of Action	PRIORITY 3
Purpose of Action	LEVEL 2
Deficiency Photo1

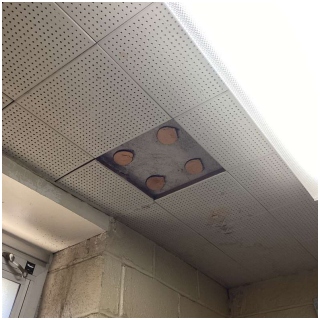
Question	Response
INTERIOR	
KITCHEN	
Ceiling	
Violations	Kitchen Locker Room No violations recorded.
Deficiency	ACOUSTIC TILES ON PLASTER: DAMAGED/MISSING
Deficiency Location/Instance	Kitchen Storage Room
Deficiency Quantity	10
Quantity Uom	S.F.
Potential Action	REPLACE
Urgency of Action	PRIORITY 4
Purpose of Action	LEVEL 4
Deficiency Photo1

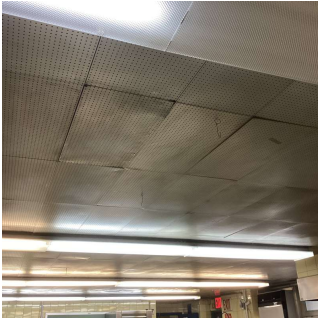
Violations	Kitchen Storage Room SF101410
Deficiency	METAL PAN: DAMAGED/MISSING
Deficiency Location/Instance	Near Locker Room, Servery
Deficiency Quantity	20
Quantity Uom	S.F.
Potential Action	REPLACE
Urgency of Action	PRIORITY 3
Purpose of Action	LEVEL 2
Deficiency Photo1

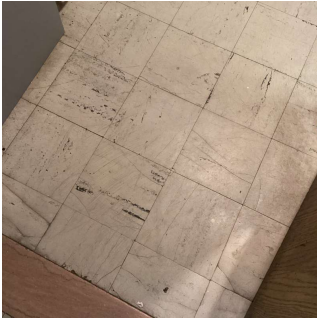
Question	Response
INTERIOR	
KITCHEN	
Door(s)	
Violations	No violations recorded.
Floor Finish	
Instance on Ground Floor	Inspected
Condition	5 - Poor
Deficiency	VINYL TILES: BROKEN/DETERIORATED/MISSING TILES
Deficiency Location/Instance	Kitchen Locker Room, In Kitchen Storage Room
Deficiency Quantity	30
Quantity Uom	S.F.
Potential Action	REPLACE
Urgency of Action	PRIORITY 3
Purpose of Action	LEVEL 2
Deficiency Photo1

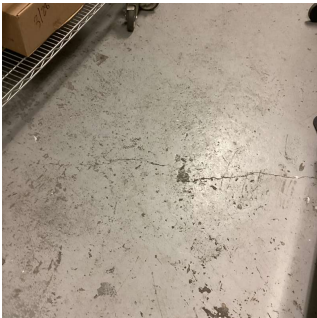
Violations	Kitchen Locker Room No violations recorded.
Deficiency	CONCRETE: CRACKS
Deficiency Location/Instance	Fridges Room
Deficiency Quantity	25
Quantity Uom	S.F.
Potential Action	REPLACE
Urgency of Action	PRIORITY 3
Purpose of Action	LEVEL 2
Deficiency Photo1

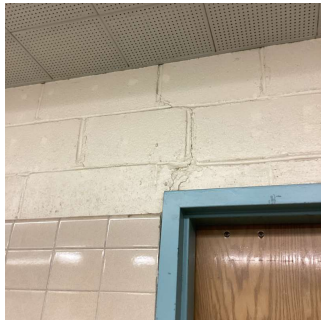
Walls	
Instance on Ground Floor	Inspected
Condition	3 - Fair
Deficiency	MASONRY: CRACKS/SPALLING
Deficiency Location/Instance	Storage Room, In Kitchen Storage Room
Deficiency Quantity	30
Quantity Uom	S.F.
Potential Action	REPLACE
Urgency of Action	PRIORITY 4
Purpose of Action	LEVEL 4
Deficiency Photo1

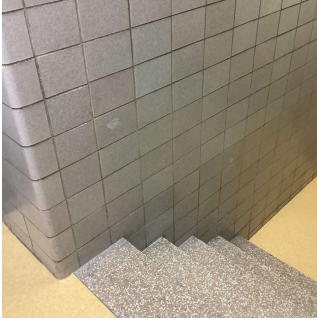
Question	Response
INTERIOR	
STAIRS/RAMPS: INTERIOR	
Railings	
Condition	4 - Between Fair and Poor
Deficiency	METAL: MISSING
Deficiency Location/Instance	Exit 1 - Vestibule, Auditorium - Right Side Exit
Deficiency Quantity	20
Quantity Uom	L.F.
Potential Action	REPLACE
Urgency of Action	PRIORITY 5
Purpose of Action	LEVEL 6
Deficiency Photo1

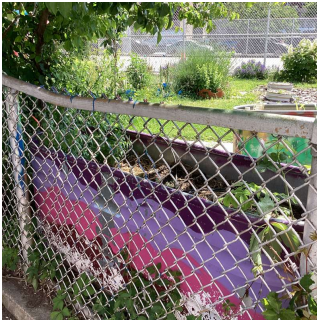
No	Protruding Elements	Severely damaged benches with a protruding metallic element is a potential safety hazard	SITE PLAYGROUN DS Benches	Near Garden	McRaymond Medy	Custodian

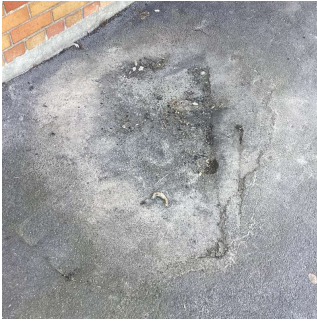
Violations	Near Garden No violations recorded.
Pavement	
Instance on Schoolyard	Inspected
Condition	3 - Fair
Deficiency	ASPHALT: POTHOLES
Deficiency Location/Instance	Near Main Entrance
Deficiency Quantity	30
Quantity Uom	S.F.
Potential Action	REPAIR
Urgency of Action	PRIORITY 3
Purpose of Action	LEVEL 2
Deficiency Photo1
