NYC Department of Education
Building Condition Assessment Survey 2023 - 2024

Architectural Inspection

Asset: P.S. 16 - BROOKLYN, 157 WILSON STREET, New York, 11211

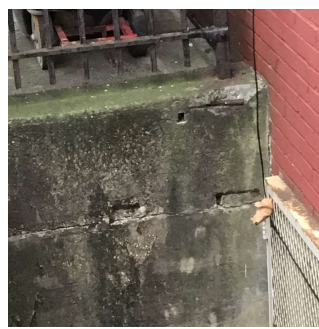
Violations	AW3 No violations recorded.
Deficiency	AREAWAY STAIRS: DETERIORATED TREADS/RISERS/NOSINGS
Roof Plan reference	<p>K016</p>

Question	Response
Architectural	
EXTERIOR	Inspected
AREAWAY	Inspected
Instance on AW1-AW9	Inspected
Instance Condition	3 - Fair
Instance Quantity	9
Instance Quantity Uom	EACH
Deficiency	AREAWAY WALLS: CRACKS AND SPALLING
Roof Plan reference	<p>K016</p>

Deficiency Quantity	10
Quantity Uom	S.F.
Potential Action	REPAIR
Urgency of Action	PRIORITY 3
Purpose of Action	LEVEL 2
Deficiency Photo1

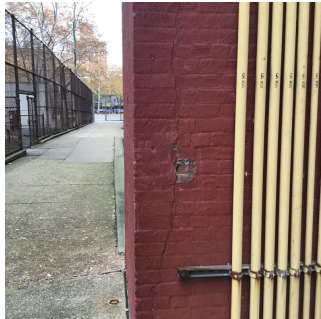
Violations	Facade E No violations recorded.
COPING	
Condition	Inspected 3 - Fair
Deficiency	TERRA COTTA: CRACKED/BROKEN PIECES

Violations	AW3 No violations recorded.
AWNINGS AND CANOPIES	
Violations	Does not Exist
CHIMNEY	
Material Type(s)	Inspected Masonry
Condition	3 - Fair
Deficiency	BRICK: MINOR CRACKS AND SPALLING
Roof Plan reference

Deficiency Quantity	50
Quantity Uom	S.F.
Potential Action	RESTITCH
Urgency of Action	PRIORITY 3
Purpose of Action	LEVEL 2
Deficiency Photo1

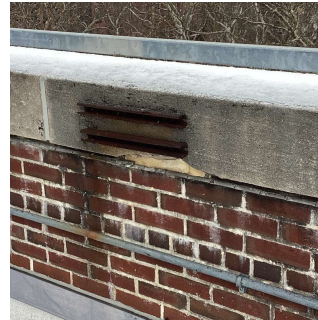
Facade D

CAST STONE: CRACKED/BROKEN PIECES

20
 L.F.
 REPLACE-IN-KIND
 PRIORITY 4
 LEVEL 2

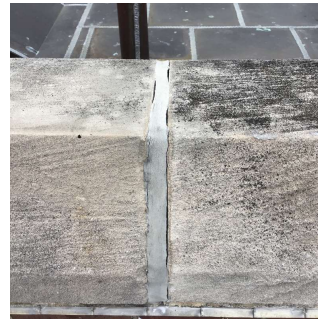
Roof 2 - Facade A

CAST STONE: DETERIORATED TRANSVERSE JOINTS

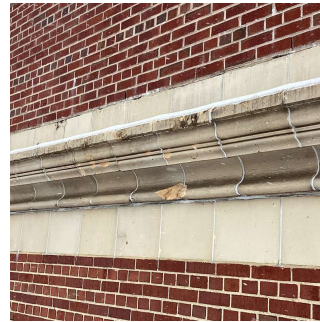
Facade G

TERRA COTTA: MAJOR CRACKS, SPALLING

20
S.F.
REPLACE
PRIORITY 4
LEVEL 2

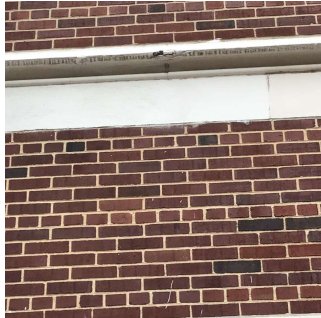
PRE-CAST CONCRETE: MAJOR CRACKS, SPALLING

Violations	<p>Cornice near Exit 7</p> <p>No violations recorded.</p>
DOORS	
DOORS AND FRAMES	
Condition	4 - Between Fair and Poor
Deficiency	METAL: DETERIORATED DOOR AND FRAME - MAJOR DETERIORATION
Roof Plan reference

10
S.F.
REPLACE
PRIORITY 5
LEVEL 6

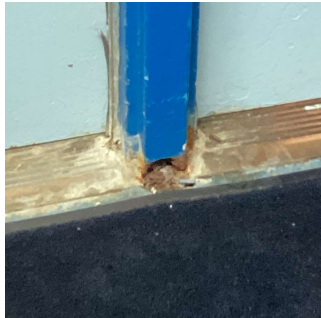
Violations	<p>Facade E</p> <p>No violations recorded.</p>
DOOR HARDWARE	
Condition	3 - Fair
Deficiency	No deficiencies recorded
LINTELS	
Condition	3 - Fair
Deficiency	STEEL: MAJOR RUSTING

Deficiency Quantity	2
Quantity Uom	EACH
Potential Action	REPLACE
Urgency of Action	PRIORITY 4
Purpose of Action	LEVEL 2
Deficiency Photo1

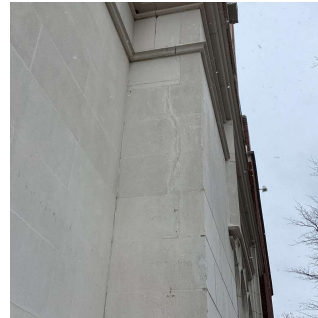
Facade A

STONE: CRACKS AT BUILDING CORNERS

REPLACE

PRIORITY 4
LEVEL 2

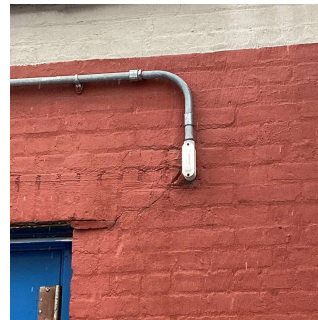
Facade E

BRICK: MAJOR / THRU CRACKS

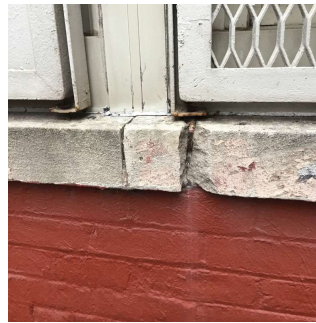
Facade E

BRICK: DETERIORATED MASONRY SILLS - MAJOR

REMOVE AND REPLACE

LEVEL 2

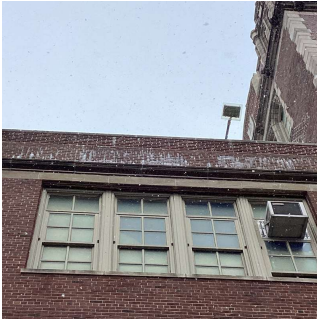
Question	Response
EXTERIOR	
PARAPETS	
Deficiency Photo1

Violations	Facade A No violations recorded.
Deficiency	BRICK: MAJOR DETERIORATION/CRACKS
Roof Plan reference

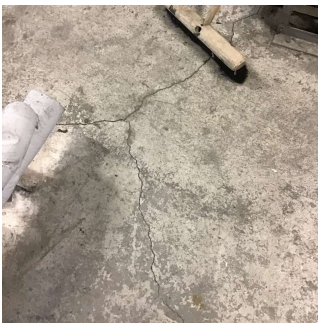
Question	Response
EXTERIOR	
WINDOWS	
EXTERIOR GUARDS	
Deficiency Quantity	60
Quantity Uom	S.F.
Potential Action	REPLACE
Urgency of Action	PRIORITY 4
Purpose of Action	LEVEL 2
Deficiency Photo1	 
Violations	Facade D - AW3 No violations recorded.
LINTELS	Inspected
Condition	2 - Between Good and Fair
Deficiency	No deficiencies recorded
WINDOWS	Inspected
Material Type(s)	Aluminum
Instance on Aluminum - Double Hung: All Facades	Inspected
Instance Condition	3 - Fair
Instance Quantity	15,000
Instance Quantity Uom	S.F.
Are these windows insulated	Yes
Installation Year	1998
Source of Installation	Custodial Staff
Deficiency	No deficiencies recorded
INTERIOR	Inspected
POOLS	Does not Exist
STRUCTURAL	Inspected
COLUMNS/BEAMS/BEARING WALLS	Inspected
Condition	2 - Between Good and Fair
Deficiency	No deficiencies recorded
FLOOR STRUCTURE	Inspected
Condition	2 - Between Good and Fair
Deficiency	CONCRETE: CRACKS/SPALLED/REINFORCEMENT EXPOSED

Violations	Room 340M No violations recorded.
FOUNDATION WALLS	
Material Type(s)	Inspected Concrete
Condition	4 - Between Fair and Poor
Deficiency	CONCRETE: WATER INFILTRATION IN NON- INSTRUCTIONAL SPACE
Deficiency Location/Instance	Boiler Room
Deficiency Quantity	100
Quantity Uom	S.F.
Potential Action	INSTALL WATERPROOFING
Urgency of Action	PRIORITY 5
Purpose of Action	LEVEL 5
Deficiency Photo1

Deficiency Location/Instance	Room 340 M
Deficiency Quantity	10
Quantity Uom	S.F.
Potential Action	REPAIR
Urgency of Action	PRIORITY 3
Purpose of Action	LEVEL 5

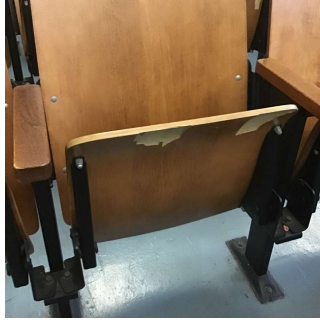
Question	Response
INTERIOR	
AUDITORIUM	
Ceiling	
Instance on 1st Floor (511 Seats)	Inspected
Condition	2 - Between Good and Fair
Deficiency	No deficiencies recorded
Door(s)	
Instance on 1st Floor (511 Seats)	Inspected
Condition	2 - Between Good and Fair
Deficiency	No deficiencies recorded
Fixed H/C Lift	
Instance on 1st Floor (511 Seats)	Does not Exist
Fixed Seating	
Instance on 1st Floor (511 Seats)	Inspected
Condition	2 - Between Good and Fair
Deficiency	DAMAGED/BROKEN/INOPERABLE
Deficiency Location/Instance	Seats J/4, O/7, Q/3, R/5, T/7, and others
Deficiency Quantity	9
Quantity Uom	EACH
Potential Action	REPLACE
Urgency of Action	PRIORITY 3
Purpose of Action	LEVEL 2
Deficiency Photo1

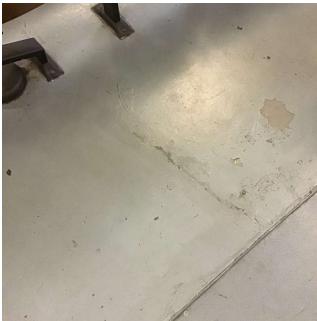
Violations	No violations recorded.
Floor Finish	
Instance on 1st Floor (511 Seats)	Inspected
Condition	2 - Between Good and Fair
Deficiency	CONCRETE: CRACKS
Deficiency Location/Instance	Near Seats B/7, H/2, G/9, O/7, S/1
Deficiency Quantity	60

Near Seat B/7
Violations	No violations recorded.
Sliding-folding Partition	
Instance on 1st Floor (511 Seats)	Does not Exist
Stage	
Instance on 1st Floor (511 Seats)	Inspected
Stage	Inspected
Instance on 1st Floor (511 Seats)	Inspected
Condition	2 - Between Good and Fair
Deficiency	DAMAGED FLOOR
Deficiency Location/Instance	Left Side
Deficiency Quantity	10
Quantity Uom	S.F.
Potential Action	REPLACE
Urgency of Action	PRIORITY 3
Purpose of Action	LEVEL 2
Deficiency Photo1

Quantity Uom	S.F.
Potential Action	REPLACE
Urgency of Action	PRIORITY 3
Purpose of Action	LEVEL 2

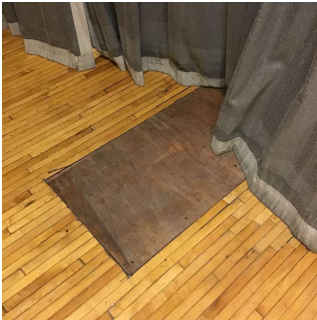
Left Side
Violations	No violations recorded.
Stage Curtain Rigging	
Instance on 1st Floor (511 Seats)	Inspected
Condition	2 - Between Good and Fair
Deficiency	No deficiencies recorded
Stage Curtains	
Instance on 1st Floor (511 Seats)	Inspected
Condition	2 - Between Good and Fair
Deficiency	No deficiencies recorded
Walls	
Instance on 1st Floor (511 Seats)	Inspected
Condition	2 - Between Good and Fair

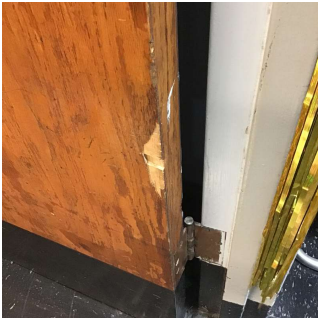
Question	Response
INTERIOR	
CLASSROOMS/CORRIDORS/ADMIN SPACES	
Door(s)	
	Room 429
Violations	No violations recorded.
Deficiency	WOOD: DETERIORATED DOOR
Deficiency Location/Instance	Rooms 207, 302, 304, 424, 526, and others
Deficiency Quantity	14
Quantity Uom	EACH
Potential Action	MAINTENANCE
Urgency of Action	PRIORITY 3
Purpose of Action	LEVEL 2
Deficiency Photo1

Room 424
Violations	No violations recorded.
Floor Finish	Inspected
Condition	3 - Fair
Deficiency	TERRAZZO: CRACKS
Deficiency Location/Instance	Main Entrance Lobby
Deficiency Quantity	10
Quantity Uom	S.F.
Potential Action	REPLACE
Urgency of Action	PRIORITY 3
Purpose of Action	LEVEL 2
Deficiency Photo1

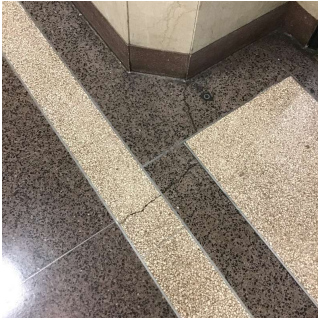
Main Entrance Lobby
Violations	No violations recorded.
Deficiency	VINYL TILES: TRIPPING HAZARD - ELECTRICAL OUTLET
Deficiency Location/Instance	Room 229
Deficiency Quantity	20
Quantity Uom	S.F.
Potential Action	REMOVE
Urgency of Action	PRIORITY 5
Purpose of Action	LEVEL 6

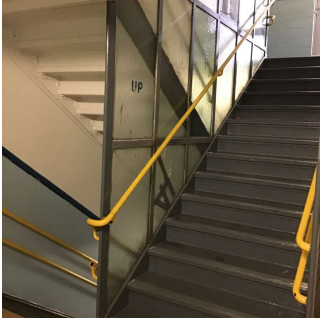
Question	Response
INTERIOR	
STAIRS/RAMPS: INTERIOR	
Railings	Inspected
Condition	4 - Between Fair and Poor
Deficiency	METAL: BROKEN BRACKET
Deficiency Location/Instance	Stair D/2
Deficiency Quantity	2
Quantity Uom	EACH
Potential Action	REPLACE
Urgency of Action	PRIORITY 3
Purpose of Action	LEVEL 2
Deficiency Photo1

Violations	Stair D/2 No violations recorded.
Deficiency	METAL: DAMAGED
Deficiency Location/Instance	Stair D/2
Deficiency Quantity	16
Quantity Uom	L.F.
Potential Action	REPLACE
Urgency of Action	PRIORITY 5
Purpose of Action	LEVEL 6
Deficiency Photo1

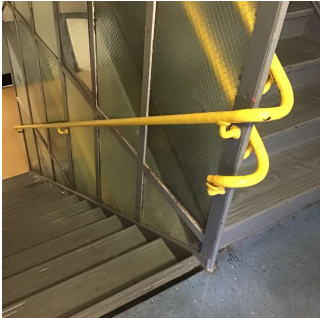
Violations	Stair D/2 No violations recorded.
Stairs and Landings	Inspected
Condition	5 - Poor
Deficiency	STONE: BROKEN/MISSING
Deficiency Location/Instance	Stairs A/1,3, B/3, E/1-5, F/1,2
Deficiency Quantity	130
Quantity Uom	S.F.
Potential Action	REPLACE
Urgency of Action	PRIORITY 3
Purpose of Action	LEVEL 2

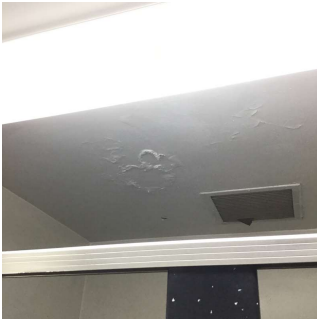
Violations	Stair C/1 No violations recorded.
TOILET ROOMS - STAFF	
Ceiling	Inspected
Condition	2 - Between Good and Fair
Deficiency	PLASTER: CRACKS/SPALLING
Deficiency Location/Instance	1st Floor Women
Deficiency Quantity	10
Quantity Uom	S.F.
Potential Action	REPLACE
Urgency of Action	PRIORITY 3
Purpose of Action	LEVEL 2
Deficiency Photo1

Violations	1st Floor Women No violations recorded.
Door(s)	
Condition	5 - Poor
Deficiency	WOOD: DETERIORATED DOOR
Deficiency Location/Instance	Room 230, In Room 334, Old Boys Locker Room, 5th Floor Staff
Deficiency Quantity	4
Quantity Uom	EACH
Potential Action	MAINTENANCE
Urgency of Action	PRIORITY 3
Purpose of Action	LEVEL 2

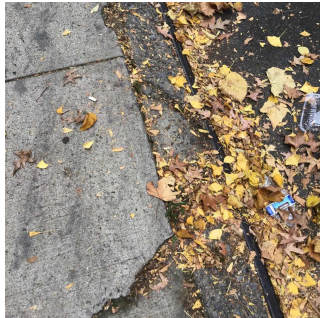
Near NYC Park
Violations	No violations recorded.
Pavers	Does not Exist
DOT Sidewalk	Inspected
Asphalt	Does not Exist
Concrete	Inspected
Condition	4 - Between Fair and Poor
Deficiency	DAMAGED CURBS
Deficiency Location/Instance	Wilson Street, Taylor Street
Deficiency Quantity	80
Quantity Uom	L.F.
Potential Action	REPLACE
Urgency of Action	PRIORITY 3
Purpose of Action	LEVEL 2
Deficiency Photo1

Wilson Street
Violations	No violations recorded.
Deficiency	DAMAGED/DETERIORATED/MISSING SECTIONS
Deficiency Location/Instance	Wilson Street, Bedford Avenue, Taylor Street
Deficiency Quantity	1,325
Quantity Uom	S.F.
Potential Action	REPLACE
Urgency of Action	PRIORITY 3
Purpose of Action	LEVEL 2

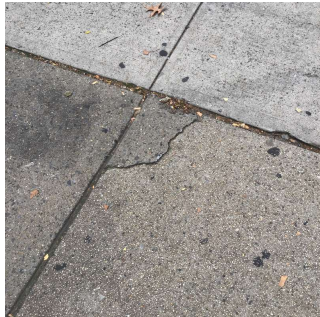
Wilson Street
Violations	No violations recorded.
Pavers	Inspected
Condition	2 - Between Good and Fair
Deficiency	DAMAGED/MISSING
Deficiency Location/Instance	Taylor Street
Deficiency Quantity	10
Quantity Uom	S.F.
Potential Action	REPLACE
Urgency of Action	PRIORITY 3
Purpose of Action	LEVEL 2
Deficiency Photo1	 
	Taylor Street
Violations	No violations recorded.
PLAYGROUNDS	Inspected
Instance on Taylor Street	Inspected
Benches	
Instance on Taylor Street	Inspected
Condition	2 - Between Good and Fair
Deficiency	No deficiencies recorded
Fence	
Instance on Taylor Street	Inspected
Condition	5 - Poor
Deficiency	CONCRETE CURB: DAMAGED/DETERIORATED
Deficiency Location/Instance	Near Entrance
Deficiency Quantity	10
Quantity Uom	S.F.
Potential Action	REPLACE
Urgency of Action	PRIORITY 3
