**NYC Department of Education**  
**Building Condition Assessment Survey 2023 - 2024**

Architectural Inspection

**Asset: P.S. 18 - BROOKLYN, 101 MAUJER STREET, New York, 11206**

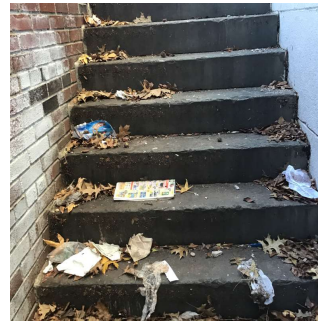
AW3

Question	Response
<b>Architectural</b>	
<b>EXTERIOR</b>	Inspected
<b>AREAWAY</b>	Inspected
Instance on AW1-AW4	Inspected
Instance Condition	3 - Fair
Instance Quantity	4
Instance Quantity Uom	EACH
Deficiency	AREAWAY STAIRS: DETERIORATED TREADS/RISERS/NOSINGS

REPAIR

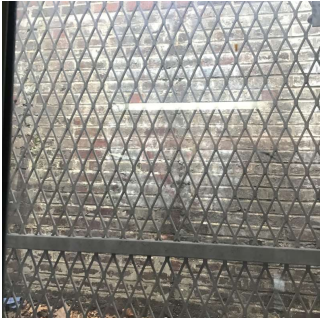
AREAWAY WALLS: CRACKS AND SPALLING

REPAIR

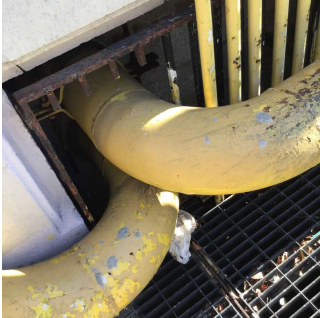
Violations	AW4 No violations recorded.
Deficiency	AREAWAY GRATINGS: MAJOR RUSTING / OR BROKEN
Roof Plan reference	K018

Deficiency Quantity	50
Quantity Uom	S.F.
Potential Action	REPLACE
Urgency of Action	PRIORITY 4
Purpose of Action	LEVEL 2
Deficiency Photo1

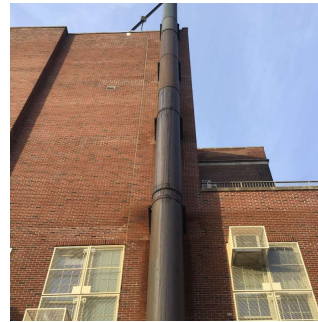
Chimney

Violations	AW1, AW2 No violations recorded.
<b>AWNINGS AND CANOPIES</b>	Does not Exist
<b>CHIMNEY</b>	Inspected
Material Type(s)	Masonry, Metal
Condition	3 - Fair
Deficiency	METAL: DENTS, MAJOR RUSTING

50  
 S.F.  
 REPLACE-UPGRADE  
 PRIORITY 4  
 LEVEL 2

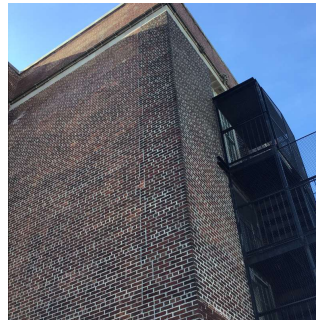
Facade B

Question	Response
<b>EXTERIOR</b>	
<b>EXTERIOR WALLS</b>	
Instance on All Facades	Inspected
Instance Condition	4 - Between Fair and Poor
Instance Quantity	17,000
Instance Quantity Uom	S.F.
Deficiency	BRICK: MINOR CRACKS AND SPALLING
Roof Plan reference	<p>K018</p>
Elevation	
Deficiency Quantity	50
Quantity Uom	S.F.
Potential Action	RESTITCH
Urgency of Action	PRIORITY 3
Purpose of Action	LEVEL 2
Deficiency Photo1	
Violations	No violations recorded.
Deficiency	BRICK: CRACKS/DISPLACED/SPALLED BRICK AT BUILDING CORNERS

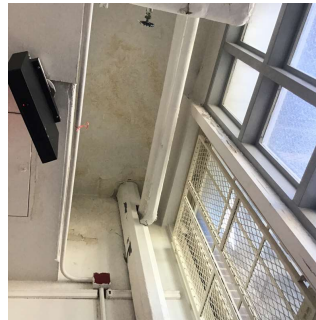
Facade B - Corridor near 4th Floor Boys Toilet, Corridor near Stair B/3

BRICK: WATER INFILTRATION IN INSTRUCTIONAL SPACE

REPAIR

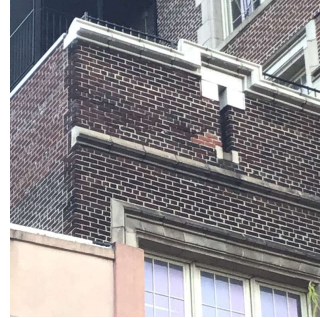
Facade A

BRICK: DETERIORATED JOINTS

REPOINT  
PRIORITY 3  
LEVEL 2

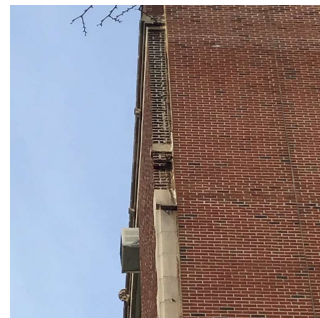
**BRICK: MAJOR / THRU CRACKS**

30  
S.F.  
REMOVE AND REBUILD  
PRIORITY 4  
LEVEL 2

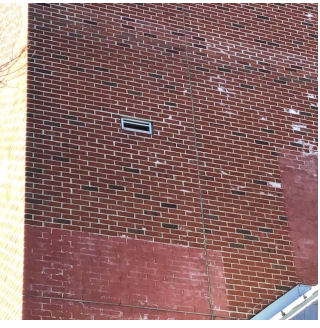
Question	Response
<b>EXTERIOR</b>	
<b>EXTERIOR WALLS</b>	Inspected
Violations	Facade C No violations recorded.
<b>EXTERIOR SOFFITS</b>	Does not Exist
<b>LOADING DOCK</b>	Does not Exist
<b>LOUVER</b>	Inspected
Condition	3 - Fair
Deficiency	BROKEN/ DENTED BLADES
Roof Plan reference	K018

Deficiency Quantity	10
Quantity Uom	S.F.
Potential Action	REPLACE
Urgency of Action	PRIORITY 4
Purpose of Action	LEVEL 2
Deficiency Photo1

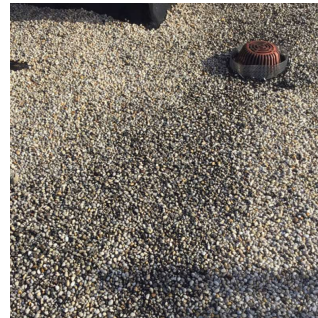
Roof 1 - Rooms 501, 502, 503, 504, 5th Floor Women's Toilet Room

BUILT-UP: ROOFING: MAJOR ACTIVE ROOF LEAKS IN INSTRUCTIONAL SPACE

REPLACE ROOFING WITHOUT MAJOR EQUIPMENT REMOVAL

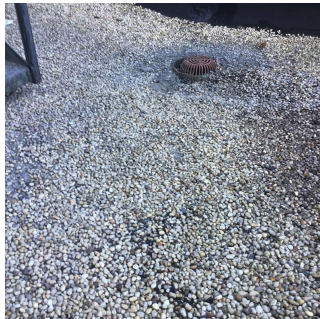
Violations	Roof 2 - Stair B2 No violations recorded.
Deficiency	<b>BUILT-UP: ROOFING: DELAMINATION</b>
Roof Plan reference	K018

Deficiency Quantity	100
Quantity Uom	S.F.
Potential Action	<b>REPLACE ROOFING WITHOUT MAJOR EQUIPMENT REMOVAL</b>
Urgency of Action	<b>PRIORITY 4</b>
Purpose of Action	<b>LEVEL 2</b>
Deficiency Photo1

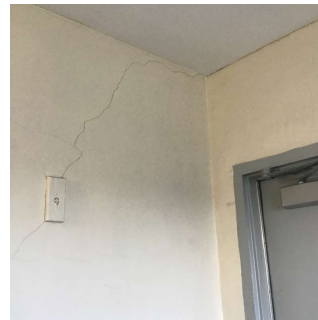
Bulkhead 1

Violations	Roof 2 No violations recorded.
<b>ROOFING DRAINS</b>	Inspected
Condition	2 - Between Good and Fair
Deficiency	No deficiencies recorded
<b>Specialties</b>	Inspected
<b>BULKHEAD/PENTHOUSE</b>	Inspected
Condition	3 - Fair
Deficiency	<b>BULKHEAD/PENTHOUSE WALLS/INTERIOR: PLASTER CRACKS/SPALLING</b>

100  
S.F.  
REPLACE  
PRIORITY 3  
LEVEL 2

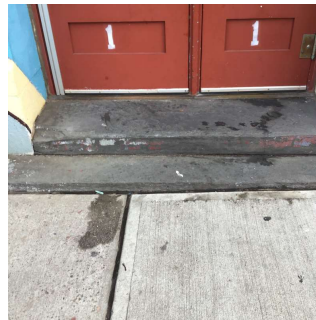
Main Entry

STONE: CRACKS/SPALLING - MAJOR

REPLACE

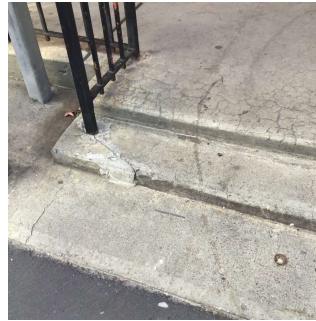
Facade C

CONCRETE: CRACKS/SPALLING - MAJOR

REPLACE

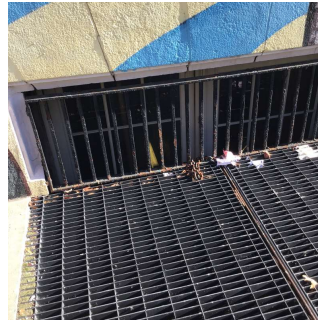
Facade A

RUST - MAJOR

REPLACE

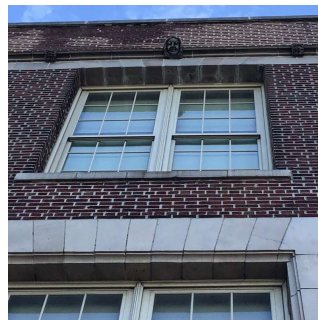
STONE: DETERIORATED JOINTS

12  
L.F.  
REPOINT  
PRIORITY 3  
LEVEL 2

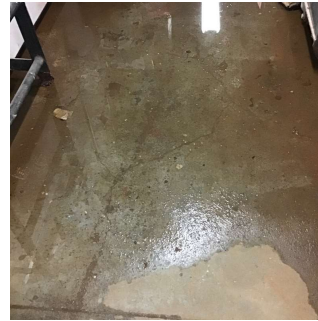
Basement near oil Tank room

Inspected
Condition	4 - Between Fair and Poor
Deficiency	CONCRETE SLAB ON GRADE: THRU CRACKS
Deficiency Location/Instance	Basement near Oil Tank Room
Deficiency Quantity	100
Quantity Uom	S.F.
Potential Action	REPAIR
Urgency of Action	PRIORITY 3
Purpose of Action	LEVEL 5

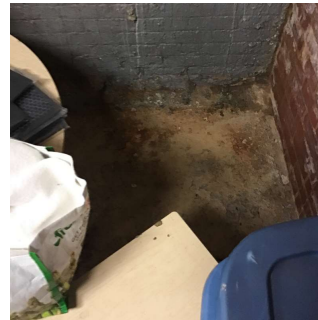
Basement below Facade C

**CONCRETE SLAB ON GRADE: WATER INFILTRATION IN NON-INSTRUCTIONAL SPACE**

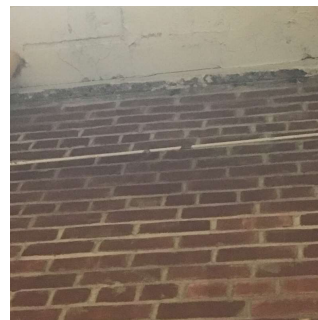
Basement Facade C

**CONCRETE: CRACKS/SPALLED/REINFORCEMENT EXPOSED**

REPAIR

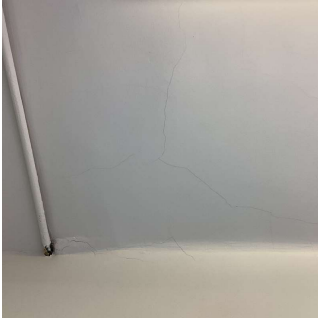
Condition	2 - Between Good and Fair
Deficiency	PLASTER: CRACKS/SPALLING

Question	Response
<b>INTERIOR</b>	
<b>CAFETERIA</b>	
<b>Ceiling</b>	
Deficiency Location/Instance	Exit 5&6 Vestibule
Deficiency Quantity	10
Quantity Uom	S.F.
Potential Action	REPLACE
Urgency of Action	PRIORITY 3
Purpose of Action	LEVEL 2
Deficiency Photo1

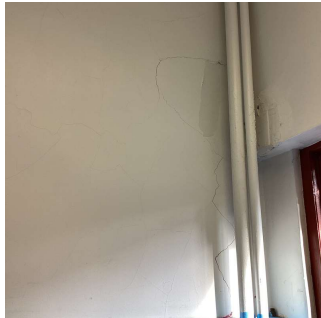
Near Kitchen
Violations	No violations recorded.
Deficiency	PLASTER: CRACKS/SPALLING
Deficiency Location/Instance	Exit 5&6
Deficiency Quantity	20
Quantity Uom	S.F.
Potential Action	REPLACE
Urgency of Action	PRIORITY 3
Purpose of Action	LEVEL 2
Deficiency Photo1

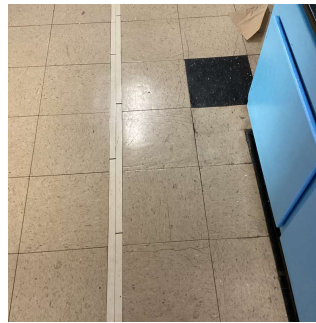
Corridor near Room 403

Violations	Room 503 No violations recorded.
<b>Floor Finish</b>	
Condition	Inspected 3 - Fair
Deficiency	VINYL TILES: BROKEN/DETERIORATED/MISSING TILES
Deficiency Location/Instance	Corridor near Room 403, Room 303
Deficiency Quantity	40
Quantity Uom	S.F.
Potential Action	REPLACE
Urgency of Action	PRIORITY 3
Purpose of Action	LEVEL 2
