NYC Department of Education
Building Condition Assessment Survey 2023 - 2024

Architectural Inspection

K020

Asset: P.S. 20 - BROOKLYN, 225 ADELPHI STREET, New York, 11205

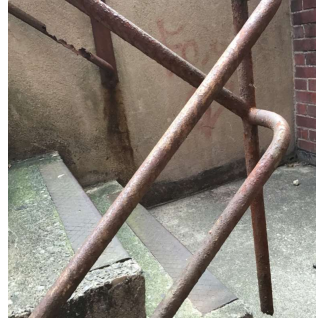
AW3

AREAWAY STAIRS: DETERIORATED RAILINGS

REPLACE

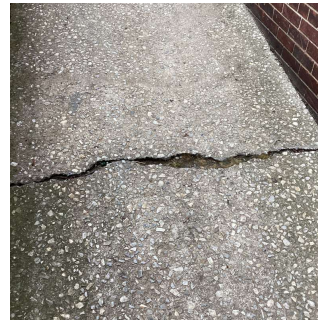
AW2

AREAWAY SLAB: CRACKS AND SPALLING

30
S.F.
REPLACE
PRIORITY 4
LEVEL 2

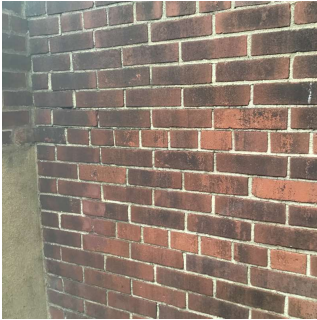
AREAWAY WALLS: DETERIORATED JOINTS

200
S.F.
REPAIR
PRIORITY 3
LEVEL 2

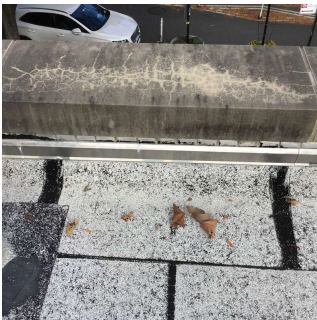
<p align="center">Adelphi Street</p>
Deficiency Quantity	200
Quantity Uom	L.F.
Potential Action	REPLACE-IN-KIND
Urgency of Action	PRIORITY 4
Purpose of Action	LEVEL 2
Deficiency Photo1

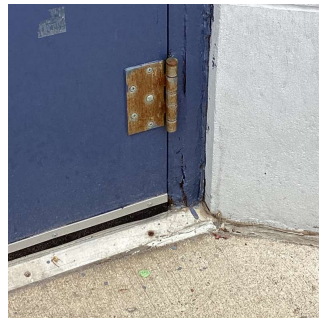
Question	Response
EXTERIOR	
DOORS	
DOORS AND FRAMES	
Condition	5 - Poor
Deficiency	METAL: DETERIORATED DOOR AND FRAME - MAJOR DETERIORATION
Roof Plan reference

<p align="center">Clermont Avenue K020 Willoghby Avenue Adelphi Street</p>
Deficiency Quantity	3
Quantity Uom	EACH
Potential Action	REPLACE
Urgency of Action	PRIORITY 4
Purpose of Action	LEVEL 2
Deficiency Photo1

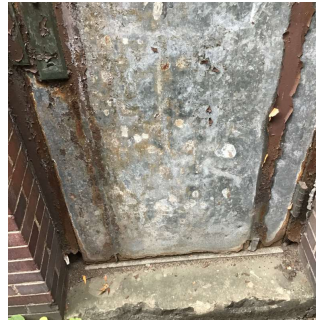
Facade F - AW3

<p align="center">Facade A</p>
Violations	No violations recorded.
Deficiency	METAL CLAD: DETERIORATED DOOR AND FRAME - MAJOR DETERIORATION
Roof Plan reference

<p align="center">Clermont Avenue K020 Willoghby Avenue Adelphi Street</p>
Deficiency Quantity	8
Quantity Uom	EACH
Potential Action	REPLACE
Urgency of Action	PRIORITY 4
Purpose of Action	LEVEL 2

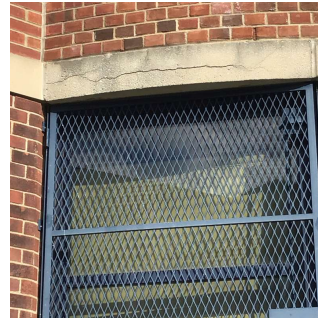
Facade D

STONE: CHIPPED/SPALLED/BROKEN PIECES - MAJOR

PRIORITY 4
LEVEL 2

REPLACE

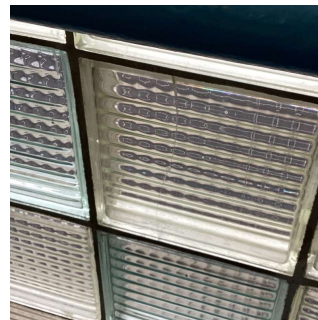
Facade F - Stair C/1

GLASS BLOCK: CHIPPED/ BROKEN PIECES

REPLACE-IN-KIND

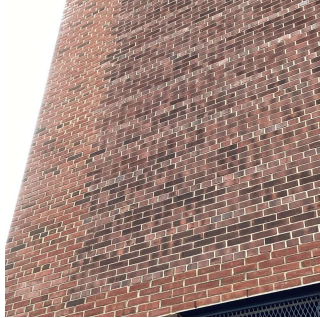
BRICK: DETERIORATED JOINTS

Question	Response
EXTERIOR	
EXTERIOR WALLS	
Deficiency Quantity	5,000
Quantity Uom	S.F.
Potential Action	REPOINT
Urgency of Action	PRIORITY 3
Purpose of Action	LEVEL 2
Deficiency Photo1

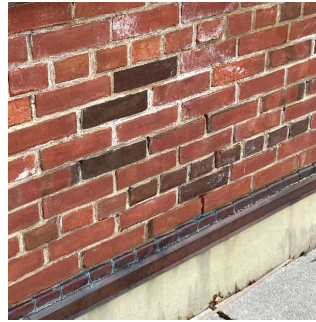
Roof 1

Violations	Facade B No violations recorded.
EXTERIOR SOFFITS	Does not Exist
LOADING DOCK	Does not Exist
LOUVER	Inspected
Condition	2 - Between Good and Fair
Deficiency	No deficiencies recorded
PARAPETS	Inspected
Material Type(s)	Masonry
Replacement Quantity	8,000
Replacement Uom	C.F.
Instance on All Facades	Inspected
Instance Condition	3 - Fair
Instance Quantity	8,000
Instance Quantity Uom	C.F.
Deficiency	BRICK: DETERIORATED JOINTS
Roof Plan reference

Deficiency Quantity	30
Quantity Uom	S.F.
Potential Action	REPOINT
Urgency of Action	PRIORITY 4
Purpose of Action	LEVEL 2

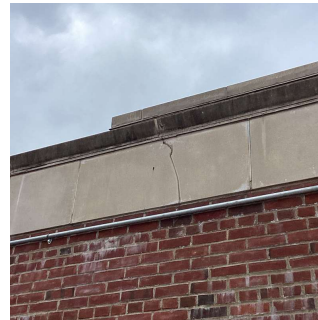
STONE: MAJOR DETERIORATION/CRACKS

10
S.F.
REMOVE AND REBUILD
PRIORITY 4
LEVEL 2

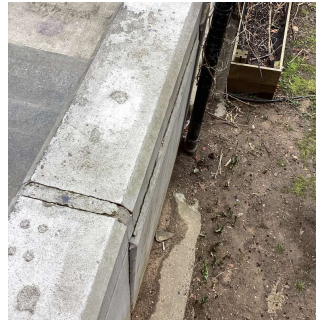
Facade B

Deficiency

20

REPLACE

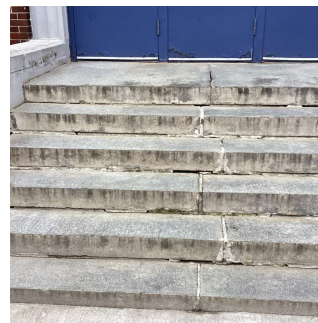
Facade B

STONE: DETERIORATED JOINTS

80
L.F.
REPOINT
PRIORITY 3
LEVEL 2

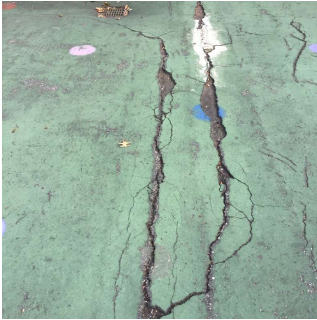
Question	Response
SITE	
PAVING	Inspected
Student Use	
Asphalt	
Deficiency	CRACKS - MAJOR
Deficiency Location/Instance	Schoolyard
Deficiency Quantity	350
Quantity Uom	S.F.
Potential Action	REPLACE
Urgency of Action	PRIORITY 5
Purpose of Action	LEVEL 6
Deficiency Photo1

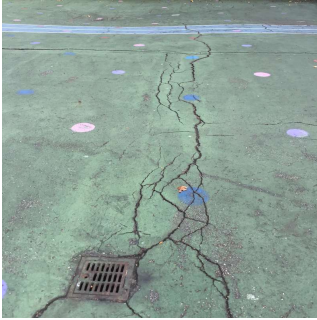
Violations	Schoolyard No violations recorded.
Deficiency	CRACKS - MAJOR
Deficiency Location/Instance	Schoolyard
Deficiency Quantity	1,400
Quantity Uom	S.F.
Potential Action	REPLACE
Urgency of Action	PRIORITY 3
Purpose of Action	LEVEL 2
Deficiency Photo1
