NYC Department of Education
Building Condition Assessment Survey 2023 - 2024

Architectural Inspection

K022

Asset: P.S. 22 - BROOKLYN, 443 ST. MARKS AVENUE, New York, 11226

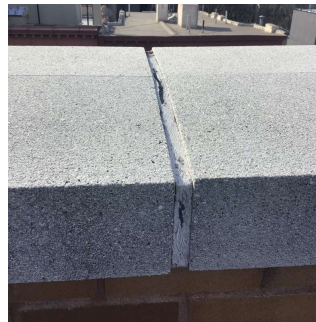
Facade A - PH3
No violations recorded.

Deficiency CAST STONE: DETERIORATED TRANSVERSE JOINTS

Deficiency Quantity	100
Quantity Uom	L.F.
Potential Action	MAINTENANCE
Urgency of Action	PRIORITY 3
Purpose of Action	LEVEL 2
Deficiency Photo1

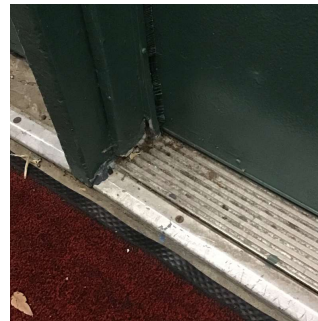
Facade A - Main Entrance

Condition	Inspected 5 - Poor
Deficiency	METAL: DETERIORATED DOOR AND FRAME - MINOR DETERIORATION

12
EACH
MAINTENANCE
PRIORITY 3
LEVEL 2

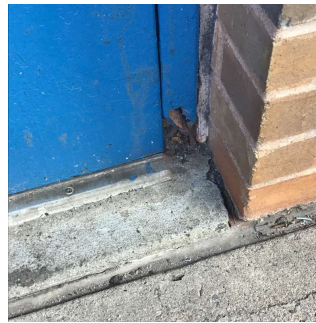
Facade B

METAL: DETERIORATED DOOR AND FRAME - MAJOR DETERIORATION

7
EACH
REPLACE
PRIORITY 4
LEVEL 2

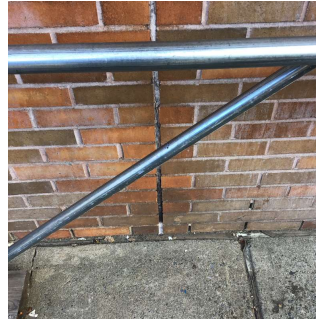
Facade B

BRICK: DETERIORATED CONTROL/EXPANSION JOINTS

50
L.F.
MAINTENANCE
PRIORITY 3
LEVEL 2

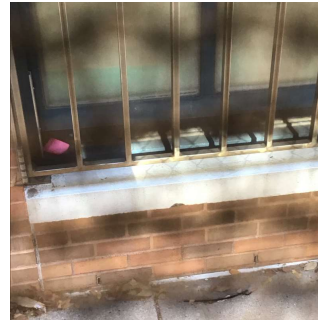
Facade A

BRICK: DETERIORATED MASONRY SILLS - MINOR

10
L.F.
REPAIR
PRIORITY 3
LEVEL 2

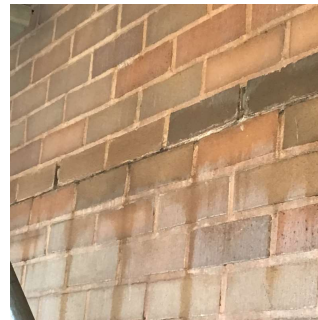
Facade B

BRICK: DETERIORATED JOINTS

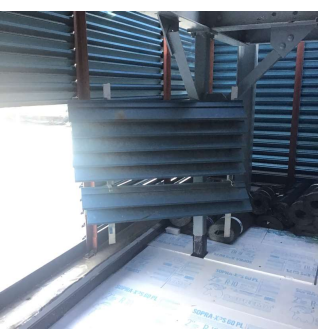
Question	Response
EXTERIOR	
EXTERIOR SOFFITS	Inspected
Deficiency	No deficiencies recorded
LOADING DOCK	Does not Exist
LOUVER	Inspected
Condition	3 - Fair
Deficiency	BROKEN/ DENTED BLADES
Roof Plan reference

Deficiency Quantity	20
Quantity Uom	S.F.
Potential Action	REPLACE
Urgency of Action	PRIORITY 4
Purpose of Action	LEVEL 2
Deficiency Photo1

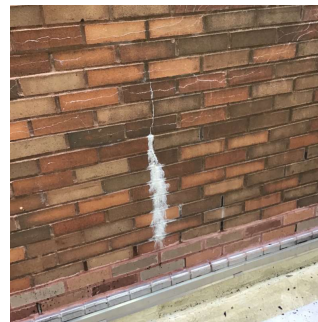
Facade J

Roof 7
Instance Quantity	1,000
Instance Quantity Uom	S.F.
ROOFING DRAINS	Under Construction
Specialties	Inspected
BULKHEAD/PENTHOUSE	Inspected
Condition	4 - Between Fair and Poor
Deficiency	BULKHEAD/PENTHOUSE WALLS/INTERIOR: BRICK CRACKS/SPALLING

10
S.F.
REPLACE
PRIORITY 3
LEVEL 2

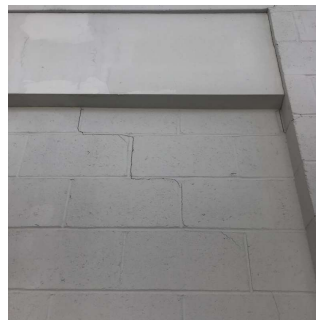
BH2

**BULKHEAD/PENTHOUSE WALLS/INTERIOR: CMU
CRACKS/SPALLING**

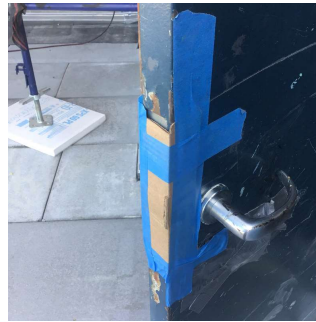
PH3
No violations recorded.

BULKHEAD/PENTHOUSE DOORS: DETERIORATED DOOR

2
EACH
REPLACE DOOR
PRIORITY 4
LEVEL 2

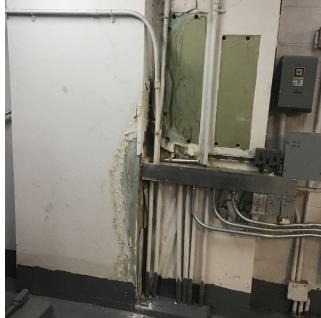
BULKHEAD/PENTHOUSE WALLS/INTERIOR: GYPSUM BOARD DAMAGED/DETERIORATED

40
S.F.
REPLACE
PRIORITY 3
LEVEL 2

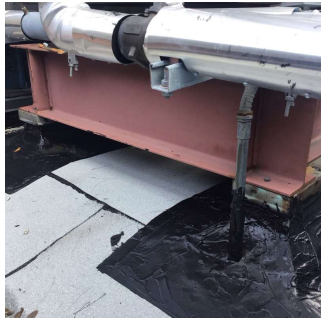
Violations	PH3 - AHU4 No violations recorded.
CUPOLA/ SPIRES/ TOWERS	Does not Exist
DORMER	Does not Exist
DUNNAGE STEEL	Inspected
Condition	2 - Between Good and Fair
Deficiency	HEIGHT LESS THAN 18"
Roof Plan reference

Deficiency Quantity	30
Quantity Uom	L.F.
Potential Action	REPLACE
Urgency of Action	PRIORITY 3
Purpose of Action	LEVEL 2
Deficiency Photo1

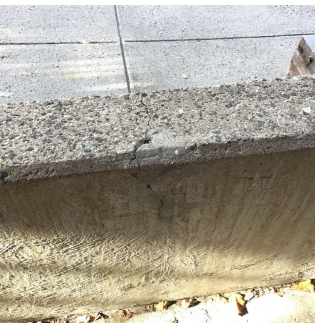
Question	Response
EXTERIOR	
STAIRS/RAMPS: EXTERIOR	Inspected
BUILDING CHEEK/FLANK WALLS	Inspected
Condition	2 - Between Good and Fair
Deficiency	CAST IN PLACE CONCRETE: CRACKS/SPALLING - MINOR
Roof Plan reference

Deficiency Quantity	10
Quantity Uom	S.F.
Potential Action	REPAIR
Urgency of Action	PRIORITY 3
Purpose of Action	LEVEL 2
Deficiency Photo1

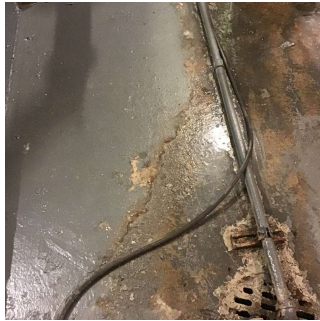
Condition	3 - Fair
Deficiency	CONCRETE SLAB ON GRADE: THRU CRACKS
Deficiency Location/Instance	Basement - Gas Meter Room
Deficiency Quantity	20
Quantity Uom	S.F.
Potential Action	REPLACE
Urgency of Action	PRIORITY 4
Purpose of Action	LEVEL 5

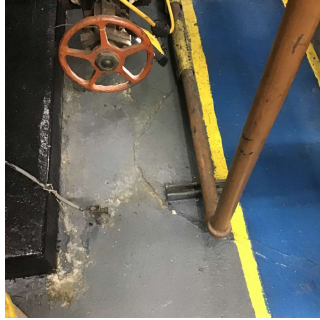
Violations	Gas Meter Room No violations recorded.
Deficiency	CONCRETE SLAB ON GRADE: THRU CRACKS
Deficiency Location/Instance	Base - Boiler Room, Room C10
Deficiency Quantity	30
Quantity Uom	S.F.
Potential Action	REPAIR
Urgency of Action	PRIORITY 3
Purpose of Action	LEVEL 5
Deficiency Photo1

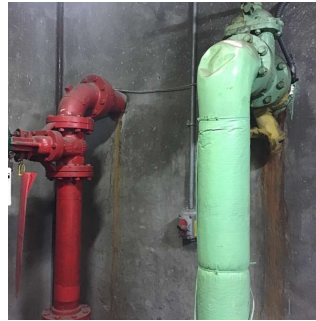
Gas Meter Room

Violations	Boiler Room No violations recorded.
FOUNDATION WALLS	
Material Type(s)	Inspected Concrete
Condition	4 - Between Fair and Poor
Deficiency	CONCRETE: WATER INFILTRATION IN NON- INSTRUCTIONAL SPACE
Deficiency Location/Instance	Basement - Gas Meter Room, Oil Tank Room
Deficiency Quantity	200
Quantity Uom	S.F.
Potential Action	INSTALL WATERPROOFING
Urgency of Action	PRIORITY 5
Purpose of Action	LEVEL 5

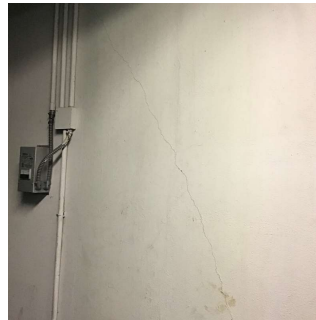
Generator Room

CONCRETE: CRACKED/SPALLED/REINFORCEMENT EXPOSED

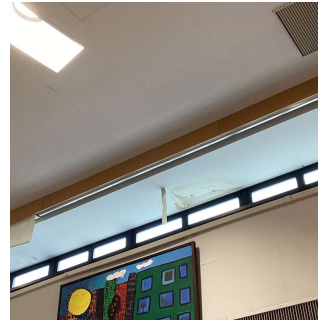
Right Side Near Windows

GYPSUM BOARD: DAMAGED/DETERIORATED

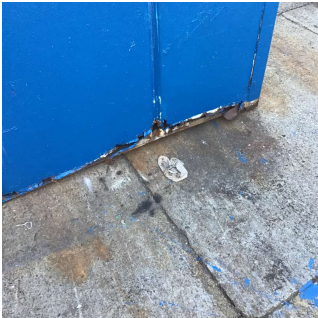
Question	Response
SITE	
CONTAINERIZATION	
Deficiency Photo1	No photo recorded
Violations	No violations recorded.
Deficiency	CONTAINER DAMAGED
Deficiency Location/Instance	North side
Deficiency Quantity	2
Quantity Uom	EACH
Potential Action	REPLACE
Urgency of Action	PRIORITY 3
Purpose of Action	LEVEL 2
Deficiency Photo1

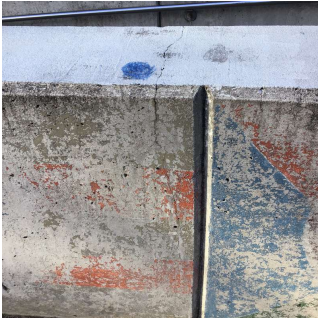
Question	Response
SITE	
STAIRS/RAMPS: EXTERIOR	
Site Cheek/flank Walls	
Deficiency	CAST IN PLACE CONCRETE: CRACKS/SPALLING - MAJOR
Deficiency Location/Instance	Near exit 7, Schoolyard
Deficiency Quantity	20
Quantity Uom	S.F.
Potential Action	REPLACE
Urgency of Action	PRIORITY 3
Purpose of Action	LEVEL 2
Deficiency Photo1

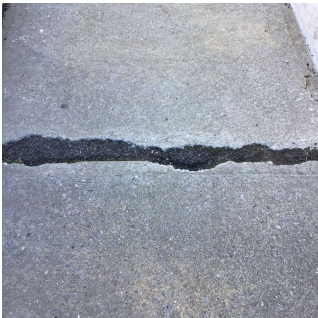
Near exit 7
Violations	No violations recorded.
Stairs/ramps	Inspected
Condition	3 - Fair
Deficiency	CAST IN PLACE CONCRETE: CRACKS/SPALLING - MAJOR
Deficiency Location/Instance	Near Schoolyard
Deficiency Quantity	200
Quantity Uom	S.F.
Potential Action	REPLACE
Urgency of Action	PRIORITY 3
Purpose of Action	LEVEL 2
Deficiency Photo1

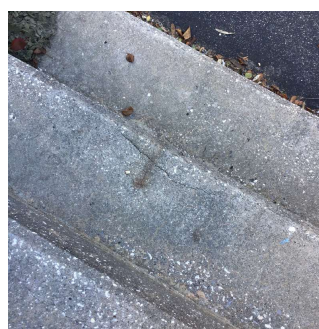
Near Schoolyard
Violations	No violations recorded.
Deficiency	CAST IN PLACE CONCRETE: WORN-OUT TREAD/RISER/NOSERS
Deficiency Location/Instance	Near Schoolyard
Deficiency Quantity	10
Quantity Uom	S.F.
Potential Action	REPLACE
Urgency of Action	PRIORITY 3
Purpose of Action	LEVEL 2
