NYC Department of Education
Building Condition Assessment Survey 2023 - 2024

Architectural Inspection

Asset: P.S. 23 - BROOKLYN, 545 WILLOUGHBY AVENUE, New York, 11206

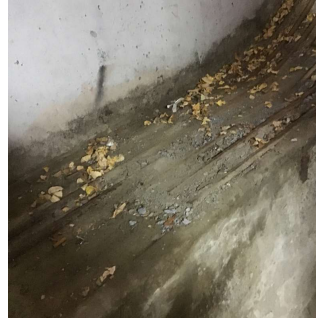
AW 1

**AREAWAY STAIRS: DETERIORATED
TREADS/RISERS/NOSINGS**

REPAIR

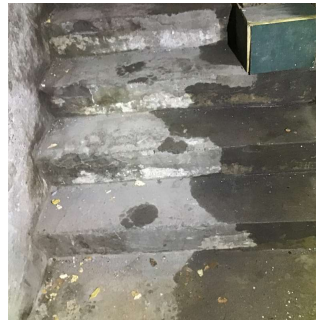
AW 1

**AREAWAY GRATINGS: MAJOR RUSTING AND / OR BROKEN
SUPPORTS**

20
L.F.
REPLACE
PRIORITY 4
LEVEL 2

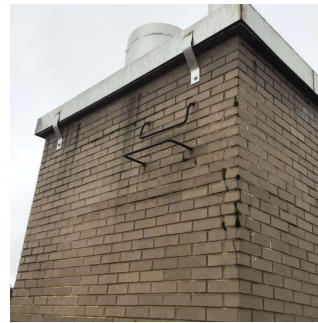
Roof 1

BRICK: MAJOR / THRU CRACKS

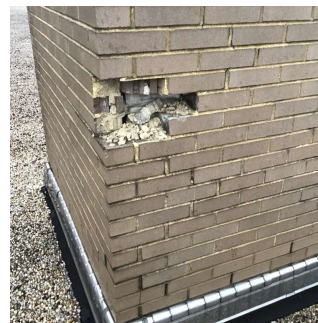
Roof 1

BRICK: DETERIORATED JOINTS

100
S.F.
REPOINT
PRIORITY 3
LEVEL 2

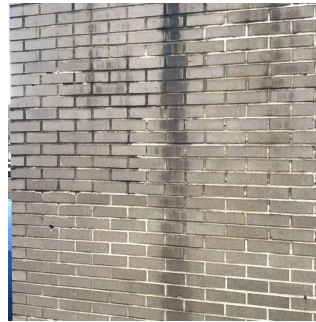
Roof 1

BRICK: MINOR CRACKS AND SPALLING

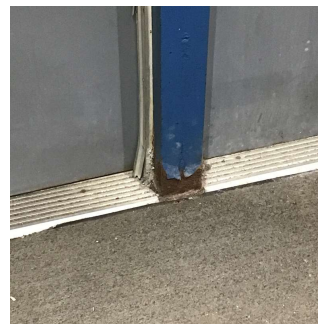
Facade C

METAL CLAD: DETERIORATED DOOR AND FRAME - MAJOR DETERIORATION

5
EACH
REPLACE
PRIORITY 4
LEVEL 2

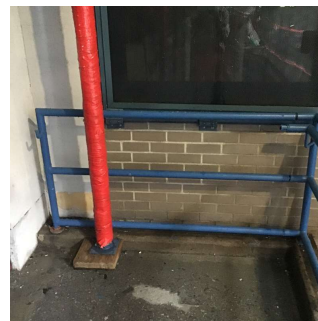
Facade F

STONE: DETERIORATED JOINTS

20
L.F.
REPOINT
PRIORITY 4
LEVEL 2

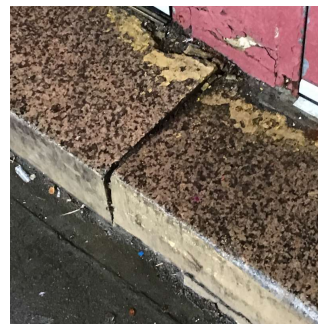
Stair Facade D - East View
No violations recorded.

STONE: CRACKS/SPALLING - MAJOR

10
S.F.
REPLACE
PRIORITY 5
LEVEL 6

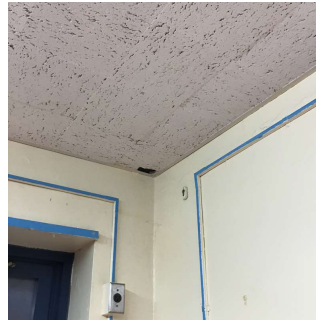
Near Windows

ACOUSTIC TILES ON PLASTER: DAMAGED/MISSING

REPLACE

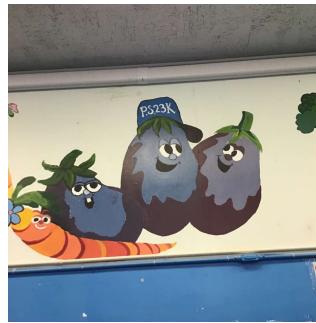
Right Side

SALT GLAZED BRICK: CRACKS/SPALLING

REPLACE

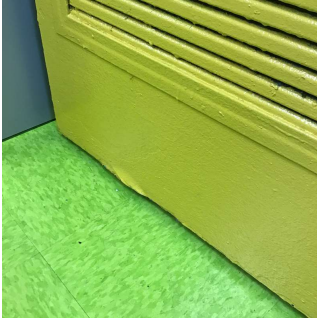
Question	Response
INTERIOR	
CLASSROOMS/CORRIDORS/ADMIN SPACES	
Door(s)	Inspected
Condition	5 - Poor
Deficiency	METAL: DETERIORATED DOOR
Deficiency Location/Instance	Room 128
Deficiency Quantity	1
Quantity Uom	EACH
Potential Action	MAINTENANCE
Urgency of Action	PRIORITY 3
Purpose of Action	LEVEL 2
Deficiency Photo1

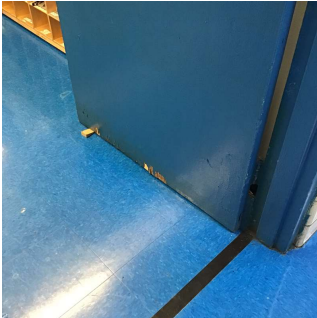
Violations	Room 128 No violations recorded.
Deficiency	WOOD: DETERIORATED DOOR
Deficiency Location/Instance	Rooms 320, 318, 310, 305, 232 and others
Deficiency Quantity	18
Quantity Uom	EACH
Potential Action	MAINTENANCE
Urgency of Action	PRIORITY 3
Purpose of Action	LEVEL 2
Deficiency Photo1

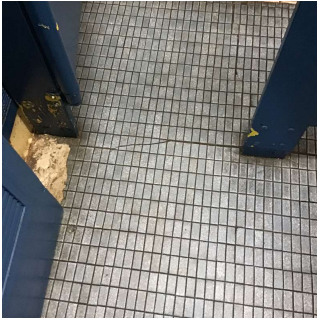
Question	Response
INTERIOR	
TOILET ROOMS - STAFF	
Floor Finish	
Deficiency	CERAMIC TILE: DETERIORATED SUBSTRATE
Deficiency Location/Instance	Rooms 323, 221
Deficiency Quantity	20
Quantity Uom	S.F.
Potential Action	REPLACE
Urgency of Action	PRIORITY 3
Purpose of Action	LEVEL 2
Deficiency Photo1

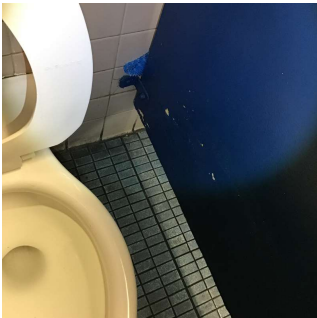
Room 323
Violations	No violations recorded.
Stalls	
	Inspected
Condition	5 - Poor
Deficiency	RUST - MAJOR
Deficiency Location/Instance	Rooms 323, 221
Deficiency Quantity	2
Quantity Uom	EACH
Potential Action	REPLACE
Urgency of Action	PRIORITY 3
Purpose of Action	LEVEL 2
Deficiency Photo1

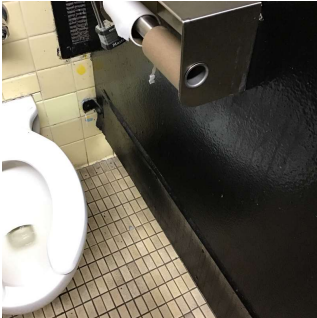
Room 117
Violations	No violations recorded.
Deficiency	RUST - MAJOR
Deficiency Location/Instance	Rooms 217, 117, 115
Deficiency Quantity	12
Quantity Uom	EACH
Potential Action	REPLACE
Urgency of Action	PRIORITY 3
Purpose of Action	LEVEL 2
Deficiency Photo1
