NYC Department of Education
Building Condition Assessment Survey 2023 - 2024

Architectural Inspection

Asset: P.S. 24 - BROOKLYN, 427 38TH STREET, New York, 11232

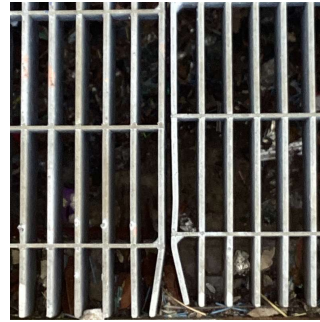
AW2

AREAWAY WALLS: CRACKS AND SPALLING

REPLACE

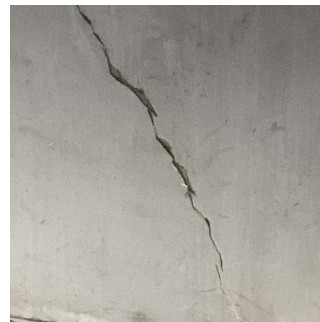
AW2

AREAWAY SLAB: CRACKS AND SPALLING

REPLACE

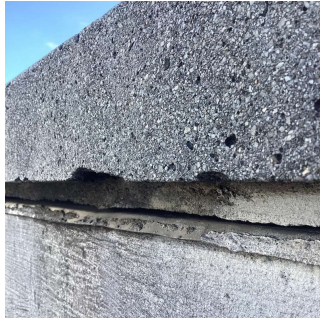
Roof 1
Violations	No violations recorded.
Deficiency	CAST STONE: DETERIORATED BED JOINT
Roof Plan reference	K024 37th Street

Violations	CH No violations recorded.
COPING	
Condition	Inspected 3 - Fair
Deficiency	CAST STONE: CRACKED/BROKEN PIECES
Roof Plan reference	K024 37th Street
Deficiency Quantity	10

Question	Response
EXTERIOR	
COPING	
Quantity Uom	L.F.
Potential Action	REPLACE-IN-KIND
Urgency of Action	PRIORITY 4
Purpose of Action	LEVEL 2
Deficiency Photo1

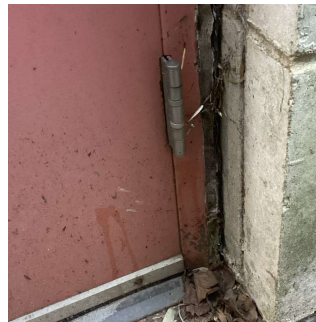
Facade B

Roof 1
Violations	No violations recorded.
CORNICE	Does not Exist
DOORS	Inspected
DOORS AND FRAMES	Inspected
Condition	4 - Between Fair and Poor
Deficiency	METAL: DETERIORATED DOOR AND FRAME - MINOR DETERIORATION

1
EACH
MAINTENANCE
PRIORITY 3
LEVEL 2

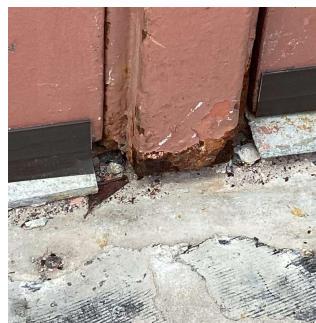
Facade C

METAL: DETERIORATED DOOR AND FRAME - MAJOR DETERIORATION

5
EACH
REPLACE
PRIORITY 4
LEVEL 2

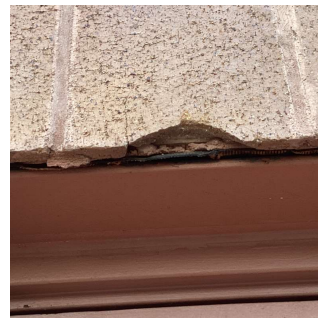
Facade C

BRICK: MAJOR / THRU CRACKS

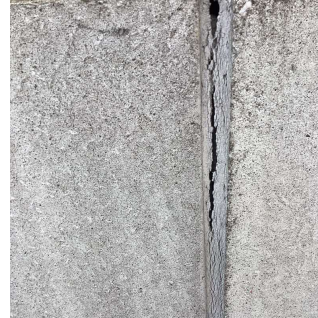
Facade B

STONE: DETERIORATED CONTROL/EXPANSION JOINTS
 K024 37th Street

20
 L.F.
 MAINTENANCE
 PRIORITY 3
 LEVEL 2

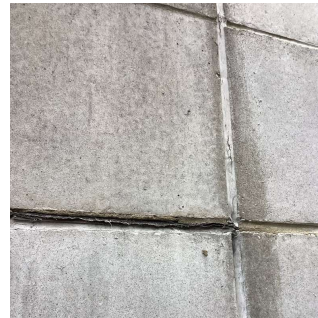
Facade C

STONE: DETERIORATED JOINTS

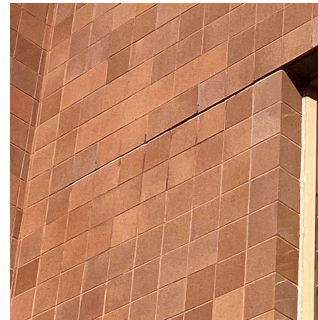
Facade A

BRICK: DETERIORATED CONTROL/EXPANSION JOINTS

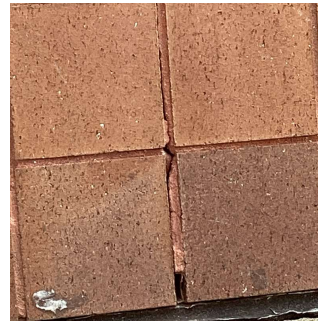
Facade B

BRICK: DETERIORATED JOINTS

S.F.
REPOINT
PRIORITY 3
LEVEL 2

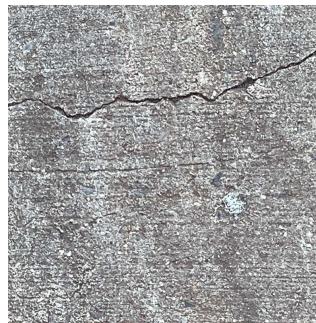
Facade B

DETERIORATED CONCRETE PLATFORM WITH CRACKED, SPALLED CONCRETE OR EXPOSED REINFORCING

20
 S.F.
 REPAIR
 PRIORITY 4
 LEVEL 2

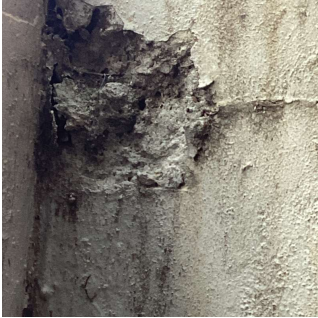
Deficiency	CAST IN PLACE CONCRETE: CRACKS/SPALLING - MAJOR
------------	---

Question	Response
EXTERIOR	
STAIRS/RAMPS: EXTERIOR	
BUILDING CHEEK/FLANK WALLS	
Quantity Uom	S.F.
Potential Action	REPLACE
Urgency of Action	PRIORITY 4
Purpose of Action	LEVEL 2
Deficiency Photo1

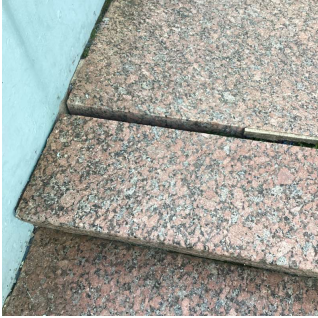
Violations	Facade C No violations recorded.
RAILINGS	Inspected
Condition	2 - Between Good and Fair
Deficiency	No deficiencies recorded
STAIRS/RAMPS	Inspected
Condition	5 - Poor
Deficiency	STONE: DETERIORATED SUBSTRATE
Roof Plan reference	K024 37th Street

Deficiency Quantity	10
Quantity Uom	S.F.
Potential Action	REPLACE SUBSTRATE AND RESET
Urgency of Action	PRIORITY 4
Purpose of Action	LEVEL 2
Deficiency Photo1

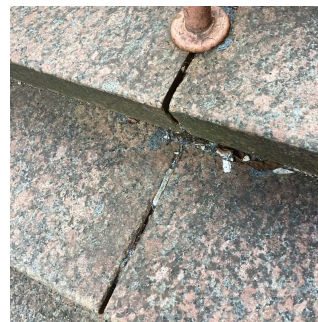
Violations	Facade C No violations recorded.
Deficiency	STONE: DETERIORATED JOINTS

10
 L.F.
 REPOINT
 PRIORITY 4
 LEVEL 2

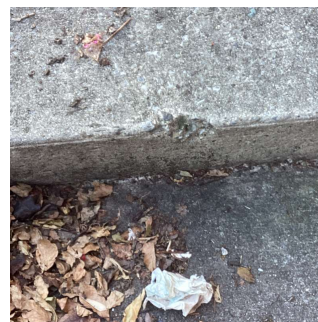
Facade C

CONCRETE: CRACKS/SPALLING - MINOR

10
 S.F.
 REPAIR
 PRIORITY 3
 LEVEL 2

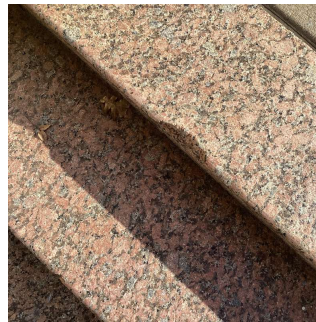
Facade A

STONE: CRACKS/SPALLING - MINOR

20
 S.F.
 REPAIR
 PRIORITY 3
 LEVEL 2

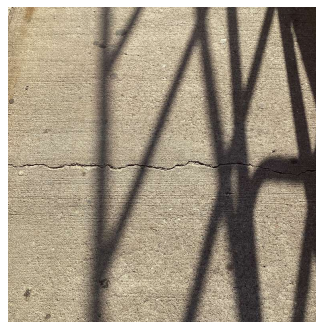
Facade A

CONCRETE: CRACKS/SPALLING - MAJOR

40
 S.F.
 REPLACE
 PRIORITY 4
 LEVEL 2

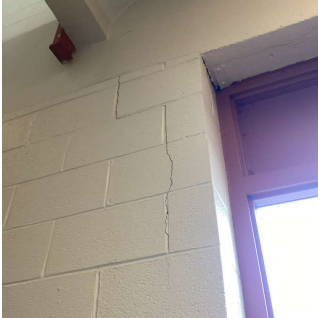
Question	Response
INTERIOR	
STAIRS/RAMPS: INTERIOR	
Walls	Inspected
Condition	2 - Between Good and Fair
Deficiency	MASONRY: CRACKS/SPALLING
Deficiency Location/Instance	Stairs A/1, B/4, 2, 1, C/1 and others
Deficiency Quantity	100
Quantity Uom	S.F.
Potential Action	REPLACE
Urgency of Action	PRIORITY 3
Purpose of Action	LEVEL 2
Deficiency Photo1
