**NYC Department of Education**  
**Building Condition Assessment Survey 2023 - 2024**

Architectural Inspection

**Asset:** P.S. 32 ADDITION - BROOKLYN, 317 HOYT STREET, New York, 11231

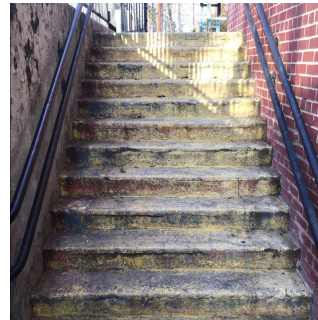
AW1  
No violations recorded.

Question	Response
<b>Architectural</b>	
<b>EXTERIOR</b>	Inspected
<b>AREAWAY</b>	Inspected
Instance on AW1-AW4	Inspected
Instance Condition	5 - Poor
Instance Quantity	4
Instance Quantity Uom	EACH
Deficiency	AREAWAY STAIRS: DETERIORATED TREADS/RISERS/NOSINGS

60  
S.F.  
REPAIR  
PRIORITY 3  
LEVEL 2

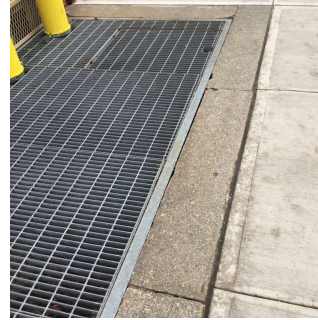
AW3, AW4

AREAWAY WALLS: DETERIORATED COPING STONE

20  
S.F.  
REPAIR  
PRIORITY 3  
LEVEL 2

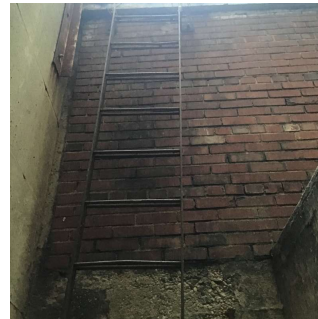
AW3, AW2

AREAWAY LADDER: DETERIORATED

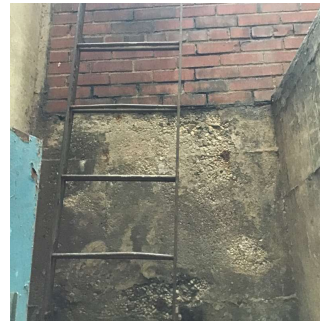
AW3  
No violations recorded.

AREAWAY WALLS: CRACKS AND SPALLING

100  
S.F.  
REPAIR  
PRIORITY 3  
LEVEL 2

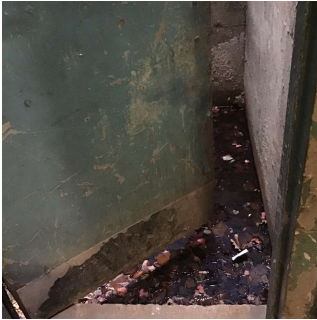
AREAWAY DRAINS: CLOGGED

AW2 (x2), AW3
Violations	No violations recorded.
<b>AWNINGS AND CANOPIES</b>	
Condition	Inspected
Deficiency	2 - Between Good and Fair
	No deficiencies recorded
<b>CHIMNEY</b>	
Material Type(s)	Inspected
Condition	Masonry
Deficiency	3 - Fair
Roof Plan reference	BRICK: DETERIORATED JOINTS

3  
EACH  
MAINTENANCE  
PRIORITY 5  
LEVEL 2

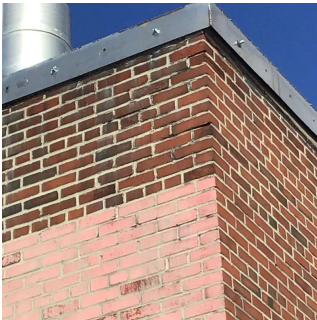
Violations	Roof 1 No violations recorded.
<b>COPING</b>	
Condition	Inspected
Deficiency	3 - Fair
	CAST STONE: CRACKED/BROKEN PIECES

Deficiency Quantity	25
Quantity Uom	S.F.
Potential Action	REPOINT
Urgency of Action	PRIORITY 3
Purpose of Action	LEVEL 2
Deficiency Photo1

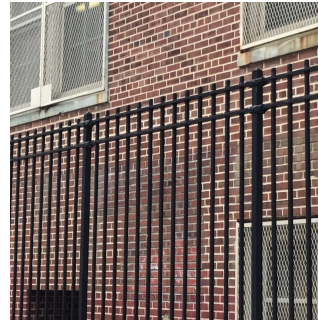
Facade J

BRICK: DETERIORATED MASONRY SILLS - MINOR

REPAIR

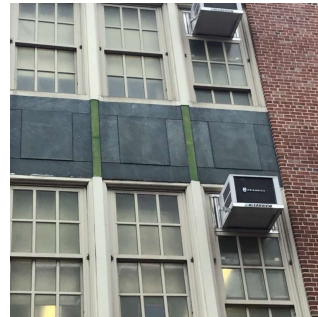
Facade M

STONE: CHIPPED/SPALLED/BROKEN PIECES - MINOR

REPAIR

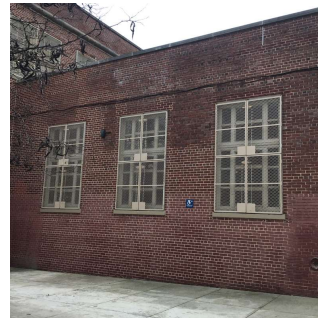
BRICK: DETERIORATED JOINTS

Facade Q at Auditorium  
No violations recorded.

300  
S.F.  
REPOINT  
PRIORITY 3  
LEVEL 2

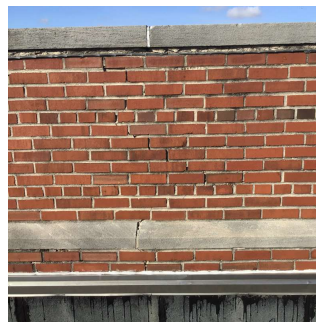
Roof 1 - Facade P

Instance Quantity	1,500
Instance Quantity Uom	C.F.
Deficiency	No deficiencies recorded
Instance on Facades H-Q, T-W Original Building)	Inspected
Instance Condition	3 - Fair
Instance Quantity	8,000
Instance Quantity Uom	C.F.
Deficiency	<b>BRICK: MAJOR DETERIORATION/CRACKS</b>

15  
S.F.  
REMOVE AND REBUILD  
PRIORITY 4  
LEVEL 2

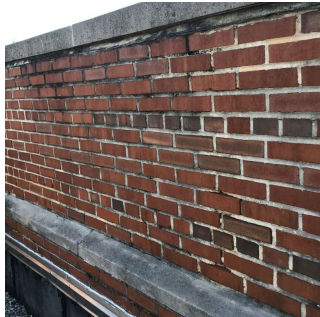
Deficiency	<b>BRICK: DETERIORATED JOINTS</b>
Roof Plan reference

Violations	Roof 1 - Facade R No violations recorded.
<b>PLAZA DECK</b>	
	Inspected
Instance on Pavers: Roof 7	Inspected
Instance Condition	1 - Good
Instance Quantity	4,800
Instance Quantity Uom	S.F.
Installation Year	2020
Source of Installation	Custodial Staff
Deficiency	No deficiencies recorded
<b>ROOF</b>	
	Inspected
<b>Roofing</b>	
	Inspected
Replacement Quantity	55,000
Replacement Uom	S.F.
<b>ROOF HATCH/SMOKE HATCH</b>	
	Inspected
Condition	1 - Good
Deficiency	No deficiencies recorded
<b>LEADERS, GUTTERS, DOWNSPOUTS, SCUPPERS</b>	
	Inspected
Condition	2 - Between Good and Fair
Deficiency	No deficiencies recorded
<b>ROOF BARRIER/FENCE</b>	
	Inspected
Condition	2 - Between Good and Fair
Deficiency	No deficiencies recorded
<b>ROOF CAGE</b>	
	Does not Exist
<b>ROOFING</b>	
	Inspected
Instance on IRMA: Roof 6	Inspected

4,000  
S.F.  
REPOINT

Question	Response
<b>EXTERIOR</b>	
<b>PARAPETS</b>	
Urgency of Action	PRIORITY 3
Purpose of Action	LEVEL 2
Deficiency Photo1

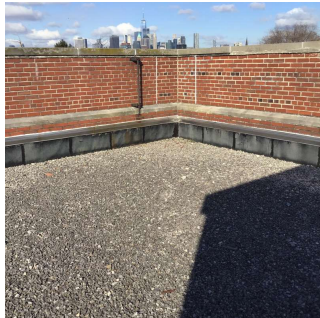
Deficiency	IRMA: ROOFING: MAJOR ACTIVE ROOF LEAKS IN INSTRUCTIONAL SPACE
------------	---------------------------------------------------------------

Violations	Roof 1 - Rooms 300, 301, 307, 314, 315, 316 No violations recorded.
Deficiency	IRMA: ROOFING: DAMAGED INSULATION
Roof Plan reference	K032

Potential Action	REPLACE ROOFING WITHOUT MAJOR EQUIPMENT REMOVAL
------------------	-------------------------------------------------

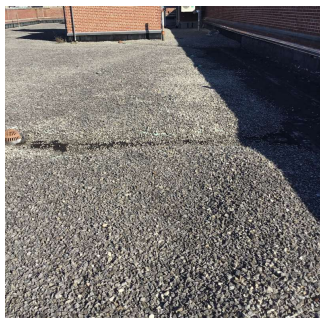
Violations	Roof 1 No violations recorded.
<b>ROOFING DRAINS</b>	Inspected
Condition	2 - Between Good and Fair
Deficiency	No deficiencies recorded
<b>Specialties</b>	Inspected
<b>BULKHEAD/PENTHOUSE</b>	Inspected
Condition	3 - Fair
Deficiency	BULKHEAD/PENTHOUSE WALLS/EXTERIOR: DETERIORATED JOINTS

Deficiency Quantity	600
Quantity Uom	S.F.
Potential Action	REPLACE
Urgency of Action	PRIORITY 4
Purpose of Action	LEVEL 2
Deficiency Photo1

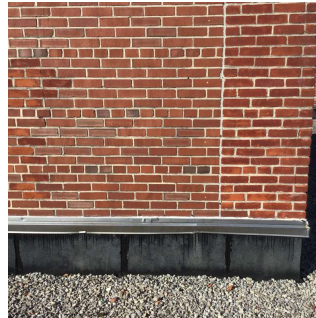
BH2

**BULKHEAD/PENTHOUSE WALLS/EXTERIOR:  
CRACKS/SPALLING - MAJOR**

15  
S.F.  
REPLACE  
PRIORITY 4  
LEVEL 2

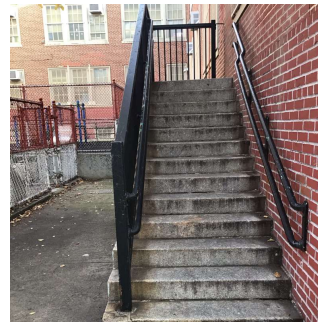
Facade K

STONE: WORN-OUT TREAD/RISER/NOSING

REPLACE

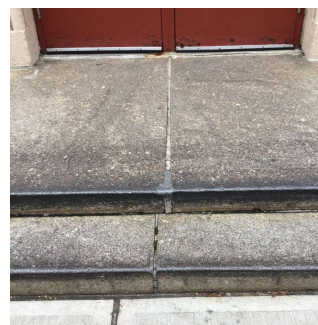
Exit 11 - Facades Q

**STONE: DETERIORATED JOINTS**

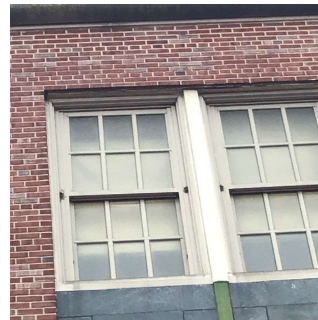
STEEL: MAJOR RUSTING

Facade M  
No violations recorded.

75  
L.F.  
REPLACE  
PRIORITY 4  
LEVEL 2

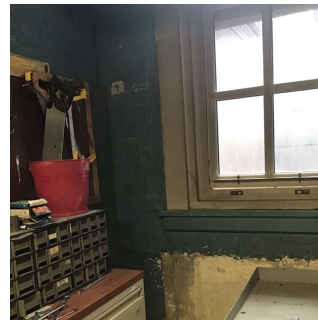
ALUMINUM - DOUBLE HUNG: DETERIORATED

Basement Custodial Locker Room  
No violations recorded.

30  
S.F.  
**REPLACE WINDOW**  
**PRIORITY 4**  
**LEVEL 2**

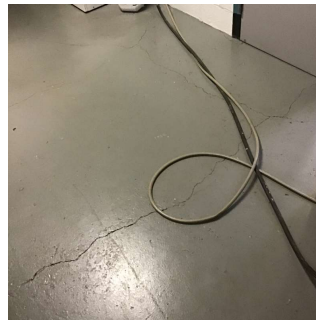
Boiler Room near B2

CONCRETE SLAB ON GRADE: THRU CRACKS

REPAIR

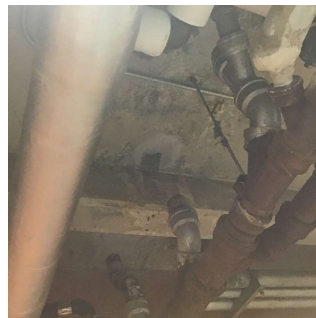
CONCRETE: CRACKS/SPALLED/REINFORCEMENT EXPOSED

REPAIR

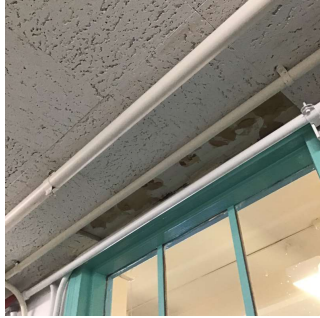
Question	Response
<b>INTERIOR</b>	
<b>CLASSROOMS/CORRIDORS/ADMIN SPACES</b>	
<b>Ceiling</b>	
Potential Action	REPLACE
Urgency of Action	PRIORITY 3
Purpose of Action	LEVEL 2
Deficiency Photo1

Corridor near Room 303
Violations	No violations recorded.
Deficiency	ACOUSTIC TILES: DAMAGED/MISSING
Deficiency Location/Instance	Corridor near Room 246
Deficiency Quantity	10
Quantity Uom	S.F.
Potential Action	REPLACE
Urgency of Action	PRIORITY 3
Purpose of Action	LEVEL 2
Deficiency Photo1

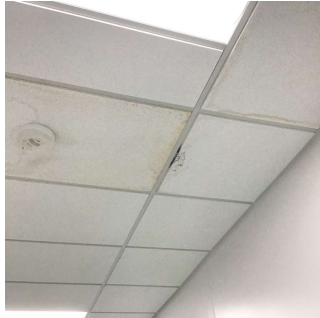
Corridor near Room 246
Violations	No violations recorded.
Deficiency	PLASTER: CRACKS/SPALLING
Deficiency Location/Instance	Rooms 300, 301, 315
Deficiency Quantity	40
Quantity Uom	S.F.
Potential Action	REPLACE
Urgency of Action	PRIORITY 3
Purpose of Action	LEVEL 2

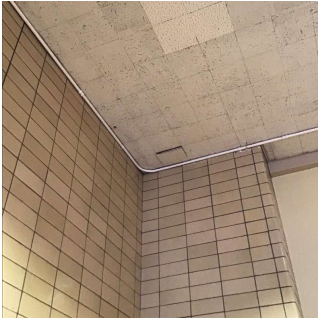
Priority Condition Exist Last Year?	Priority Category	Condition Description	Component Affected	Location Description	Person(s) Notified	Person(s) Title	PhotoImage
Yes	Potential Falling Debris	Loose ceiling tile is a potential safety hazard.	INTERIOR   GYMNASIUM   Ceiling	Right Rear Corner	Robert Meehan	Custodian

Question	Response
<b>INTERIOR</b>	
<b>GYMNASIUM</b>	
<b>Ceiling</b>	
Deficiency Quantity	10
Quantity Uom	S.F.
Potential Action	REPLACE
Urgency of Action	PRIORITY 5
Purpose of Action	LEVEL 6
Deficiency Photo1

Right Rear Corner
Violations	No violations recorded.
Deficiency	ACOUSTIC TILES ON PLASTER: DAMAGED/MISSING
Deficiency Location/Instance	Center
Deficiency Quantity	25
Quantity Uom	S.F.
Potential Action	REPLACE
Urgency of Action	PRIORITY 3
Purpose of Action	LEVEL 2
Deficiency Photo1	 
	Center
Violations	No violations recorded.
<b>Door(s)</b>	
Instance on 1st Floor	Inspected
Condition	5 - Poor
Deficiency	WOOD: DETERIORATED DOOR
Deficiency Location/Instance	Main Entrance, Exit to Basement Corridor
Deficiency Quantity	3
Quantity Uom	EACH
Potential Action	MAINTENANCE
Urgency of Action	PRIORITY 3
Purpose of Action	LEVEL 2

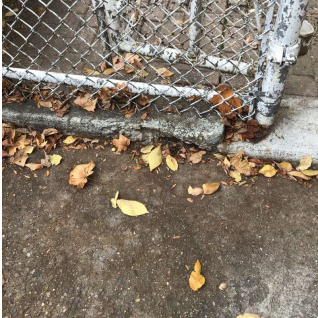
<b>Question</b>	<b>Response</b>
<b>SITE</b>	
<b>FENCES</b>	
Deficiency Quantity	20
Quantity Uom	S.F.
Potential Action	REPLACE
Urgency of Action	PRIORITY 3
Purpose of Action	LEVEL 2
Deficiency Photo1

Violations	Near President Street Playground No violations recorded.
Deficiency	<b>WROUGHT IRON: DAMAGED/DETERIORATED</b>
Deficiency Location/Instance	President Street
Deficiency Quantity	80
Quantity Uom	S.F.
Potential Action	REPLACE
Urgency of Action	PRIORITY 3
Purpose of Action	LEVEL 2
Deficiency Photo1

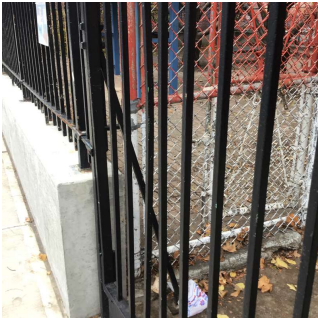
Violations	President Street No violations recorded.
<b>IRRIGATION SYSTEM</b>	Does not Exist
<b>PAVING</b>	Inspected
<b>Student Non-Use</b>	Inspected
Gravel Exists?	No
<b>Asphalt</b>	Does not Exist
<b>Concrete</b>	Inspected
Condition	2 - Between Good and Fair
Deficiency	No deficiencies recorded
<b>Pavers</b>	Does not Exist
<b>Student Use</b>	Inspected
Gravel Exists?	No
<b>Asphalt</b>	Inspected
Condition	2 - Between Good and Fair

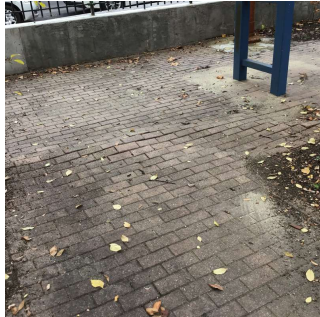
Question	Response
<b>SITE</b>	
<b>PAVING</b>	
<b>Student Use</b>	
<b>Asphalt</b>	
Deficiency	CRACKS - MINOR
Deficiency Location/Instance	Schoolyard Near Exit 2
Deficiency Quantity	10
Quantity Uom	S.F.
Potential Action	MAINTENANCE
Urgency of Action	PRIORITY 3
Purpose of Action	LEVEL 2
Deficiency Photo1	No photo recorded
Violations	No violations recorded.
<b>Concrete</b>	Does not Exist
<b>Pavers</b>	Inspected
Condition	3 - Fair
Deficiency	HEAVING
Deficiency Location/Instance	Near President Street Playground
Deficiency Quantity	100
Quantity Uom	S.F.
Potential Action	REPLACE
Urgency of Action	PRIORITY 3
Purpose of Action	LEVEL 2
Deficiency Photo1

Violations	Near President Street Playground No violations recorded.
<b>Site Sidewalks &amp; Walkways</b>	Inspected
<b>Asphalt</b>	Inspected
Condition	1 - Good
Deficiency	No deficiencies recorded
<b>Concrete</b>	Inspected
Condition	3 - Fair
Deficiency	HEAVING
Deficiency Location/Instance	Union Street
