NYC Department of Education
Building Condition Assessment Survey 2023 - 2024

Architectural Inspection

Asset: I.S. 33 - BROOKLYN, 70 TOMPKINS AVENUE, New York, 11206

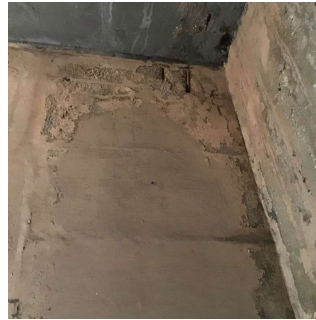
AW3

Deficiency AREAWAY WALLS: CRACKS AND SPALLING

REPAIR

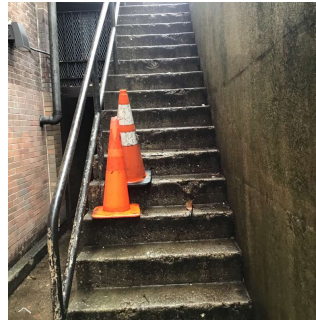
AW3
No violations recorded.

Deficiency AREAWAY STAIRS: DETERIORATED TREADS/RISERS/NOSINGS

REPAIR

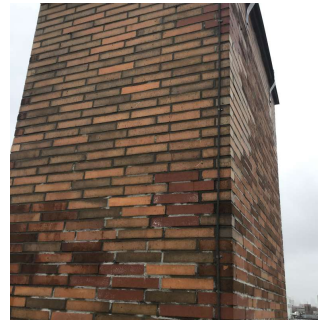
Facade

BRICK: MINOR CRACKS AND SPALLING

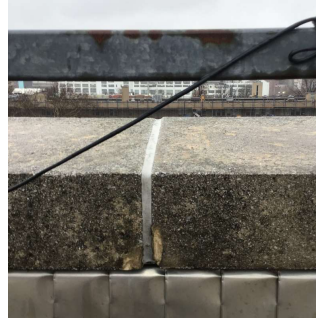
Facade F

CAST STONE: DETERIORATED TRANSVERSE JOINTS

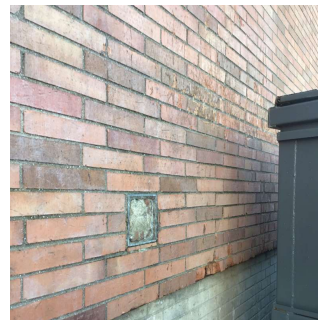
Facade A

Violations	No violations recorded.
DOOR HARDWARE	Inspected
Condition	3 - Fair
Deficiency	No deficiencies recorded
LINTELS	Inspected
Condition	2 - Between Good and Fair
Deficiency	No deficiencies recorded
TRANSOM/SIDE LIGHT	Inspected
Condition	2 - Between Good and Fair
Deficiency	No deficiencies recorded
EXTERIOR WALLS	Inspected
Material Type(s)	Masonry
Replacement Quantity	50,000
Replacement Uom	S.F.
Instance on All Facades	Inspected
Instance Condition	3 - Fair
Instance Quantity	50,000
Instance Quantity Uom	S.F.
Deficiency	BRICK: MINOR CRACKS AND SPALLING

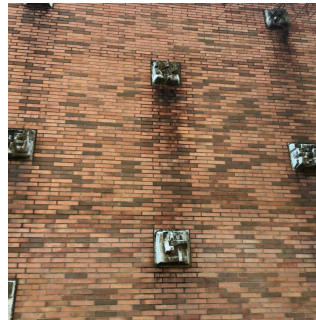
Facade E

BRICK: DETERIORATED JOINTS

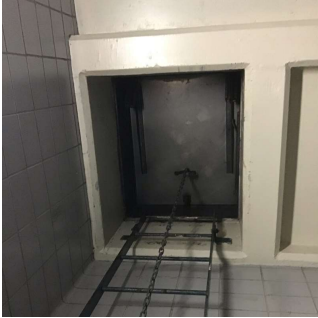
Question	Response
EXTERIOR	
ROOF	
Roofing	
ROOF HATCH/SMOKE HATCH	
Urgency of Action	PRIORITY 4
Purpose of Action	LEVEL 2
Deficiency Photo1

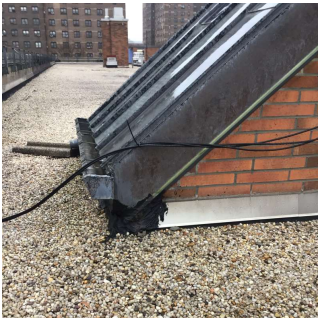
Violations	Auditorium Stage No violations recorded.
LEADERS, GUTTERS, DOWNSPOUTS, SCUPPERS	Inspected
Condition	3 - Fair
Deficiency	DAMAGED/MISSING
Roof Plan reference	K033

Deficiency Quantity	10
Quantity Uom	L.F.
Potential Action	REPLACE
Urgency of Action	PRIORITY 4
Purpose of Action	LEVEL 2
Deficiency Photo1

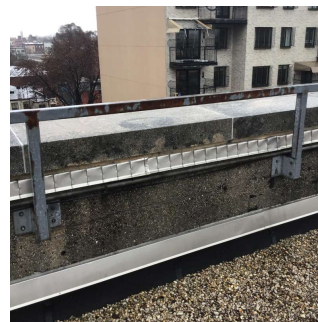
Violations	Bulkhead 2 No violations recorded.
ROOF BARRIER/FENCE	Inspected
Condition	4 - Between Fair and Poor
Deficiency	RAILINGS/PANELS: DETERIORATED, MAJOR RUSTING

100
S.F.
REPLACE
PRIORITY 4
LEVEL 2

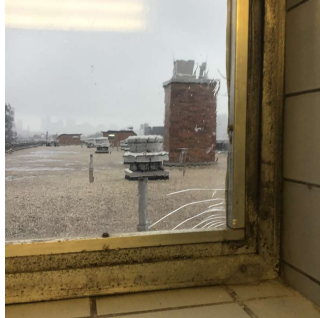
BULKHEAD/PENTHOUSE WINDOWS: DAMAGED, DETERIORATED WINDOWS

Question	Response
EXTERIOR	
ROOF	
Specialties	
BULKHEAD/PENTHOUSE	
Deficiency Quantity	30
Quantity Uom	S.F.
Potential Action	REPLACE
Urgency of Action	PRIORITY 4
Purpose of Action	LEVEL 2
Deficiency Photo1

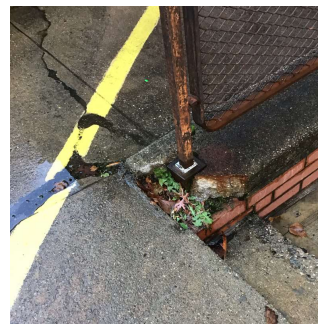
Exit 8
No violations recorded.

Deficiency Quantity	30
Quantity Uom	S.F.
Potential Action	MAINTENANCE
Urgency of Action	PRIORITY 3
Purpose of Action	LEVEL 2
Deficiency Photo1	No photo recorded
Violations	No violations recorded.
ROOF/GRAVITY TANK	Does not Exist
STAIRS/RAMPS: EXTERIOR	Inspected
BUILDING CHEEK/FLANK WALLS	Inspected
Condition	3 - Fair
Deficiency	CAST IN PLACE CONCRETE: CRACKS/SPALLING - MAJOR

10
S.F.
REPLACE
PRIORITY 4
LEVEL 2

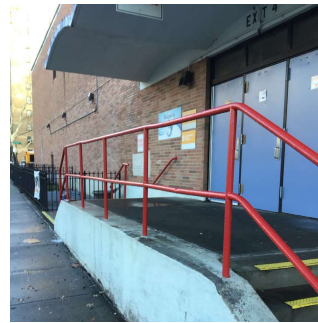
Main Entrance- Facade A

DAMAGED

20
L.F.
REPLACE
PRIORITY 4
LEVEL 2

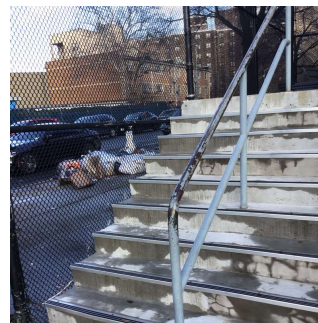
Gymnasium Exit - Facade A

MISSING RAILING

REPLACE

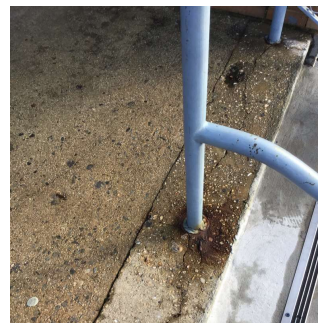
Gymnasium Exit - Facade A

CONCRETE: CRACKS/SPALLING - MINOR

10
S.F.
REPAIR
PRIORITY 3
LEVEL 2

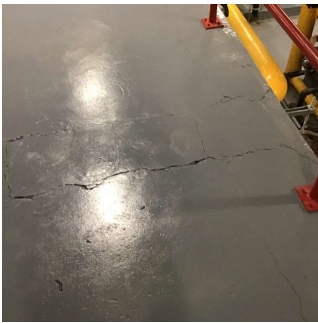
Question	Response
INTERIOR	Inspected
POOLS	Does not Exist
STRUCTURAL	Inspected
COLUMNS/BEAMS/BEARING WALLS	Inspected
Condition	2 - Between Good and Fair
Deficiency	No deficiencies recorded
FLOOR STRUCTURE	Inspected
Condition	3 - Fair
Deficiency	CONCRETE: CRACKS/SPALLED/REINFORCEMENT EXPOSED
Deficiency Location/Instance	Boiler Room
Deficiency Quantity	80
Quantity Uom	S.F.
Potential Action	REPAIR
Urgency of Action	PRIORITY 3
Purpose of Action	LEVEL 5
Deficiency Photo1

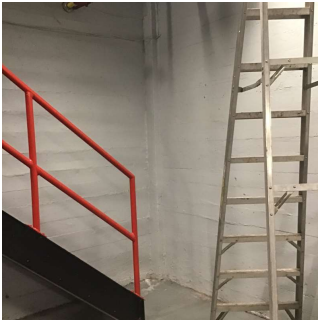
Violations	Boiler Room No violations recorded.
FOUNDATION WALLS	Inspected
Material Type(s)	Concrete
Condition	4 - Between Fair and Poor
Deficiency	CONCRETE: WATER INFILTRATION IN NON- INSTRUCTIONAL SPACE
Deficiency Location/Instance	Boiler Room
Deficiency Quantity	100
Quantity Uom	S.F.
Potential Action	INSTALL WATERPROOFING
Urgency of Action	PRIORITY 5
Purpose of Action	LEVEL 5
Deficiency Photo1

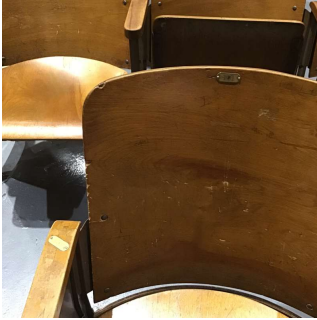
Question	Response
INTERIOR	
AUDITORIUM	
Fixed Seating	
Instance on 1st Floor (506 seats)	Inspected
Condition	5 - Poor
Deficiency	DAMAGED/BROKEN/INOPERABLE
Deficiency Location/Instance	Seat A/8,6,4,2,101, and others
Deficiency Quantity	52
Quantity Uom	EACH
Potential Action	REPLACE
Urgency of Action	PRIORITY 3
Purpose of Action	LEVEL 2
Deficiency Photo1

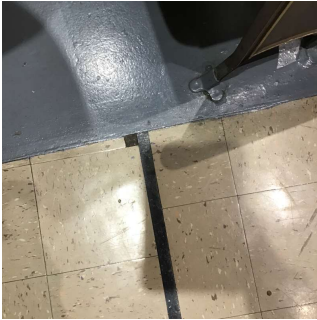
Violations	No violations recorded.
Floor Finish	
Instance on 1st Floor (506 seats)	Inspected
Condition	2 - Between Good and Fair
Deficiency	VINYL TILES: BROKEN/DETERIORATED/MISSING TILES
Deficiency Location/Instance	Near seat T/2, near stage, aisles
Deficiency Quantity	40
Quantity Uom	S.F.
Potential Action	REPLACE
Urgency of Action	PRIORITY 3
Purpose of Action	LEVEL 2
Deficiency Photo1

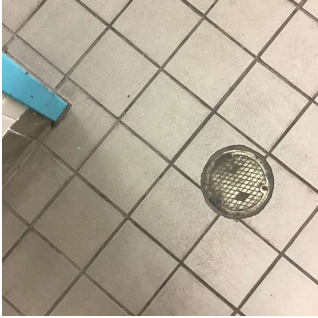
Violations	Exit 13 No violations recorded.
Door(s)	
Instance on Sub - Basement	Inspected
Condition	2 - Between Good and Fair
Deficiency	No deficiencies recorded
Floor Finish	
Instance on Sub - Basement	Inspected
Condition	2 - Between Good and Fair
Deficiency	QUARRY TILE: BROKEN/MISSING TILES
Deficiency Location/Instance	Near sink
Deficiency Quantity	10
Quantity Uom	S.F.
Potential Action	REPLACE
Urgency of Action	PRIORITY 3
Purpose of Action	LEVEL 2
Deficiency Photo1

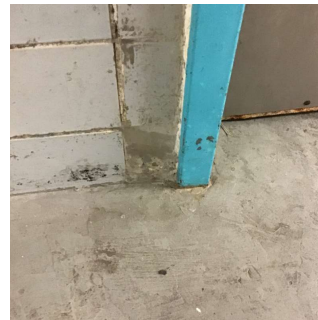
GLAZED BLOCK: CRACKS/SPALLING
Near slop area
10
S.F.
REPLACE
PRIORITY 3
LEVEL 2

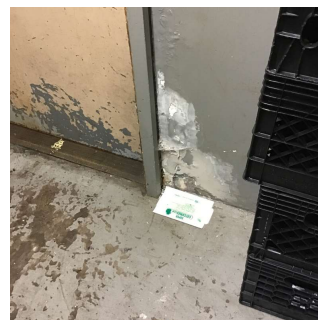
PLASTER: CRACKS/SPALLING - ACTIVE LEAK
Exit 13
10
S.F.
REPLACE
PRIORITY 5
LEVEL 2

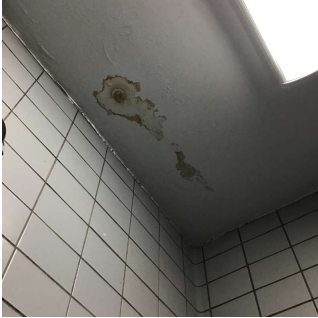
Question	Response
INTERIOR	
SHOWER ROOM	Inspected
Instance on 1st Floor - Boys	Inaccessible
Instance on 1st Floor - Girls	Inaccessible
STAIRS/RAMPS: INTERIOR	Inspected
Do Letter Stair Signs Exist?	Yes
Ceiling	Inspected
Condition	2 - Between Good and Fair
Deficiency	PLASTER: CRACKS/SPALLING - ACTIVE LEAK
Deficiency Location/Instance	Stair A/4
Deficiency Quantity	10
Quantity Uom	S.F.
Potential Action	REPLACE
Urgency of Action	PRIORITY 5
Purpose of Action	LEVEL 2
Deficiency Photo1

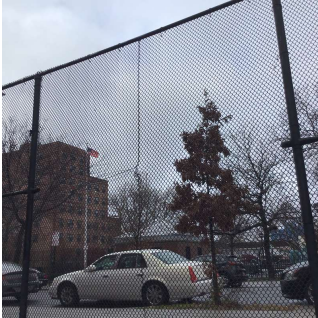
Question	Response
SITE	
FENCES	
Deficiency	CHAIN LINK: DAMAGED POST/RAIL
Deficiency Location/Instance	Along Martin Luther King Jr. Place, Stockton Street
Deficiency Quantity	20
Quantity Uom	L.F.
Potential Action	REPLACE
Urgency of Action	PRIORITY 3
Purpose of Action	LEVEL 2
Deficiency Photo1
