NYC Department of Education
Building Condition Assessment Survey 2023 - 2024

Architectural Inspection

Asset: P.S. 34 - BROOKLYN, 131 NORMAN AVENUE, New York, 11222

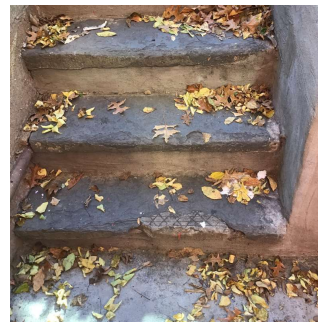
AW1 Facade A

Question	Response
Architectural	
EXTERIOR	Inspected
AREAWAY	Inspected
Instance on AW1 - AW6	Inspected
Instance Condition	3 - Fair
Instance Quantity	6
Instance Quantity Uom	EACH
Deficiency	AREAWAY STAIRS: DETERIORATED TREADS/RISERS/NOSINGS

10
S.F.
REPLACE
PRIORITY 4
LEVEL 2

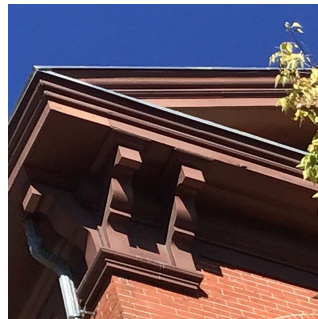
Facade A - North View
 No violations recorded.

WOOD: DETERIORATED

30
 S.F.
 REPAIR
 PRIORITY 3
 LEVEL 2

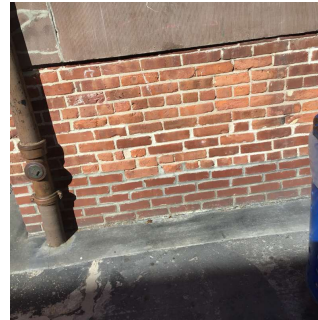
Facade G - North View

BRICK: MINOR CRACKS AND SPALLING

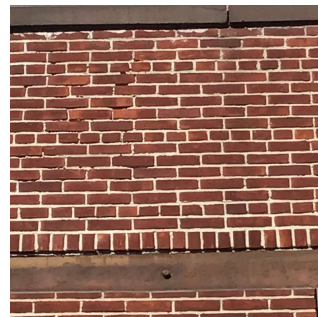
Facade E North View

BRICK: DETERIORATED JOINTS

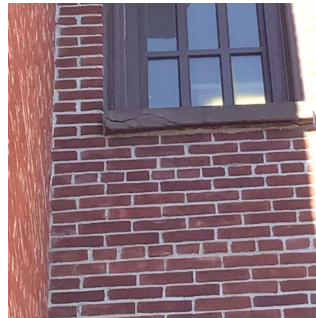
Facade L North View Room 214

BRICK: DETERIORATED MASONRY SILLS - MAJOR

REMOVE AND REPLACE

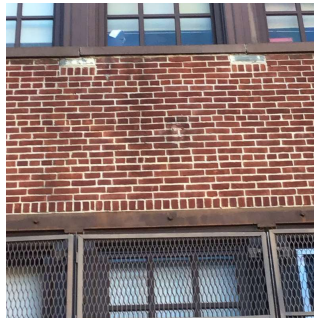
Facade F - East View

BRICK: MASONRY SILLS - DETERIORATED JOINTS

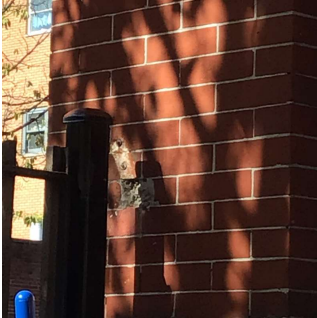
BRICK: CRACKS/DISPLACED/SPALLED BRICK AT BUILDING CORNERS

Question	Response
EXTERIOR	
EXTERIOR WALLS	
Potential Action	REMOVE AND REBUILD
Urgency of Action	PRIORITY 4
Purpose of Action	LEVEL 2
Deficiency Photo1

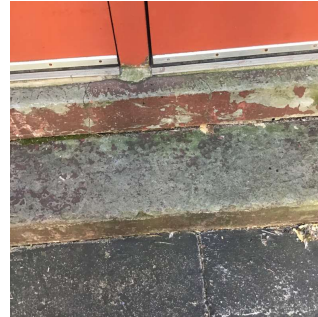
Facade F - near Exit 2

STONE: CRACKS/SPALLING - MINOR

REPAIR

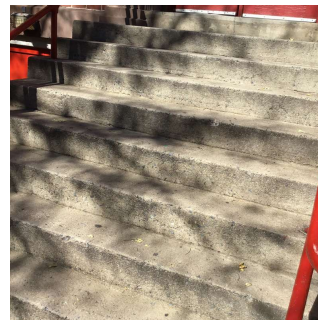
Facade Facade A - Main Entry

STONE: CRACKS/SPALLING - MAJOR

REPLACE

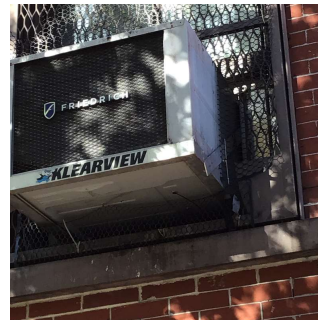
Facade A North View
 No violations recorded.

DETERIORATED/TORN-OUT/MISSING

60
 S.F.
 REPLACE
 PRIORITY 4
 LEVEL 2

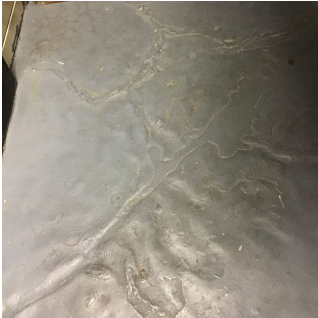
Basement Staff Lounge
Violations	No violations recorded.
FOUNDATION WALLS	Inspected
Material Type(s)	Masonry
Condition	5 - Poor
Deficiency	BRICK: WATER INFILTRATION IN INSTRUCTIONAL SPACE

Deficiency Location/Instance	Basement East Cafeteria, Basement Staff Lounge
Deficiency Quantity	800
Quantity Uom	S.F.
Potential Action	INSTALL WATERPROOFING
Urgency of Action	PRIORITY 5
Purpose of Action	LEVEL 5

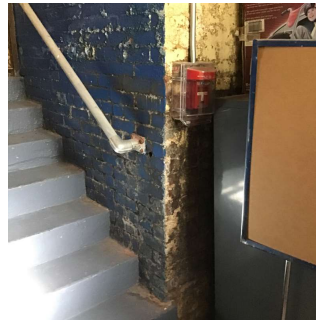
Basement Stair 3 (and similar) at Basement Storage Room, near Stair 3.

BRICK: WATER INFILTRATION IN NON- INSTRUCTIONAL SPACE

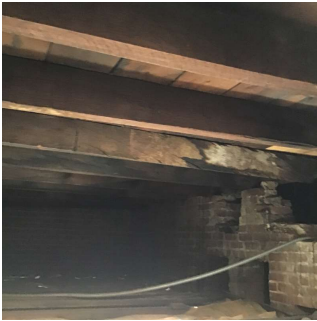
WOOD COLUMNS AND BEAMS: DETERIORATED

Violations	Roof Structure at Roof 4 No violations recorded.
VAULTS-BUNKERS	Does not Exist
AUDITORIUM	Does not Exist
CAFETERIA	Inspected
Instance on Basement - East	Inspected
Instance on Basement - West (300 SF)	Inspected
Ceiling	
Instance on Basement - East	Inspected
Condition	2 - Between Good and Fair
Deficiency	No deficiencies recorded
Instance on Basement - West (300 SF)	Inspected
Condition	2 - Between Good and Fair
Deficiency	No deficiencies recorded
Door(s)	
Instance on Basement - East	Not Required
Instance on Basement - West (300 SF)	Not Required
Fixed Equipment	
Instance on Basement - East	Does not Exist
Instance on Basement - West (300 SF)	Does not Exist
Floor Finish	
Instance on Basement - West (300 SF)	Inspected
Condition	4 - Between Fair and Poor
Deficiency	VINYL TILES: DETERIORATED SUBSTRATE
Deficiency Location/Instance	Center, Near Stair E

REPLACE

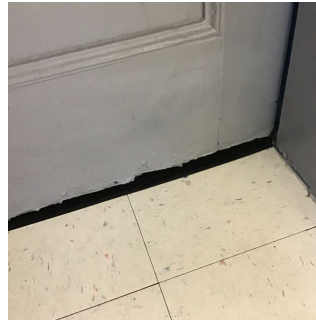
Room 112

Room 212
Violations	No violations recorded.
Door(s)	
Condition	5 - Poor
Deficiency	METAL CLAD WOOD: DETERIORATED DOOR
Deficiency Location/Instance	Rooms 111, 112
Deficiency Quantity	2
Quantity Uom	EACH
Potential Action	MAINTENANCE
Urgency of Action	PRIORITY 3
Purpose of Action	LEVEL 2

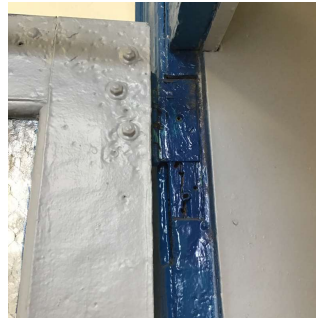
Room 112

METAL CLAD WOOD: DETERIORATED DOOR AND FRAME

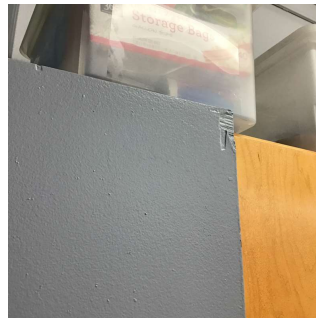
Room 204

WOOD: DETERIORATED DOOR

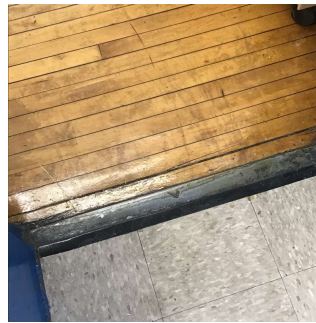
Question	Response
INTERIOR	
CLASSROOMS/CORRIDORS/ADMIN SPACES	
Floor Finish	Inspected
Condition	2 - Between Good and Fair
Deficiency	ROLLED ASPHALT: CRACKS
Deficiency Location/Instance	Basement Staff Lounge
Deficiency Quantity	150
Quantity Uom	S.F.
Potential Action	REPLACE
Urgency of Action	PRIORITY 3
Purpose of Action	LEVEL 2
Deficiency Photo1	 
Violations	Basement Staff Lounge No violations recorded.
Deficiency	VINYL TILES: BROKEN/DETERIORATED/MISSING TILES
Deficiency Location/Instance	Rooms 106, 204, 205, 211, 212, and others
Deficiency Quantity	240
Quantity Uom	S.F.
Potential Action	REPLACE
Urgency of Action	PRIORITY 3
Purpose of Action	LEVEL 2
Deficiency Photo1	 
Violations	Room 212 No violations recorded.
Deficiency	WOOD: DAMAGED/DETERIORATED
Deficiency Location/Instance	Room 214
Deficiency Quantity	10
Quantity Uom	S.F.
Potential Action	REPLACE
Urgency of Action	PRIORITY 3
Purpose of Action	LEVEL 2

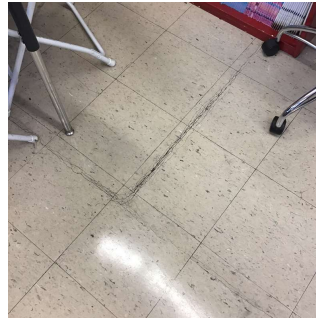
Room 210

VINYL TILES: DETERIORATED SUBSTRATE

REPLACE

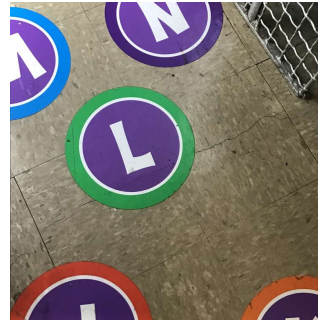
Question	Response
INTERIOR	
STAIRS/RAMPS: INTERIOR	
Railings	
Quantity Uom	L.F.
Potential Action	REPLACE
Urgency of Action	PRIORITY 3
Purpose of Action	LEVEL 2
Deficiency Photo1	 
	Stair F/2
Violations	No violations recorded.
Stairs and Landings	Inspected
Condition	2 - Between Good and Fair
Deficiency	VINYL TILES: BROKEN/DETERIORATED/MISSING TILES
Deficiency Location/Instance	Stair G/2
Deficiency Quantity	10
Quantity Uom	S.F.
Potential Action	REPLACE
Urgency of Action	PRIORITY 3
Purpose of Action	LEVEL 2
Deficiency Photo1	 
	Stair G/2
Violations	No violations recorded.
Deficiency	VINYL TILES: DETERIORATED SUBSTRATE
Deficiency Location/Instance	Stair C/1
Deficiency Quantity	10
Quantity Uom	S.F.
Potential Action	REPLACE
Urgency of Action	PRIORITY 3
Purpose of Action	LEVEL 2

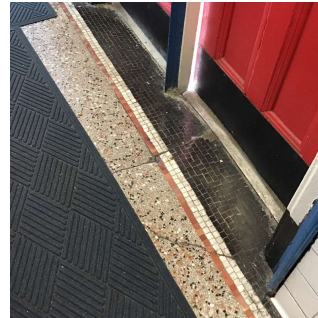
Stair B/1 (Main Entrance)

TERRAZZO: CRACKS

REPLACE

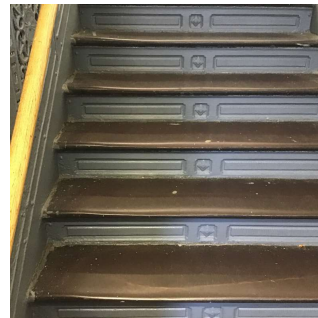
Stair G/Basement

STONE: WORN-OUT TREAD/NOSINGS

REPLACE
