NYC Department of Education
Building Condition Assessment Survey 2023 - 2024

Architectural Inspection

Asset: P.S. 39 - BROOKLYN, 417 6TH AVENUE, New York, 11215

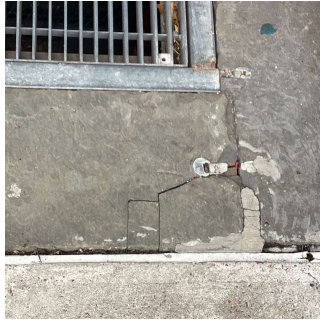
Question	Response
Architectural	
EXTERIOR	Inspected
AREAWAY	Inspected
Instance on AW1-AW3	Inspected
Instance Condition	3 - Fair
Instance Quantity	3
Instance Quantity Uom	EACH
Deficiency	AREAWAY WALLS: DETERIORATED COPING STONE
Roof Plan reference	K039
Deficiency Quantity	20
Quantity Uom	S.F.
Potential Action	REPLACE
Urgency of Action	PRIORITY 4
Purpose of Action	LEVEL 2

Violations	Facade D - AW2 No violations recorded.
AWNINGS AND CANOPIES	
	Does not Exist
CHIMNEY	
Material Type(s)	Inspected Masonry
Condition	2 - Between Good and Fair
Deficiency	BRICK: MINOR CRACKS AND SPALLING
Roof Plan reference	K039

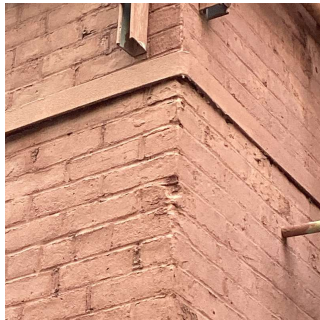
Deficiency Quantity	10
Quantity Uom	S.F.
Potential Action	RESTITCH
Urgency of Action	PRIORITY 3
Purpose of Action	LEVEL 2
Deficiency Photo1

Violations	CH No violations recorded.
COPING	
Condition	Inspected 2 - Between Good and Fair
Deficiency	No deficiencies recorded
CORNICE	
Condition	Inspected 2 - Between Good and Fair
Deficiency	No deficiencies recorded

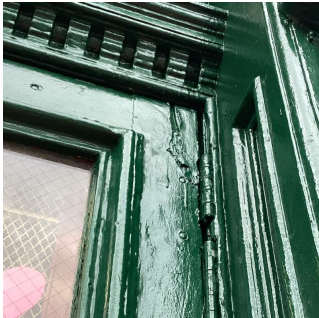
Question	Response
EXTERIOR	
DOORS	Inspected
DOORS AND FRAMES	Inspected
Condition	5 - Poor
Deficiency	WOOD: DETERIORATED DOOR AND FRAME - MAJOR DETERIORATION
Roof Plan reference	K039

Deficiency Quantity	2
Quantity Uom	EACH
Potential Action	REPLACE
Urgency of Action	PRIORITY 4
Purpose of Action	LEVEL 2
Deficiency Photo1

Violations	Facade A - Main Entrance No violations recorded.
Deficiency	METAL CLAD: DETERIORATED DOOR AND FRAME - MAJOR DETERIORATION
Roof Plan reference	K039

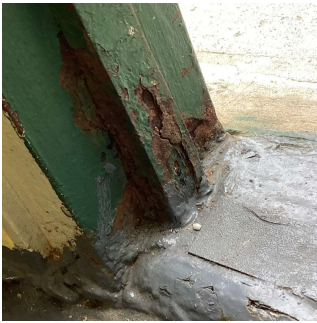
Deficiency Quantity	2
Quantity Uom	EACH
Potential Action	REPLACE
Urgency of Action	PRIORITY 4
Purpose of Action	LEVEL 2

Violations	Facade A - Exit 2 No violations recorded.
Deficiency	METAL CLAD: DETERIORATED DOOR - MAJOR DETERIORATION
Roof Plan reference	K039

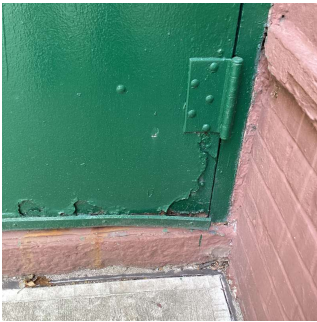
Deficiency Quantity	2
Quantity Uom	EACH
Potential Action	REPLACE
Urgency of Action	PRIORITY 4
Purpose of Action	LEVEL 2
Deficiency Photo1

Violations	Facade B - Exit 1A No violations recorded.
DOOR HARDWARE	Inspected
Condition	3 - Fair
Deficiency	No deficiencies recorded
LINTELS	Inspected
Condition	2 - Between Good and Fair
Deficiency	No deficiencies recorded
TRANSOM/SIDE LIGHT	Inspected
Condition	2 - Between Good and Fair
Deficiency	No deficiencies recorded

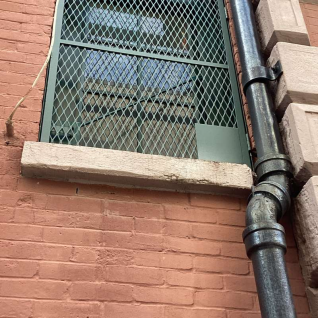
Question	Response
EXTERIOR	
EXTERIOR WALLS	Inspected
Material Type(s)	Masonry, Steel
Replacement Quantity	15,000
Replacement Uom	S.F.
Instance on All Facades	Inspected
Instance Condition	3 - Fair
Instance Quantity	15,000
Instance Quantity Uom	S.F.
Deficiency	BRICK: DETERIORATED MASONRY SILLS - MINOR
Roof Plan reference	K039

Deficiency Quantity	10
Quantity Uom	L.F.
Potential Action	REPAIR
Urgency of Action	PRIORITY 3
Purpose of Action	LEVEL 2
Deficiency Photo1

Violations	Facade B No violations recorded.
Deficiency	BRICK: CRACKS/DISPLACED/SPALLED BRICK AT BUILDING CORNERS

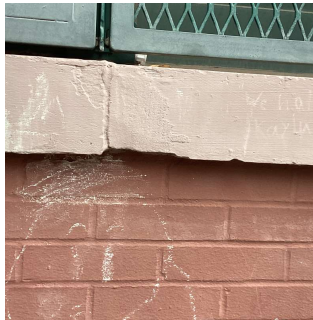
Facade D - Near AW1

BRICK: DETERIORATED MASONRY SILLS - MAJOR

REMOVE AND REPLACE

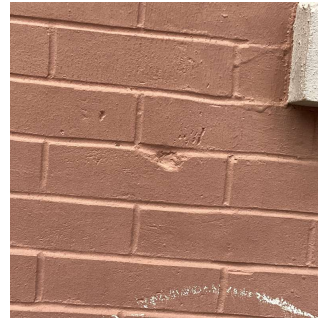
Facade D - Near AW2

BRICK: MINOR CRACKS AND SPALLING

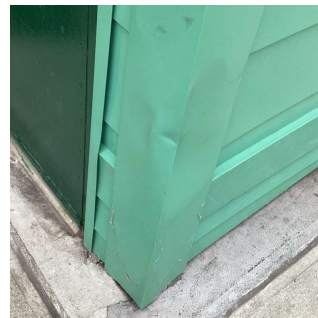
Facade D - by Roof 8

METAL PANEL: DAMAGED TRIM

REPLACE

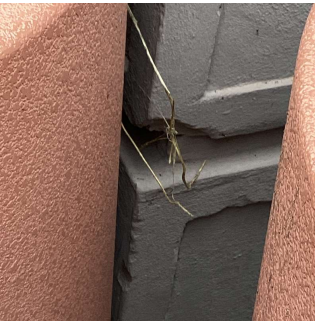
Question	Response
EXTERIOR	
EXTERIOR WALLS	
Violations	No violations recorded.
Deficiency	STONE: CRACKS AT BUILDING CORNERS
Roof Plan reference	K039

Deficiency Quantity	10
Quantity Uom	S.F.
Potential Action	REPLACE
Urgency of Action	PRIORITY 4
Purpose of Action	LEVEL 2
Deficiency Photo1

Violations	Corner of Facade A and Facade D No violations recorded.
EXTERIOR SOFFITS	Does not Exist
LOADING DOCK	Does not Exist
LOUVER	Inspected
Condition	2 - Between Good and Fair
Deficiency	No deficiencies recorded
PARAPETS	Does not Exist
PLAZA DECK	Does not Exist
ROOF	Inspected
Roofing	Inspected
Replacement Quantity	9,000

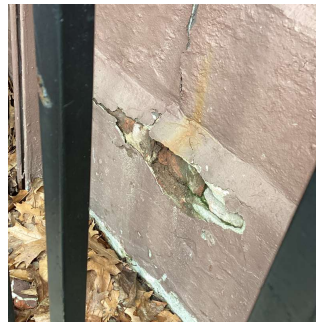
Facade B - Near Exit 3B

Condition	3 - Fair
Deficiency	CAST IN PLACE CONCRETE: CRACKS/SPALLING - MAJOR
Roof Plan reference	K039

Deficiency Quantity	10
Quantity Uom	S.F.
Potential Action	REPLACE
Urgency of Action	PRIORITY 4
Purpose of Action	LEVEL 2

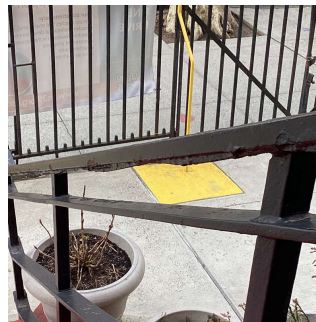
Facade A - Main Entrance

RUST - MAJOR

REPLACE

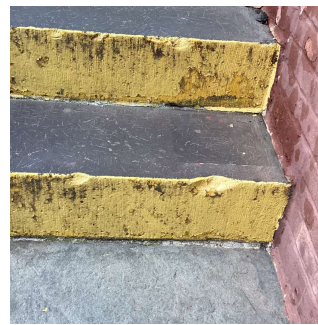
STONE: WORN-OUT TREAD/RISER/NOSING

40
S.F.
REPLACE
PRIORITY 4
LEVEL 2

Facade B - Near Exit 3B
No violations recorded.

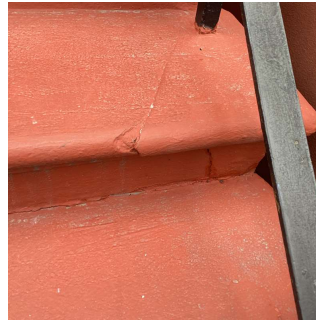
Facade A - Main Entrance

CONCRETE: CRACKS/SPALLING - MAJOR

20
S.F.
REPLACE
PRIORITY 4
LEVEL 2

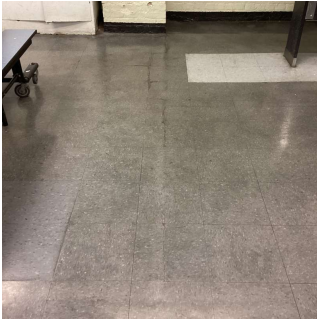
Violations	Near kitchen No violations recorded.
Deficiency	VINYL TILES: DETERIORATED SUBSTRATE
Deficiency Location/Instance	Near center, windows
Deficiency Quantity	120
Quantity Uom	S.F.
Potential Action	REPLACE
Urgency of Action	PRIORITY 3
Purpose of Action	LEVEL 2
Deficiency Photo1

Violations	Near center No violations recorded.
Sliding-folding Partition	
Instance on Basement (1,000 SF)	Does not Exist
Stage	
Instance on Basement (1,000 SF)	Does not Exist
Walls	
Instance on Basement (1,000 SF)	Inspected
Condition	2 - Between Good and Fair
Deficiency	No deficiencies recorded
Window Curtains/Shades/Blinds	
Instance on Basement (1,000 SF)	Does not Exist
CLASSROOMS/CORRIDORS/ADMIN SPACES	
Ceiling	Inspected
Condition	2 - Between Good and Fair
Deficiency	No deficiencies recorded
Door(s)	Inspected
Condition	5 - Poor
Deficiency	METAL: DETERIORATED DOOR AND FRAME

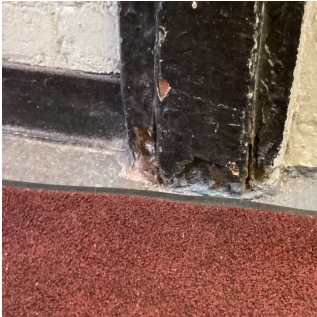
Deficiency Location/Instance	Exit 2

Question	Response
INTERIOR	
CLASSROOMS/CORRIDORS/ADMIN SPACES	
Door(s)	
Deficiency Quantity	1
Quantity Uom	EACH
Potential Action	MAINTENANCE
Urgency of Action	PRIORITY 3
Purpose of Action	LEVEL 2
Deficiency Photo1

Violations	Exit 2 No violations recorded.
Deficiency	METAL CLAD WOOD: DETERIORATED DOOR
Deficiency Location/Instance	Room 100
Deficiency Quantity	1
Quantity Uom	EACH
Potential Action	MAINTENANCE
Urgency of Action	PRIORITY 3
Purpose of Action	LEVEL 2
Deficiency Photo1

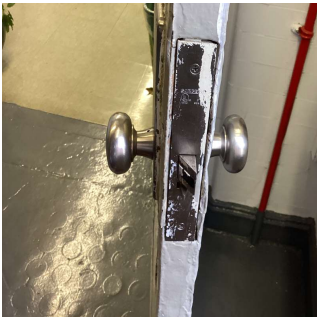
Violations	Room 100 No violations recorded.
Deficiency	WOOD: DETERIORATED DOOR
Deficiency Location/Instance	Room 300B, 204, 104
Deficiency Quantity	3
Quantity Uom	EACH
Potential Action	MAINTENANCE
Urgency of Action	PRIORITY 3
Purpose of Action	LEVEL 2

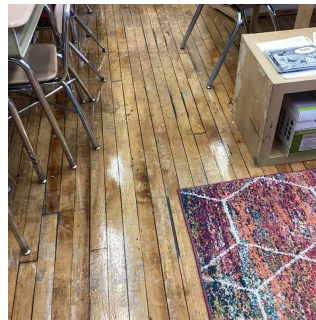
Room 306

WOOD: DAMAGED/DETERIORATED

REPLACE

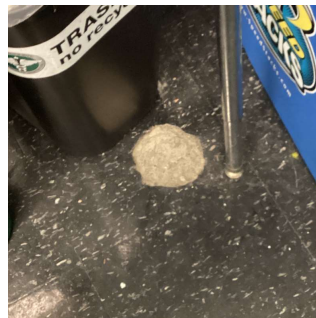
VINYL TILES: BROKEN/DETERIORATED/MISSING TILES

Question	Response
INTERIOR	
CLASSROOMS/CORRIDORS/ADMIN SPACES	
Floor Finish	
Violations	Room 200B No violations recorded.
Deficiency	VINYL TILES: DETERIORATED SUBSTRATE
Deficiency Location/Instance	Room 203, 202, 106, 105, 103, and others
Deficiency Quantity	80
Quantity Uom	S.F.
Potential Action	REPLACE
Urgency of Action	PRIORITY 3
Purpose of Action	LEVEL 2
Deficiency Photo1

REPLACE

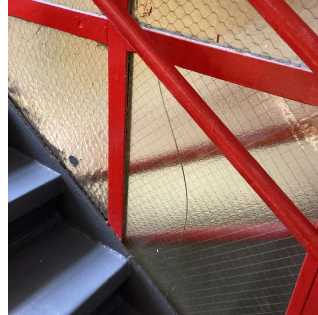
Stair A/2

Partition	
Condition	Inspected 3 - Fair
Deficiency	GLASS PANEL: DAMAGED/DETERIORATED
Deficiency Location/Instance	Stair AB/3, 2, 1, Basement
Deficiency Quantity	55
Quantity Uom	S.F.
Potential Action	REPLACE

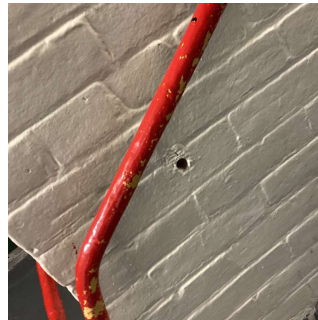
Stair F/1

METAL: BROKEN BRACKET

REPLACE

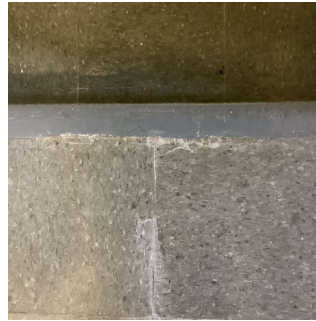
Stair AB/Basement

VINYL TILES: BROKEN/DETERIORATED/MISSING TILES

REPLACE

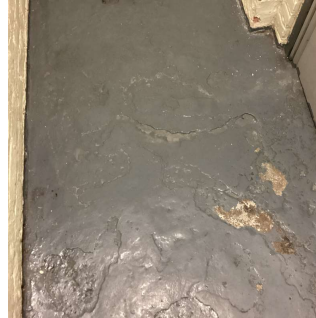
Stair F/Basement

ROLLED ASPHALT: CRACKS

REPLACE

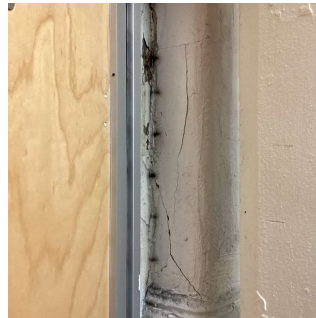
PLASTER: CRACKS/SPALLING

Question	Response
INTERIOR	
STAIRS/RAMPS: INTERIOR	
Walls	
Violations	Stair AB/2 No violations recorded.
Deficiency	CERAMIC TILE: BROKEN/ MISSING
Deficiency Location/Instance	Stair AB/ 3, 2, 1
Deficiency Quantity	50
Quantity Uom	S.F.
Potential Action	REPLACE
Urgency of Action	PRIORITY 3
Purpose of Action	LEVEL 2
Deficiency Photo1

REPLACE

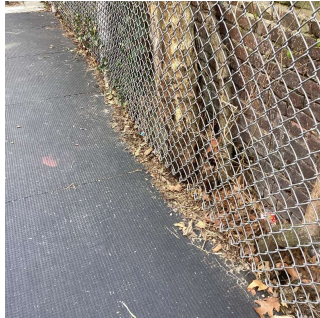
Question	Response
SITE	
Drainage System for Concrete	Inspected
Catch Basins/Manhole - Surrounded by concrete	Inspected
Condition	2 - Between Good and Fair
Deficiency	No deficiencies recorded
Culverts - Concrete Covering	Does not Exist
Drainage System for Soil	Does not Exist
DRINKING FOUNTAINS	Does not Exist
FENCES	Inspected
Condition	4 - Between Fair and Poor
Deficiency	CHAIN LINK: MISSING SECTIONS
Deficiency Location/Instance	Schoolyard
Deficiency Quantity	30
Quantity Uom	S.F.
Potential Action	REPLACE
Urgency of Action	PRIORITY 3
Purpose of Action	LEVEL 2
Deficiency Photo1

Schoolyard
Violations	No violations recorded.
Deficiency	CONCRETE CURB: DAMAGED/DETERIORATED
Deficiency Location/Instance	Along 6th Avenue
Deficiency Quantity	15
Quantity Uom	S.F.
Potential Action	REPLACE
Urgency of Action	PRIORITY 3
Purpose of Action	LEVEL 2
Deficiency Photo1

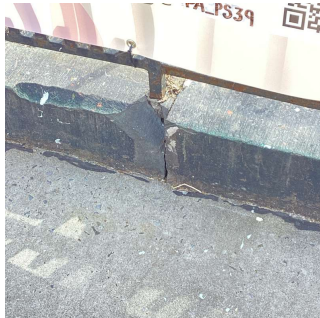
Along 6th Avenue
Violations	No violations recorded.
Deficiency	WROUGHT IRON: RUST - MAJOR

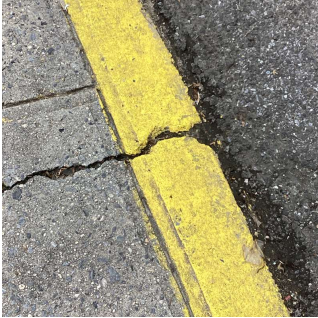
Question	Response
SITE	
PAVING	
Student Non-Use	Inspected
Concrete	Inspected
Violations	No violations recorded.
Pavers	Does not Exist
Student Use	Inspected
Gravel Exists?	No
Asphalt	Does not Exist
Concrete	Inspected
Condition	2 - Between Good and Fair
Deficiency	No deficiencies recorded
Pavers	Does not Exist
Site Sidewalks & Walkways	Inspected
Asphalt	Does not Exist
Concrete	Inspected
Condition	2 - Between Good and Fair
Deficiency	No deficiencies recorded
Pavers	Does not Exist
DOT Sidewalk	Inspected
Asphalt	Does not Exist
Concrete	Inspected
Condition	4 - Between Fair and Poor
Deficiency	DAMAGED CURBS
Deficiency Location/Instance	Along 6th Avenue, 8th Street
Deficiency Quantity	40
Quantity Uom	L.F.
Potential Action	REPLACE
Urgency of Action	PRIORITY 3
Purpose of Action	LEVEL 2
Deficiency Photo1

Violations	Along 6th Avenue No violations recorded.
Deficiency	HEAVING
Deficiency Location/Instance	Along 6th Avenue, 8th Street

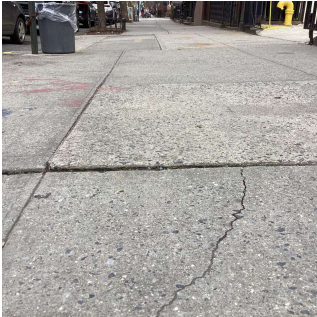
Deficiency Quantity	150
Quantity Uom	S.F.
Potential Action	REPLACE
Urgency of Action	PRIORITY 3
Purpose of Action	LEVEL 2

Violations	Along 6th Avenue No violations recorded.
Deficiency	DAMAGED/DETERIORATED/MISSING SECTIONS
Deficiency Location/Instance	Along 6th Avenue, 8th Street
Deficiency Quantity	825
Quantity Uom	S.F.
Potential Action	REPLACE
Urgency of Action	PRIORITY 3
Purpose of Action	LEVEL 2
Deficiency Photo1

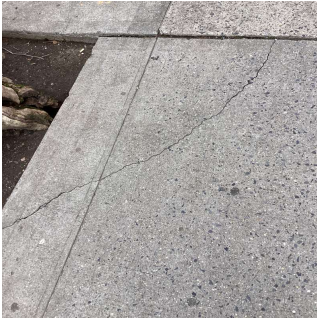
Violations	Along 6th Avenue No violations recorded.
Pavers	Does not Exist
PLAYGROUNDS	Inspected
Instance on Upper Level	Inspected
Instance on Lower Level	Inspected
Benches	
Instance on Upper Level	Inspected
Condition	2 - Between Good and Fair
Deficiency	No deficiencies recorded
Instance on Lower Level	Inspected
Condition	2 - Between Good and Fair
Deficiency	No deficiencies recorded
Fence	
Instance on Upper Level	Inspected
Condition	2 - Between Good and Fair
Deficiency	CONCRETE CURB: DAMAGED/DETERIORATED
Deficiency Location/Instance	Schoolyard
Deficiency Quantity	10

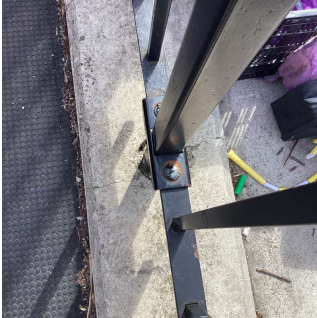
Question	Response
SITE	
PLAYGROUNDS	
Fence	
Quantity Uom	S.F.
Potential Action	REPLACE
Urgency of Action	PRIORITY 3
Purpose of Action	LEVEL 2
Deficiency Photo1

Schoolyard
Violations	No violations recorded.
Pavement	
Instance on Lower Level	Inspected
Condition	2 - Between Good and Fair
Deficiency	CONCRETE: DAMAGED/DETERIORATED/MISSING SECTIONS
Deficiency Location/Instance	Schoolyard
Deficiency Quantity	25
Quantity Uom	S.F.
Potential Action	REPLACE
Urgency of Action	PRIORITY 3
Purpose of Action	LEVEL 2
Deficiency Photo1

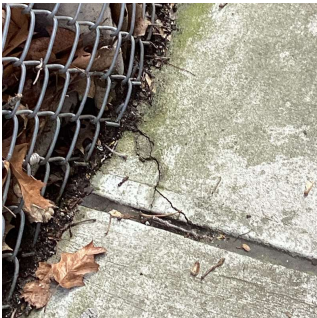
Schoolyard
Violations	No violations recorded.
Instance on Upper Level	Inspected
Condition	2 - Between Good and Fair
Deficiency	CONCRETE: DAMAGED/DETERIORATED/MISSING SECTIONS
Deficiency Location/Instance	Schoolyard
Deficiency Quantity	25
Quantity Uom	S.F.
Potential Action	REPLACE
Urgency of Action	PRIORITY 3
Purpose of Action	LEVEL 2

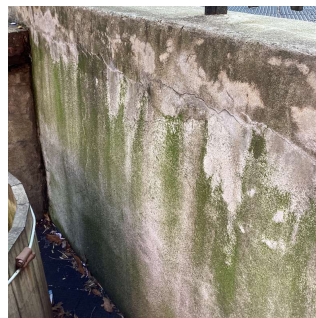
Condition	3 - Fair
Deficiency	CAST IN PLACE CONCRETE: CRACKS/SPALLING - MAJOR
Deficiency Location/Instance	Schoolyard
Deficiency Quantity	50
Quantity Uom	S.F.
Potential Action	REPLACE
Urgency of Action	PRIORITY 3
Purpose of Action	LEVEL 2
Deficiency Photo1

Question	Response
SITE	
RETAINING WALLS	Inspected
Violations	Schoolyard No violations recorded.
SEATING	Does not Exist
SITE WALLS (NOT RETAINING WALLS)	Does not Exist
STAIRS/RAMPS: EXTERIOR	Inspected
Railings	Inspected
Condition	3 - Fair
Deficiency	MISSING
Deficiency Location/Instance	Schoolyard
Deficiency Quantity	10
Quantity Uom	L.F.
Potential Action	REPLACE
Urgency of Action	PRIORITY 5
Purpose of Action	LEVEL 6
Deficiency Photo1

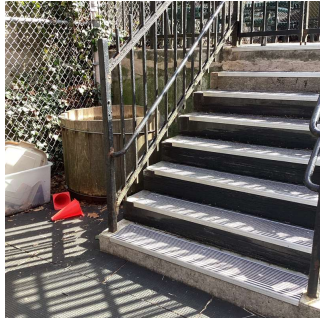
Violations	Schoolyard No violations recorded.
Deficiency	DAMAGED
Deficiency Location/Instance	Schoolyard
Deficiency Quantity	10
Quantity Uom	L.F.
Potential Action	REPLACE
Urgency of Action	PRIORITY 3
Purpose of Action	LEVEL 2
Deficiency Photo1

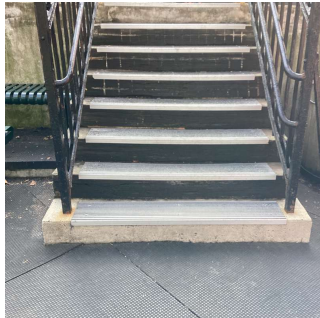
Violations	Schoolyard No violations recorded.
Site Cheek/flank Walls	Inspected
Condition	2 - Between Good and Fair
Deficiency	No deficiencies recorded
Stairs/ramps	Inspected
