NYC Department of Education
Building Condition Assessment Survey 2023 - 2024

Architectural Inspection

Asset: P.S. 40 - BROOKLYN, 265 RALPH AVENUE, New York, 11221

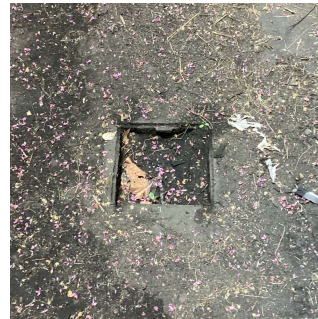
AW2

AREAWAY DRAINS: DETERIORATED

REPLACE

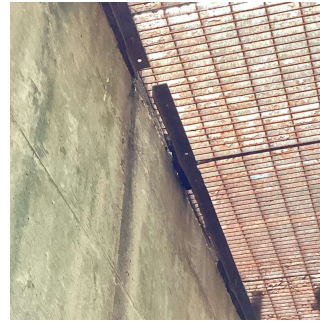
AW2

AREAWAY GRATINGS: MAJOR RUSTING AND / OR BROKEN SUPPORTS

REPLACE

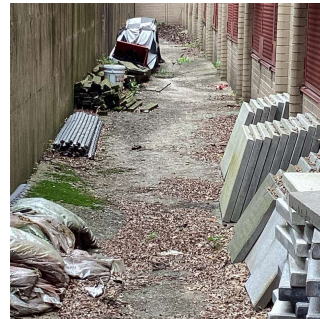
AW1

AREAWAY SLAB: DISPLACED

REPLACE

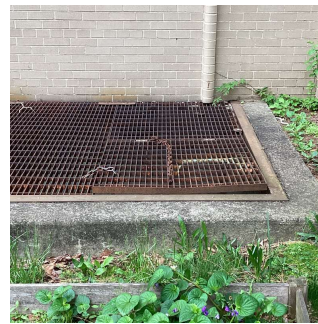
AW2
No violations recorded.

AREAWAY GRATINGS: MAJOR RUSTING / OR BROKEN

100
S.F.
REPLACE
PRIORITY 4
LEVEL 2

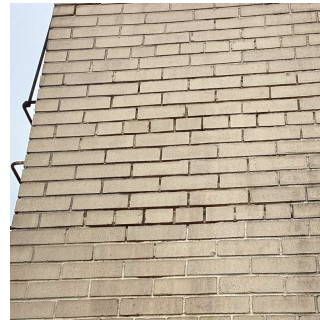
CH

BRICK: DETERIORATED JOINTS

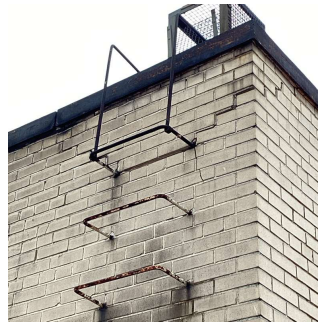
CH

BRICK: MAJOR / THRU CRACKS

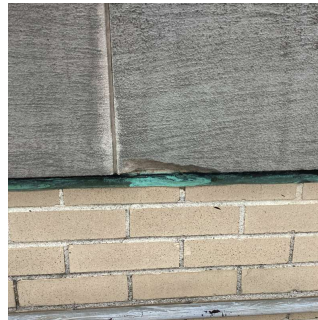
Roof 1

CAST STONE: CRACKED/BROKEN PIECES

REPLACE-IN-KIND

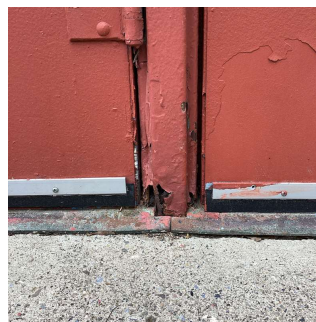
Facade K

METAL CLAD: DETERIORATED DOOR AND FRAME - MAJOR DETERIORATION

5
 EACH
 REPLACE
 PRIORITY 4
 LEVEL 2

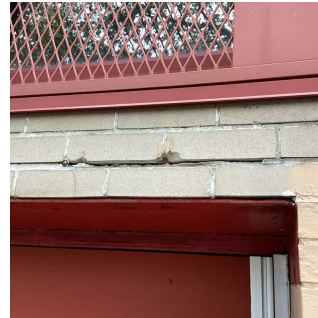
Facade G

BRICK: DETERIORATED JOINTS

PRIORITY 4
LEVEL 2

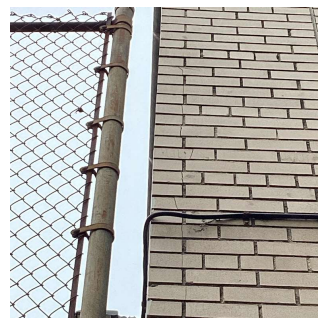
BRICK: CRACKS/DISPLACED/SPALLED BRICK AT BUILDING CORNERS

50
S.F.
REMOVE AND REBUILD
PRIORITY 4
LEVEL 2

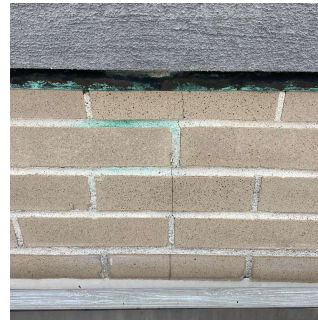
Roof 1

BRICK: MINOR CRACKS, SPALLING

REPAIR

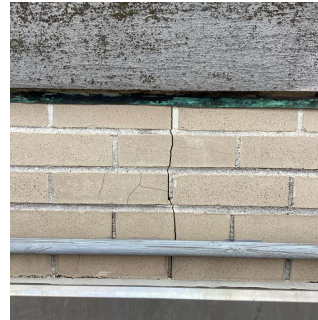
Roof 1

BRICK: MAJOR DETERIORATION/CRACKS

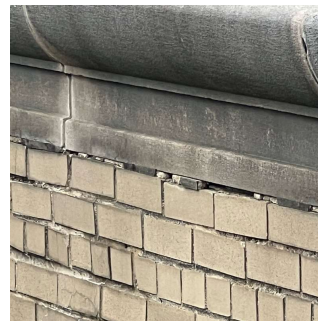
Roof 1A

BRICK: DETERIORATED JOINTS

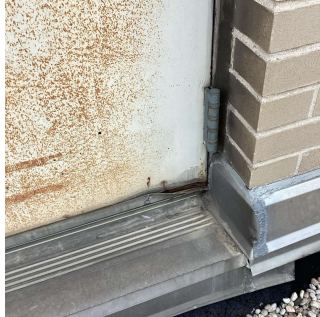
BULKHEAD/PENTHOUSE DOORS: DETERIORATED DOOR AND FRAME

1
EACH
REPLACE DOOR AND FRAME
PRIORITY 4
LEVEL 2

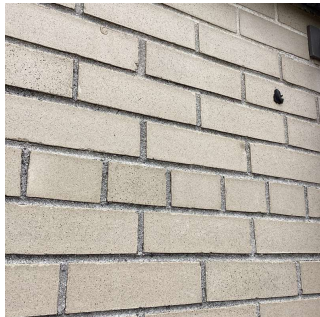
Violations	BH3 No violations recorded.
Deficiency	BULKHEAD/PENTHOUSE WALLS/EXTERIOR: DETERIORATED JOINTS
Roof Plan reference

Deficiency Quantity	40
Quantity Uom	S.F.
Potential Action	REPOINT
Urgency of Action	PRIORITY 3
Purpose of Action	LEVEL 2
Deficiency Photo1

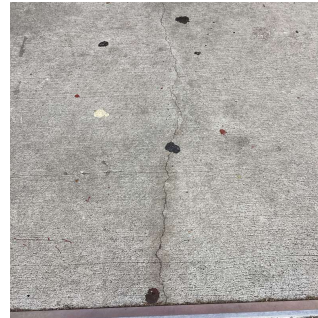
Facade A

Deficiency	CONCRETE: CRACKS/SPALLING - MINOR
------------	-----------------------------------

REPAIR

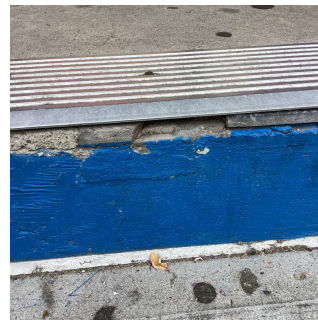
Facade A

CONCRETE: WORN-OUT TREAD/RISER/NOSING

10

REPLACE

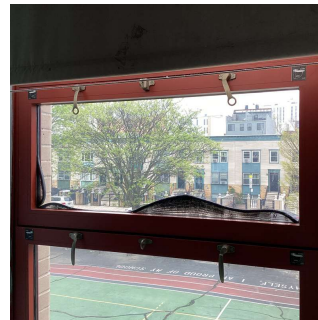
Facade K - Room 219 (Facade K - Rooms 221, Facade A - Rooms 235, 243, 245, Facade L - Rooms 246, 248, similar throughout)

Violations	Facade A No violations recorded.
WINDOWS	Inspected
Replacement Quantity	12,000
Replacement Uom	S.F.
EXTERIOR GUARDS	
Condition	2 - Between Good and Fair
Deficiency	No deficiencies recorded
LINTELS	
Condition	2 - Between Good and Fair
Deficiency	No deficiencies recorded
WINDOWS	
Material Type(s)	Aluminum
Instance on Aluminum - Other: All Facades except Gymnasium Facades	Inspected
Instance Condition	5 - Poor
Instance Quantity	11,500
Instance Quantity Uom	S.F.
Are these windows insulated	Yes
Installation Year	2008
Source of Installation	Custodial Staff
Deficiency	ALUMINUM - OTHER: DETERIORATED

REPLACE WINDOW

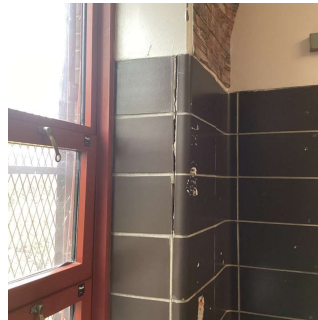
Corridor near Room 348

Violations	Room 316 No violations recorded.
Deficiency	GLAZED BLOCK: CRACKS/SPALLING
Deficiency Location/Instance	Corridor near Rooms 348, 112
Deficiency Quantity	20
Quantity Uom	S.F.
Potential Action	REPLACE
Urgency of Action	PRIORITY 3
Purpose of Action	LEVEL 2
Deficiency Photo1

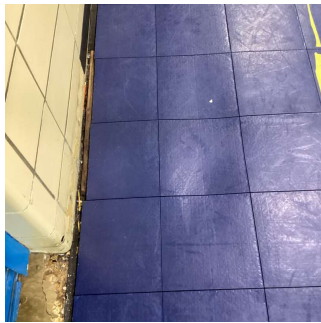
No	Tripping Hazard	Severely damage substrate under rubber flooring resulting in potential tripping hazard	INTERIOR GYMNASIUM Floor Finish	Near Metal Gate	Paul Townes	Custodian

Question	Response
INTERIOR	
GYMNASIUM	
Door(s)	
Violations	No violations recorded.
Fixed Equipment	
Instance on 1st Floor	Inspected
Condition	2 - Between Good and Fair
Deficiency	No deficiencies recorded
Floor Finish	
Instance on 1st Floor	Inspected
Condition	2 - Between Good and Fair
Deficiency	RUBBER MATTING: DETERIORATED SUBSTRATE
Deficiency Location/Instance	Near Metal Gate
Deficiency Quantity	25
Quantity Uom	S.F.
Potential Action	REPLACE
Urgency of Action	PRIORITY 5
Purpose of Action	LEVEL 6
Deficiency Photo1

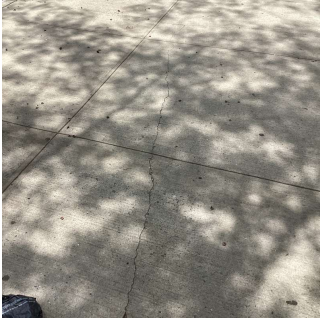
Yes	Tripping Hazard	Severely heaving concrete resulting in potential tripping hazard	SITE PAVING DOT Sidewalk Concrete	Sumpter Street	Paul Townes	Custodian

Question	Response
SITE	
PAVING	
DOT Sidewalk	
Concrete	
Deficiency Photo1
