**NYC Department of Education**  
**Building Condition Assessment Survey 2023 - 2024**

Architectural Inspection

**Asset: P.S. 41 - BROOKLYN, 411 THATFORD AVENUE, New York, 11212**

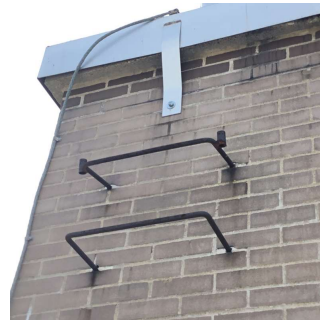
Deficiency Quantity	10
Quantity Uom	L.F.
Potential Action	REPLACE
Urgency of Action	PRIORITY 4
Purpose of Action	LEVEL 2
Deficiency Photo1	 
Violations	Chimney No violations recorded.
Deficiency	BRICK: DETERIORATED LADDER

1  
EACH  
REPLACE  
PRIORITY 3  
LEVEL 2

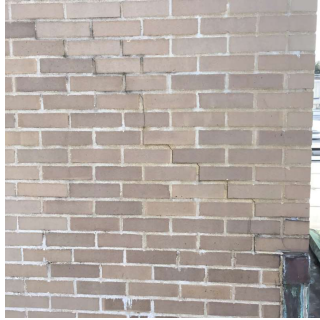
**BRICK: MAJOR / THRU CRACKS**

40  
S.F.  
REMOVE AND REBUILD  
PRIORITY 4  
LEVEL 2

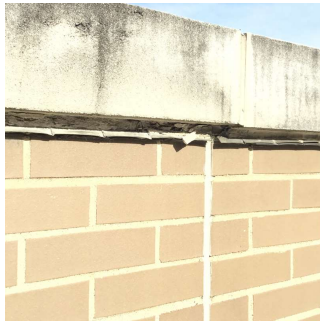
Violations	Chimney No violations recorded.
<b>COPING</b>	
Condition	Inspected 3 - Fair
Deficiency	CAST STONE: DETERIORATED BED JOINT
Roof Plan reference

Deficiency Quantity	85
Quantity Uom	L.F.
Potential Action	REPOINT
Urgency of Action	PRIORITY 3
Purpose of Action	LEVEL 2
Deficiency Photo1

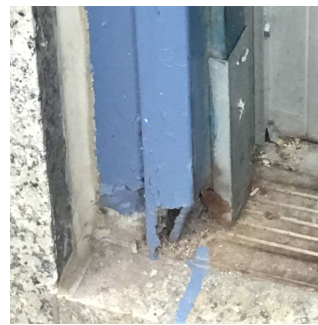
Facade B

Violations	Roof 3 No violations recorded.
<b>CORNICE</b>	
	Does not Exist
<b>DOORS</b>	
	Inspected
<b>DOORS AND FRAMES</b>	
Condition	Inspected 5 - Poor
Deficiency	METAL: DETERIORATED DOOR AND FRAME - MAJOR DETERIORATION

5  
EACH  
REPLACE  
PRIORITY 4  
LEVEL 2

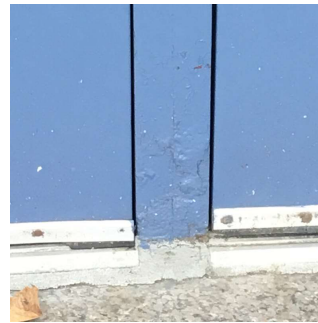
Facade B

**METAL: DETERIORATED DOOR AND FRAME - MINOR DETERIORATION**

2  
EACH  
MAINTENANCE  
PRIORITY 3  
LEVEL 2

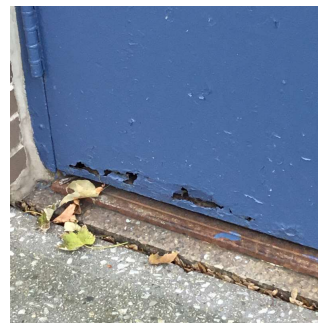
Facade B

**METAL: DETERIORATED DOOR - MAJOR DETERIORATION**

REPLACE

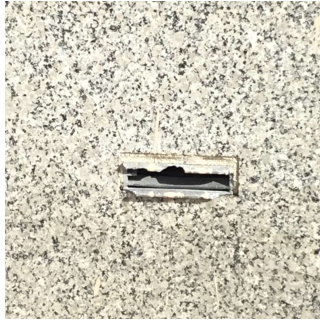
BROKEN/ DENTED BLADES

20  
S.F.  
REPLACE  
PRIORITY 4  
LEVEL 2

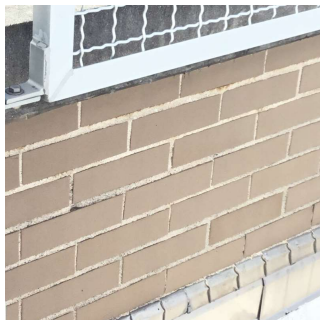
Violations	Facade A No violations recorded.
<b>PARAPETS</b>	Inspected
Material Type(s)	Masonry
Replacement Quantity	12,000
Replacement Uom	C.F.
Instance on All Roofs	Inspected
Instance Condition	3 - Fair
Instance Quantity	12,000
Instance Quantity Uom	C.F.
Deficiency	<b>BRICK: DETERIORATED JOINTS</b>
Roof Plan reference

Deficiency Quantity	20
Quantity Uom	S.F.
Potential Action	REPOINT
Urgency of Action	PRIORITY 3
Purpose of Action	LEVEL 2
Deficiency Photo1

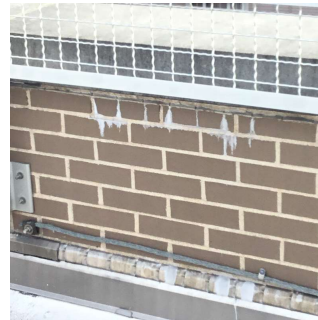
Roof 1

Violations	Roof 2 No violations recorded.
Deficiency	<b>BRICK: EFFLORESCENCE</b>

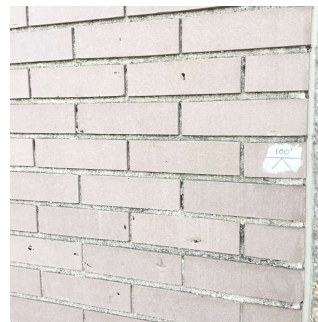
Deficiency	No deficiencies recorded
<b>ROOFING DRAINS</b>	Inspected
Condition	2 - Between Good and Fair
Deficiency	No deficiencies recorded
<b>Specialties</b>	Inspected
<b>BULKHEAD/PENTHOUSE</b>	Inspected
Condition	3 - Fair
Deficiency	BULKHEAD/PENTHOUSE WALLS/EXTERIOR: DETERIORATED JOINTS

15  
 S.F.  
 REPOINT  
 PRIORITY 4  
 LEVEL 2

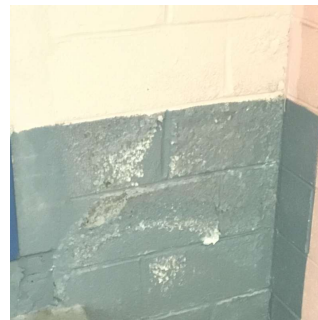
BH1

**BULKHEAD/PENTHOUSE WALLS/INTERIOR: CMU  
CRACKS/SPALLING**

REPLACE

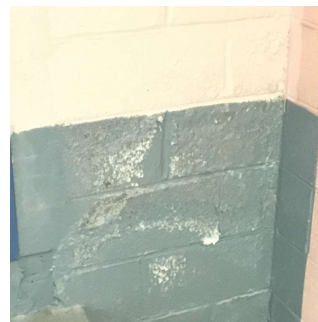
**BULKHEAD/PENTHOUSE WALLS/EXTERIOR: WATER  
INFILTRATION**

50  
S.F.  
REPAIR  
PRIORITY 5  
LEVEL 2

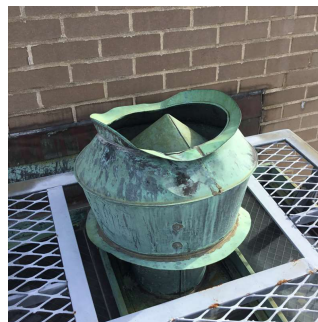
Roof 1

Violations	BH2 No violations recorded.
<b>CUPOLA/ SPIRES/ TOWERS</b>	Does not Exist
<b>DORMER</b>	Does not Exist
<b>DUNNAGE STEEL</b>	Does not Exist
<b>SKYLIGHT/ROOF VENT</b>	Inspected
Material Type(s)	Glass
Condition	3 - Fair
Deficiency	SHAFT VENTS DAMAGED

1  
EACH  
MAINTENANCE  
PRIORITY 3  
LEVEL 2

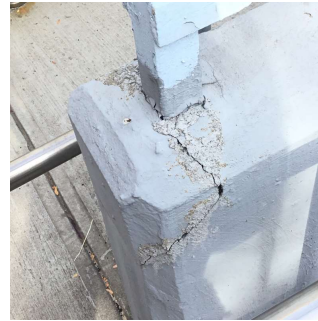
Facade D

CAST IN PLACE CONCRETE: CRACKS/SPALLING - MAJOR

40  
S.F.  
REPLACE  
PRIORITY 4  
LEVEL 2

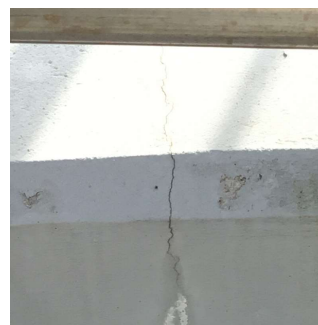
Facade D

**CAST IN PLACE CONCRETE: CRACKS/SPALLING - MINOR**

REPAIR

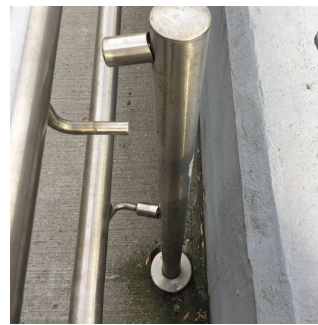
BROKEN BRACKET

2  
 EACH  
 REPLACE  
 PRIORITY 4  
 LEVEL 2

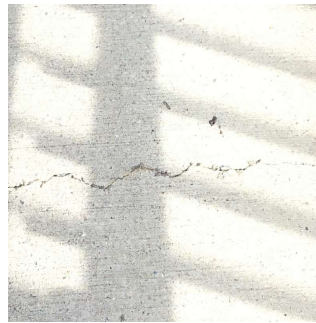
Facade D

CONCRETE: CRACKS/SPALLING - MINOR

25  
 S.F.  
 REPAIR  
 PRIORITY 3  
 LEVEL 2

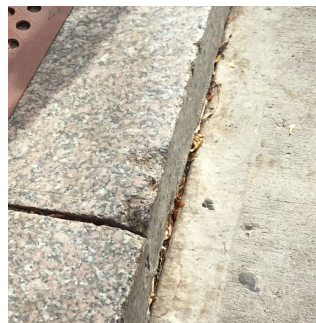
Facade A

**STONE: CRACKS/SPALLING - MINOR**

REPAIR

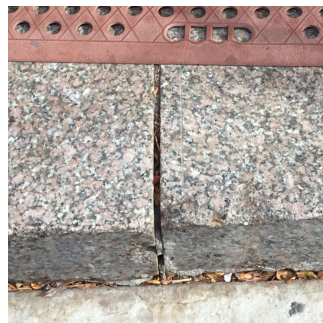
**STONE: DETERIORATED JOINTS**

Deficiency Quantity	20
Quantity Uom	L.F.
Potential Action	REPOINT
Urgency of Action	PRIORITY 4
Purpose of Action	LEVEL 2
Deficiency Photo1

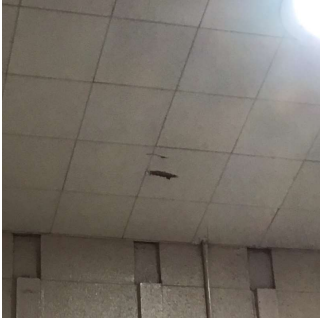
Violations	Storage No violations recorded.
Deficiency	ACOUSTIC TILES: DAMAGED/MISSING
Deficiency Location/Instance	Near right side, left side
Deficiency Quantity	10
Quantity Uom	S.F.
Potential Action	REPLACE
Urgency of Action	PRIORITY 3
Purpose of Action	LEVEL 2
Deficiency Photo1

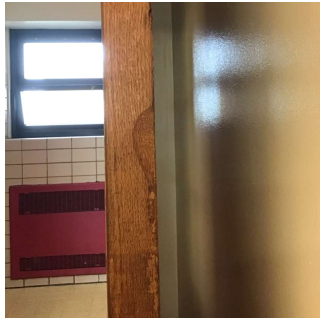
Violations	Room 319 No violations recorded.
<b>Door(s)</b>	Inspected
Condition	5 - Poor
Deficiency	WOOD: DETERIORATED DOOR
Deficiency Location/Instance	Rooms 328,324,322,320, and others
Deficiency Quantity	15
Quantity Uom	EACH
Potential Action	MAINTENANCE
Urgency of Action	PRIORITY 3
Purpose of Action	LEVEL 2
Deficiency Photo1
