**NYC Department of Education**  
**Building Condition Assessment Survey 2023 - 2024**

Architectural Inspection

**Asset: I.S. 98 - BROOKLYN, 1401 EMMONS AVENUE, New York, 11235**

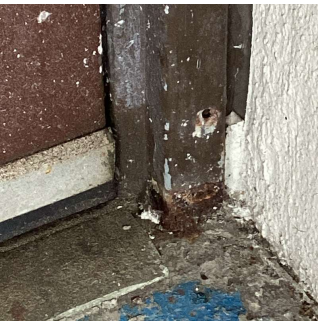
<p>The photograph shows a close-up of a metal door and its frame. The metal is heavily corroded, with large areas of rust and peeling paint. The door is set in a concrete or masonry frame, and the surrounding area shows signs of neglect and decay.</p>
Violations	Facade B No violations recorded.
<b>DOOR HARDWARE</b>	Inspected
Condition	3 - Fair
Deficiency	No deficiencies recorded
<b>LINTELS</b>	Under Construction
<b>TRANSOM/SIDE LIGHT</b>	Inspected
Condition	4 - Between Fair and Poor
Deficiency	METAL: DENTED, MAJOR RUSTING

Deficiency Quantity	3
Quantity Uom	EACH
Potential Action	REPLACE
Urgency of Action	PRIORITY 4
Purpose of Action	LEVEL 2
Deficiency Photo1

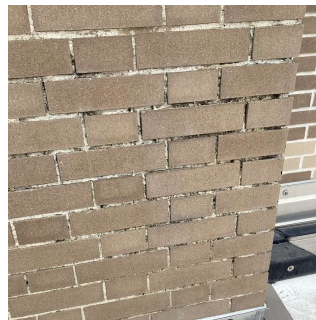
BH6  
 No violations recorded.

Deficiency BULKHEAD/PENTHOUSE WALLS/EXTERIOR: DETERIORATED JOINTS

Deficiency Quantity 30  
 Quantity Uom S.F.  
 Potential Action REPOINT  
 Urgency of Action PRIORITY 4  
 Purpose of Action LEVEL 2  
 Deficiency Photo1

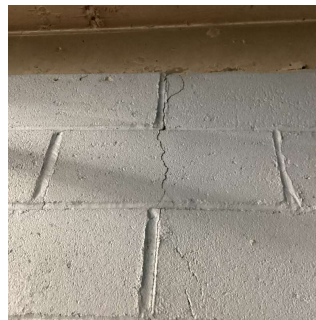
BH6

**BULKHEAD/PENTHOUSE WALLS/INTERIOR: CMU  
CRACKS/SPALLING**

REPLACE

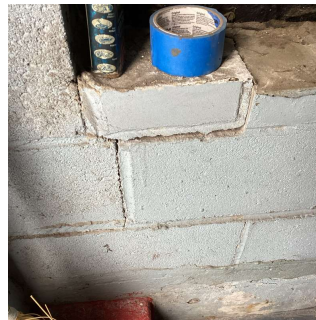
PH  
 No violations recorded.

**BULKHEAD/PENTHOUSE WALLS/INTERIOR: CMU  
DETERIORATED JOINTS**

10  
 S.F.  
 REPOINT  
 PRIORITY 3  
 LEVEL 2

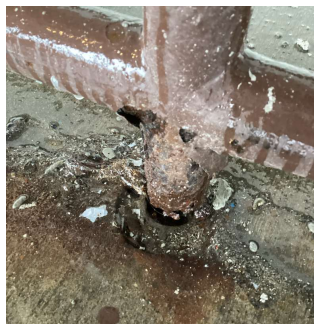
Facade A  
No violations recorded.

<b>CUPOLA/ SPIRES/ TOWERS</b>	Does not Exist
<b>DORMER</b>	Does not Exist
<b>DUNNAGE STEEL</b>	Inspected
Condition	2 - Between Good and Fair
Deficiency	No deficiencies recorded
<b>SKYLIGHT/ROOF VENT</b>	Does not Exist
<b>ROOF/GRAVITY TANK</b>	Does not Exist
<b>STAIRS/RAMPS: EXTERIOR</b>	Inspected
<b>BUILDING CHEEK/FLANK WALLS</b>	Inspected
Condition	2 - Between Good and Fair
Deficiency	No deficiencies recorded
<b>RAILINGS</b>	Inspected
Condition	5 - Poor
Deficiency	RUST - MAJOR

30  
L.F.  
REPLACE  
PRIORITY 4  
LEVEL 2

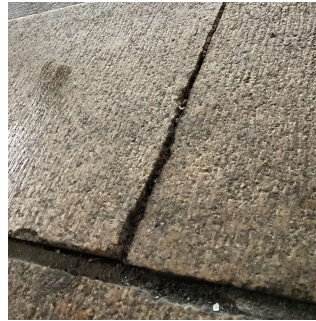
Facade A

STONE: DETERIORATED SUBSTRATE

10  
S.F.  
REPLACE SUBSTRATE AND RESET  
PRIORITY 4  
LEVEL 2

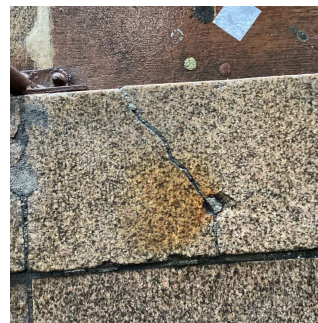
Facade A

**STONE: CRACKS/SPALLING - MAJOR**

REPLACE

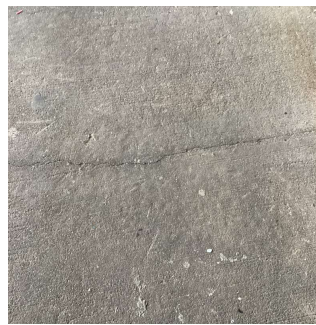
Facade A

**CONCRETE: CRACKS/SPALLING - MINOR**

10  
 S.F.  
 REPAIR  
 PRIORITY 3  
 LEVEL 2

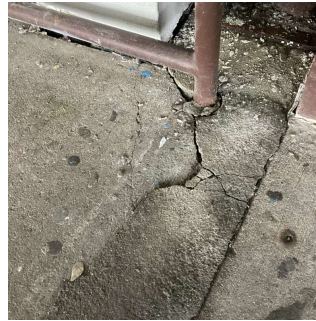
Facade A

**CONCRETE: CRACKS/SPALLING - MAJOR**

20  
 S.F.  
 REPLACE  
 PRIORITY 4  
 LEVEL 2

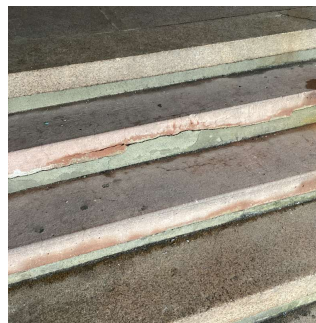
Facade A

**STONE: WORN-OUT TREAD/RISER/NOSING**

REPLACE

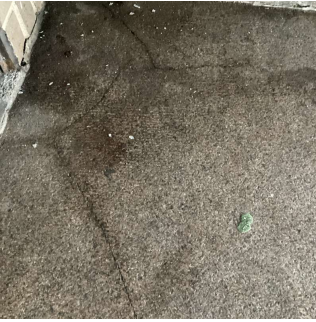
**STONE: CRACKS/SPALLING - MINOR**

Violations	Facade A No violations recorded.
<b>WINDOWS</b>	Inspected
Replacement Quantity	16,000
Replacement Uom	S.F.
<b>EXTERIOR GUARDS</b>	Under Construction
<b>LINTELS</b>	Under Construction
<b>WINDOWS</b>	Inspected
Material Type(s)	Aluminum
Instance on Aluminum - Double Hung: All Facades	Under Construction
Instance Quantity	13,700
Instance Quantity Uom	S.F.
Instance on Aluminum - Other: All Facades	Under Construction
Instance Quantity	2,300
Instance Quantity Uom	S.F.
<b>INTERIOR</b>	Inspected
<b>POOLS</b>	Does not Exist
<b>STRUCTURAL</b>	Inspected
<b>COLUMNS/BEAMS/BEARING WALLS</b>	Inspected
Condition	2 - Between Good and Fair
Deficiency	STEEL COLUMNS/BEAMS: DETERIORATED CONCRETE FIREPROOFING

Deficiency Quantity	10
Quantity Uom	S.F.
Potential Action	REPAIR
Urgency of Action	PRIORITY 3
Purpose of Action	LEVEL 2
Deficiency Photo1

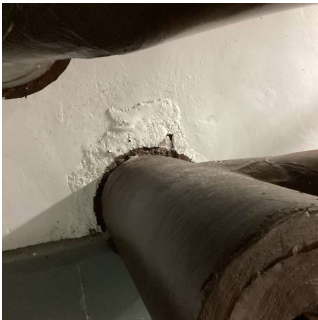
Violations	PH No violations recorded.
<b>FOUNDATION WALLS</b>	
Material Type(s)	Inspected Concrete
Condition	4 - Between Fair and Poor
Deficiency	CONCRETE: WATER INFILTRATION IN NON- INSTRUCTIONAL SPACE
Deficiency Location/Instance	Basement - Gas Meter Room, Boiler Room
Deficiency Quantity	200
Quantity Uom	S.F.
Potential Action	INSTALL WATERPROOFING
Urgency of Action	PRIORITY 5
Purpose of Action	LEVEL 5
Deficiency Photo1

Violations	Basement - Gas Meter Room No violations recorded.
<b>ROOF STRUCTURE</b>	
Condition	Inspected 3 - Fair
Deficiency	STEEL COLUMNS/BEAMS: DETERIORATED CONCRETE FIREPROOFING
Deficiency Location/Instance	BH6
Deficiency Quantity	10
Quantity Uom	S.F.
Potential Action	REPLACE
Urgency of Action	PRIORITY 4
Purpose of Action	LEVEL 5

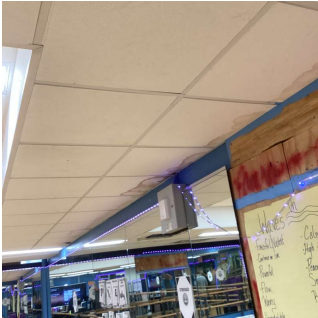
Violations	Room 139 No violations recorded.

Violations	Near Right Side Drinking Fountain No violations recorded.
<b>Window Curtains/Shades/Blinds</b>	
Instance on 1st Floor	Does not Exist
<b>CLASSROOMS/CORRIDORS/ADMIN SPACES</b>	
<b>Ceiling</b>	
Instance on 1st Floor	Inspected
Condition	2 - Between Good and Fair
Deficiency	ACOUSTIC TILES: DAMAGED/MISSING
Deficiency Location/Instance	Room 139
Deficiency Quantity	70
Quantity Uom	S.F.
Potential Action	REPLACE

Urgency of Action	PRIORITY 3
Purpose of Action	LEVEL 2
Deficiency Photo1

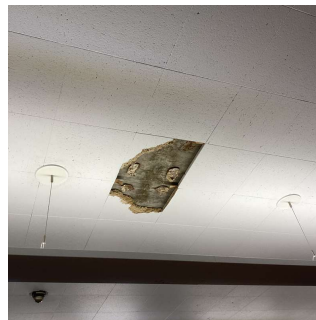
Room 336

Deficiency	ACOUSTIC TILES ON PLASTER: DAMAGED/MISSING
Deficiency Location/Instance	Rooms 336, 318
Deficiency Quantity	30
Quantity Uom	S.F.
Potential Action	REPLACE
Urgency of Action	PRIORITY 3
Purpose of Action	LEVEL 2
Deficiency Photo1

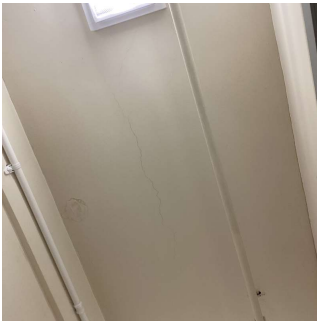
Deficiency	PLASTER: CRACKS/SPALLING
Deficiency Location/Instance	Corridor near Room 249B
Deficiency Quantity	10
Quantity Uom	S.F.
Potential Action	REPLACE
Urgency of Action	PRIORITY 3
Purpose of Action	LEVEL 2

Violations	Corridor near Room 249B No violations recorded.
<b>Door(s)</b>	Inspected
Condition	5 - Poor
Deficiency	WOOD: DETERIORATED DOOR
Deficiency Location/Instance	Rooms 416, 424, 432, Corridor near Cafeteria, by Room 405 and others
Deficiency Quantity	13
Quantity Uom	EACH
Potential Action	MAINTENANCE
Urgency of Action	PRIORITY 3
Purpose of Action	LEVEL 2
Deficiency Photo1

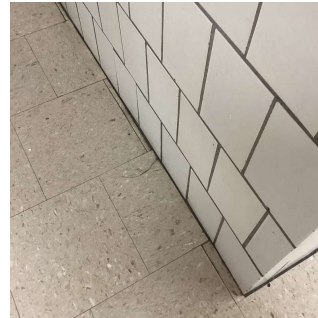
Corridor near Stair D/4

**VINYL TILES: BROKEN/DETERIORATED/MISSING TILES**

REPLACE

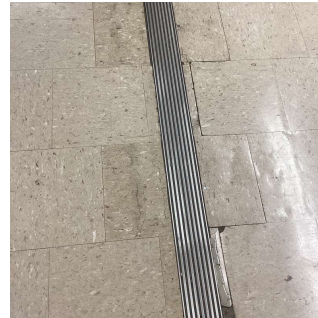
Corridor near Room 412

**VINYL TILES: DETERIORATED SUBSTRATE**

REPLACE

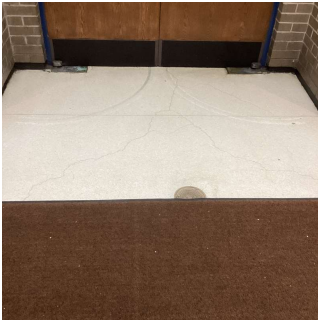
Question	Response
<b>INTERIOR</b>	
<b>CLASSROOMS/CORRIDORS/ADMIN SPACES</b>	
<b>Floor Finish</b>	
Deficiency	TERRAZZO: CRACKS
Deficiency Location/Instance	Corridor near Auditorium, by Rooms 100, 112, Main Entrance - Vestibule, Main Entrance - Lobby and others
Deficiency Quantity	200
Quantity Uom	S.F.
Potential Action	REPLACE
Urgency of Action	PRIORITY 3
Purpose of Action	LEVEL 2
Deficiency Photo1

Corridor near Auditorium
Violations	No violations recorded.
<b>Walls</b>	
Condition	Inspected
	2 - Between Good and Fair
Deficiency	PLASTER: CRACKS/SPALLING - ACTIVE LEAK
Deficiency Location/Instance	Room 118
Deficiency Quantity	10
Quantity Uom	S.F.
Potential Action	REPLACE
Urgency of Action	PRIORITY 5
Purpose of Action	LEVEL 2
Deficiency Photo1

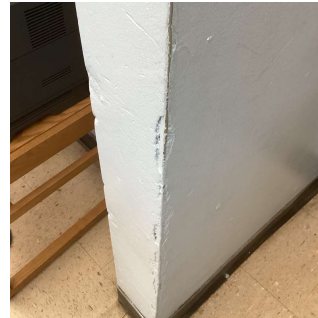
Room 336

**PLASTER: CRACKS/SPALLING**

REPLACE

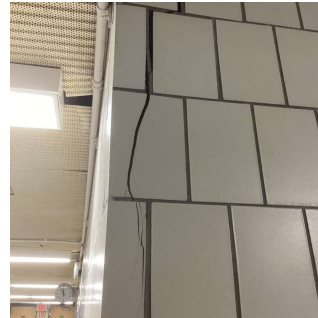
Corridor near Stair G/1

**GLAZED BLOCK: CRACKS/SPALLING**

REPLACE

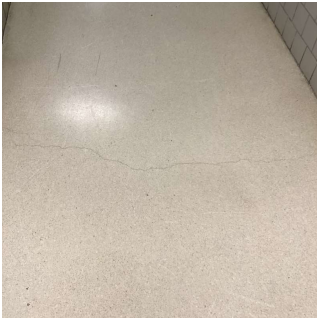
Violations	Stair B/4 No violations recorded.
Deficiency	TERRAZZO: CRACKS
Deficiency Location/Instance	Stairs B/1, C/1, G/1, G/Exit - Vestibule, Exit 2 - Vestibule
Deficiency Quantity	100
Quantity Uom	S.F.
Potential Action	REPLACE
Urgency of Action	PRIORITY 3
Purpose of Action	LEVEL 2
Deficiency Photo1

Violations	Stair G/1 No violations recorded.
Deficiency	STONE: BROKEN/MISSING
Deficiency Location/Instance	Stairs C/3, E/1, 3, G/1, 2 and others
Deficiency Quantity	300
Quantity Uom	S.F.
Potential Action	REPLACE
Urgency of Action	PRIORITY 3

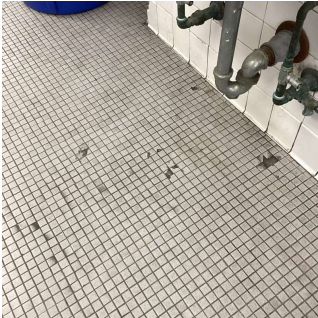
Room 404
Violations	No violations recorded.
<b>Floor Finish</b>	Inspected
Condition	2 - Between Good and Fair
Deficiency	CERAMIC TILE: BROKEN/MISSING TILES
Deficiency Location/Instance	Room 404
Deficiency Quantity	10
Quantity Uom	S.F.
Potential Action	REPLACE
Urgency of Action	PRIORITY 3
Purpose of Action	LEVEL 2
Deficiency Photo1

Room 404
Violations	No violations recorded.
Deficiency	CERAMIC TILE: DETERIORATED SUBSTRATE
Deficiency Location/Instance	Room 410
Deficiency Quantity	10
Quantity Uom	S.F.
Potential Action	REPLACE
Urgency of Action	PRIORITY 3
Purpose of Action	LEVEL 2

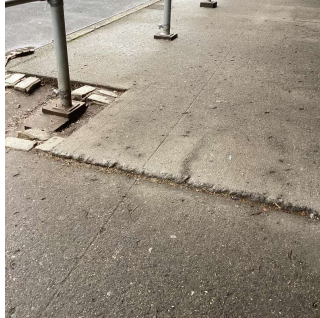
Violations	Emmons Avenue No violations recorded.
<b>DOT Sidewalk</b>	Inspected
<b>Asphalt</b>	Does not Exist
<b>Concrete</b>	Inspected
Condition	4 - Between Fair and Poor
Deficiency	HEAVING
Deficiency Location/Instance	East 15th Street, East 14th Street
Deficiency Quantity	350
Quantity Uom	S.F.
Potential Action	REPLACE
Urgency of Action	PRIORITY 4
Purpose of Action	LEVEL 4
Deficiency Photo1

Violations	East 15th Street 56288
Deficiency	DAMAGED CURBS
Deficiency Location/Instance	East 15th Street, East 14th Street
Deficiency Quantity	280
Quantity Uom	L.F.
Potential Action	REPLACE
Urgency of Action	PRIORITY 4
Purpose of Action	LEVEL 4

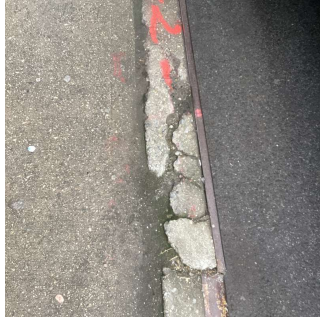
East 15th Street 56288
Violations	
Deficiency	DAMAGED/DETERIORATED/MISSING SECTIONS
Deficiency Location/Instance	East 15th Street, Emmons Avenue, East 14th Street, Shore Parkway
Deficiency Quantity	3,150
Quantity Uom	S.F.
Potential Action	REPLACE
Urgency of Action	PRIORITY 4
Purpose of Action	LEVEL 4
Deficiency Photo1
