**NYC Department of Education**  
**Building Condition Assessment Survey 2023 - 2024**

Architectural Inspection

**Asset:** P.S. 45 - BROOKLYN, 84 SCHAFFER STREET, New York, 11207

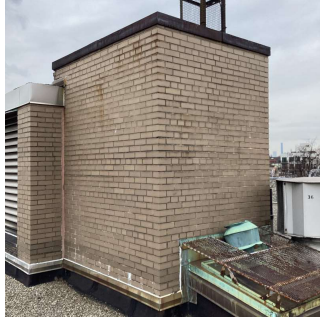
Violations	Chimney No violations recorded.
Deficiency	<b>BRICK: DETERIORATED JOINTS</b>
Roof Plan reference	K045

Deficiency Quantity	80
Quantity Uom	S.F.
Potential Action	REPOINT
Urgency of Action	PRIORITY 3
Purpose of Action	LEVEL 2
Deficiency Photo1

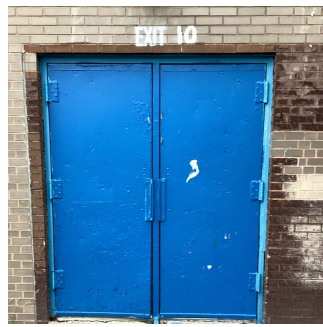
Violations	Chimney No violations recorded.
<b>COPING</b>	Does not Exist
<b>CORNICE</b>	Does not Exist
<b>DOORS</b>	Inspected
<b>DOORS AND FRAMES</b>	Inspected
Condition	3 - Fair
Deficiency	METAL CLAD: DETERIORATED DOOR AND FRAME - MAJOR DETERIORATION

Deficiency Quantity	4
Quantity Uom	EACH
Potential Action	REPLACE
Urgency of Action	PRIORITY 4
Purpose of Action	LEVEL 2
Deficiency Photo1

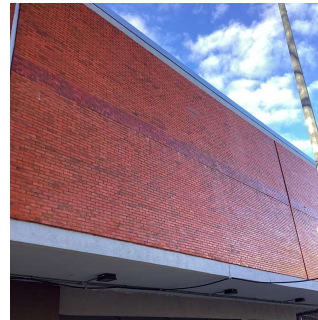
Facade C

Violations	Stair F5 No violations recorded.
<b>DOOR HARDWARE</b>	Inspected
Condition	3 - Fair
Deficiency	No deficiencies recorded
<b>LINTELS</b>	Inspected
Condition	2 - Between Good and Fair
Deficiency	No deficiencies recorded
<b>TRANSOM/SIDE LIGHT</b>	Inspected
Condition	2 - Between Good and Fair
Deficiency	No deficiencies recorded
<b>EXTERIOR WALLS</b>	Inspected
Material Type(s)	Masonry
Replacement Quantity	32,000
Replacement Uom	S.F.
Instance on All Facades	Inspected
Instance Condition	5 - Poor
Instance Quantity	32,000
Instance Quantity Uom	S.F.
Deficiency	BRICK: MAJOR BULGING, STEEL DAMAGE

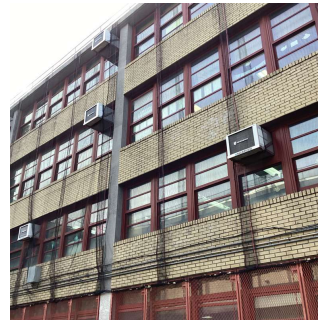
Facade J

**BRICK: DETERIORATED JOINTS**

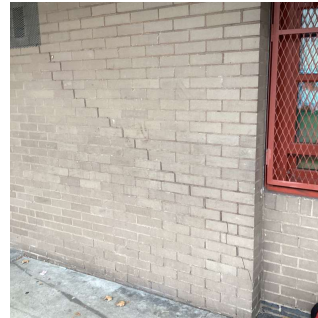
Facade D

**BRICK: MINOR CRACKS AND SPALLING**

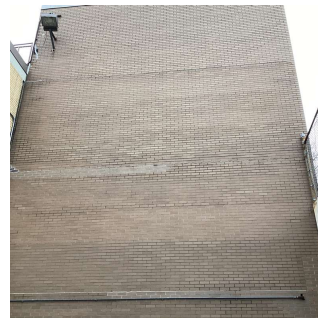
Facade D

**BRICK: DETERIORATED CONTROL/EXPANSION JOINTS**

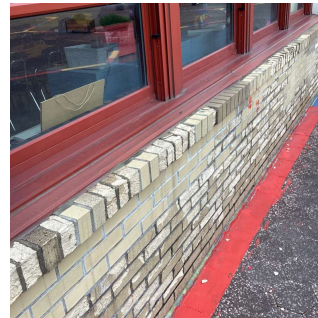
Facade G

**BRICK: DETERIORATED MASONRY SILLS - MAJOR**

**REMOVE AND REPLACE**

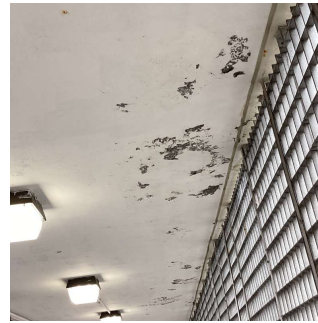
2nd, 3rd Floor Exterior Walkways

CONCRETE: MAJOR CRACKS/SPALLING

S.F.  
REPLACE  
PRIORITY 4  
LEVEL 2

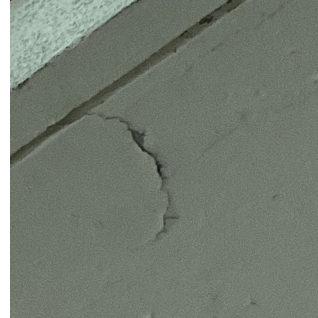
Facade A, C

**CONCRETE: MINOR CRACKS/SPALLING**

50  
S.F.  
REPAIR  
PRIORITY 3  
LEVEL 2

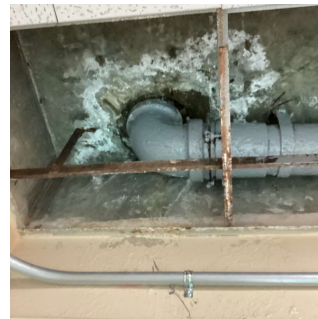
Roof 1 - 3rd Floor corridor near Stair F  
No violations recorded.

Roof 1
Instance Quantity	23,000
Instance Quantity Uom	S.F.
Does the roof have major mechanical equipment sitting on Dunnage Steel less than 18" above the Roofing?	No
Does this roof instance have a Sustainable Roof System?	No
Do solar panels exist on these roofs?	No
Is/Are the roof(s) suitable for Solar Panel installation?	Yes
Installation Year	2005
Source of Installation	Custodial Staff
Deficiency	<b>BUILT-UP: ROOFING: MAJOR ACTIVE ROOF LEAKS IN INSTRUCTIONAL SPACE</b>

REPLACE ROOFING WITHOUT MAJOR EQUIPMENT REMOVAL

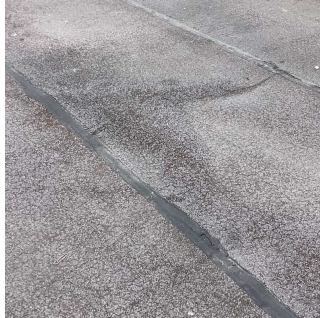
Question	Response
<b>EXTERIOR</b>	
<b>ROOF</b>	
<b>Roofing</b>	
<b>ROOFING</b>	
Deficiency Photo1	 
	Roof 1
Violations	No violations recorded.
Instance on Modified Bitumen: Roofs 3, 4	Inspected
Instance Condition	5 - Poor
Instance Photo	 
	Roofs 3, 4
Instance Quantity	2,000
Instance Quantity Uom	S.F.
Does the roof have major mechanical equipment sitting on Dunnage Steel less than 18" above the Roofing?	No
Does this roof instance have a Sustainable Roof System?	No
Do solar panels exist on these roofs?	No
Is/Are the roof(s) suitable for Solar Panel installation?	No
Installation Year	2005
Source of Installation	Custodial Staff
Deficiency	MODIFIED BITUMEN: ROOFING: DELAMINATION
Roof Plan reference	 
Deficiency Quantity	200
Quantity Uom	S.F.
Potential Action	REPLACE ROOFING WITHOUT MAJOR EQUIPMENT REMOVAL
Urgency of Action	PRIORITY 4
Purpose of Action	LEVEL 2

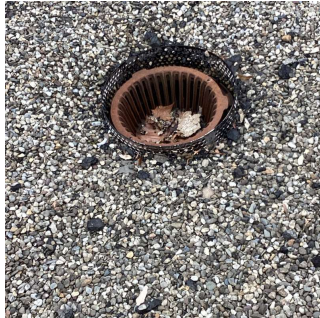
Violations	Roofs 3, 4 No violations recorded.
<b>ROOFING DRAINS</b>	Inspected
Condition	4 - Between Fair and Poor
Deficiency	DETERIORATED
Roof Plan reference

Deficiency Quantity	2
Quantity Uom	EACH
Potential Action	REPLACE
Urgency of Action	PRIORITY 4
Purpose of Action	LEVEL 2
Deficiency Photo1

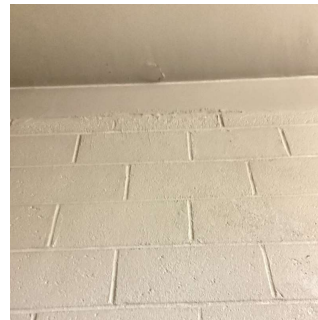
Bulkhead 5  
No violations recorded.

Violations	Roof 1 No violations recorded.
<b>Specialties</b>	Inspected
<b>BULKHEAD/PENTHOUSE</b>	Inspected
Condition	4 - Between Fair and Poor
Deficiency	BULKHEAD/PENTHOUSE ROOF: MINOR LEAKAGE

100  
S.F.  
MAINTENANCE  
PRIORITY 3  
LEVEL 2

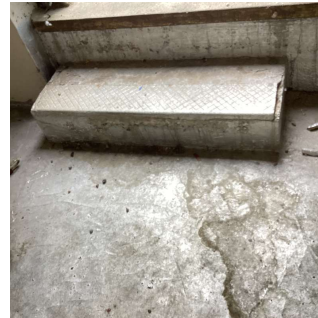
Bulkhead 1 - Damaged Step

**BULKHEAD/PENTHOUSE WALLS/INTERIOR: CMU  
CRACKS/SPALLING**

10  
S.F.  
REPLACE  
PRIORITY 4  
LEVEL 2

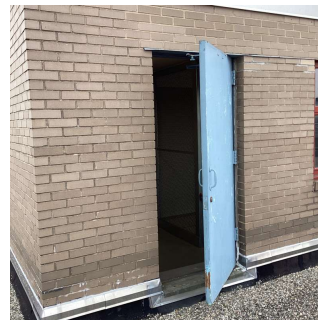
Bulkhead 2

**BULKHEAD/PENTHOUSE DOORS: DETERIORATED DOOR AND FRAME**

REPLACE DOOR AND FRAME

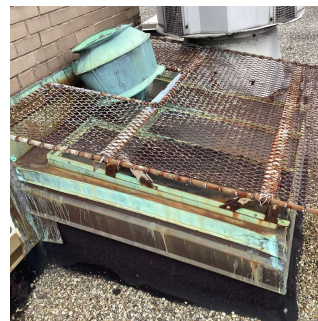
Skylight

**SHAFT VENTS DAMAGED**

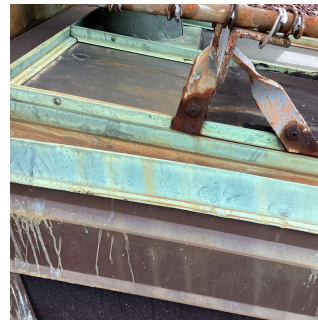
Skylight  
No violations recorded.

**BROKEN GLASS**

10  
S.F.  
MAINTENANCE  
PRIORITY 3  
LEVEL 2

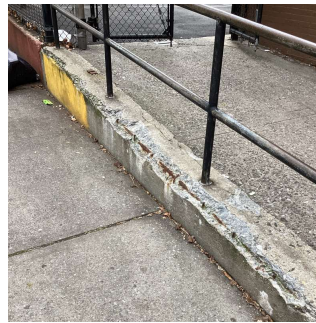
HC Ramp

CAST IN PLACE CONCRETE: CRACKS/SPALLING - MAJOR

60  
S.F.  
REPLACE  
PRIORITY 4  
LEVEL 2

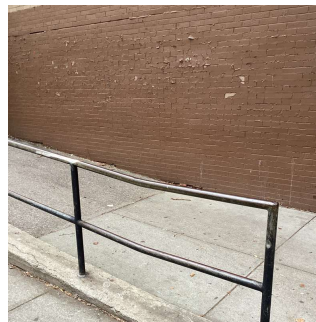
HC Ramp

**DAMAGED**

REPLACE

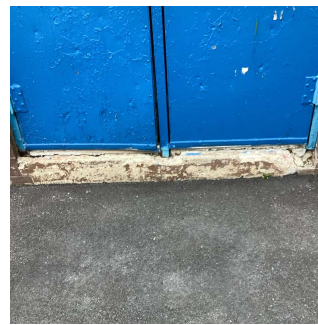
Stair F5

STONE: CRACKS/SPALLING - MAJOR

10  
S.F.  
REPLACE  
PRIORITY 4  
LEVEL 2

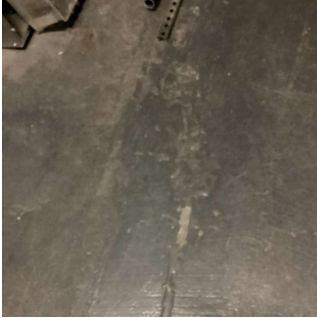
Question	Response
<b>INTERIOR</b>	
<b>STRUCTURAL</b>	
<b>VAULTS-BUNKERS</b>	
<b>Slab Structure</b>	
Urgency of Action	PRIORITY 3
Purpose of Action	LEVEL 5
Deficiency Photo1

Violations	Vault No violations recorded.
<b>Vault/Ash Hoist Doors and Framing</b>	Does not Exist
<b>AUDITORIUM</b>	
Instance on Basement (420 seats)	Inspected
<b>Ceiling</b>	
Instance on Basement (420 seats)	Inspected
Condition	2 - Between Good and Fair
Deficiency	ACOUSTIC TILES: DAMAGED/MISSING
Deficiency Location/Instance	Near seat N/105
Deficiency Quantity	10
Quantity Uom	S.F.
Potential Action	REPLACE
Urgency of Action	PRIORITY 3
Purpose of Action	LEVEL 2
Deficiency Photo1

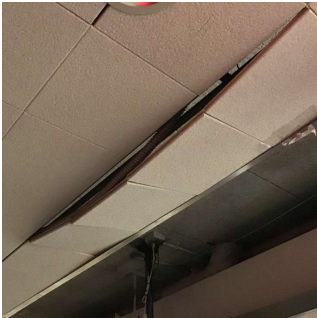
Violations	Near seat N/105 No violations recorded.
<b>Door(s)</b>	
Instance on Basement (420 seats)	Inspected
Condition	2 - Between Good and Fair
Deficiency	No deficiencies recorded
<b>Fixed H/C Lift</b>	
Instance on Basement (420 seats)	Does not Exist
<b>Fixed Seating</b>

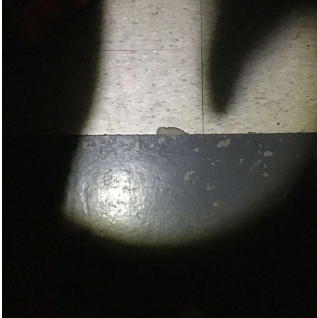
Near seat N/105
Violations	No violations recorded.
Deficiency	VINYL TILES: BROKEN/DETERIORATED/MISSING TILES
Deficiency Location/Instance	Near center
Deficiency Quantity	20
Quantity Uom	S.F.
Potential Action	REPLACE
Urgency of Action	PRIORITY 3
Purpose of Action	LEVEL 2
Deficiency Photo1

Near center
Violations	No violations recorded.
<b>Sliding-folding Partition</b>	
Instance on Basement (420 seats)	Does not Exist
<b>Stage</b>	
Instance on Basement (420 seats)	Inspected

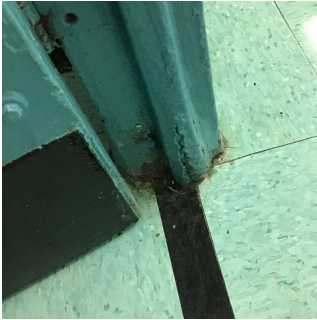
Violations	Near center No violations recorded.
<b>Door(s)</b>	
Instance on Basement	Inspected
Condition	4 - Between Fair and Poor
Deficiency	METAL: DETERIORATED DOOR AND FRAME
Deficiency Location/Instance	Entrance
Deficiency Quantity	2
Quantity Uom	EACH
Potential Action	MAINTENANCE
Urgency of Action	PRIORITY 3
Purpose of Action	LEVEL 2
Deficiency Photo1

Violations	Entrance No violations recorded.
<b>Fixed Equipment</b>	
Instance on Basement	Does not Exist
<b>Floor Finish</b>	
Instance on Basement	Inspected
Condition	2 - Between Good and Fair
Deficiency	VINYL TILES: BROKEN/DETERIORATED/MISSING TILES
Deficiency Location/Instance	Near water fountain, kitchen
Deficiency Quantity	20
Quantity Uom	S.F.
Potential Action	REPLACE
Urgency of Action	PRIORITY 3
Purpose of Action	LEVEL 2

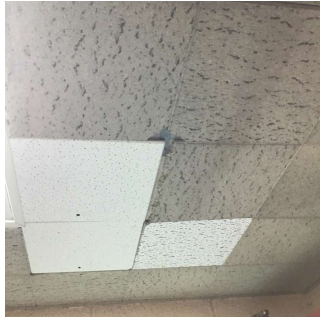
Violations	Corridor near Room 342 No violations recorded.
Deficiency	ACOUSTIC TILES: DAMAGED/MISSING - ACTIVE LEAK
Deficiency Location/Instance	Corridor near Stair F/3, F/2
Deficiency Quantity	20
Quantity Uom	S.F.
Potential Action	REPLACE
Urgency of Action	PRIORITY 5
Purpose of Action	LEVEL 2
Deficiency Photo1

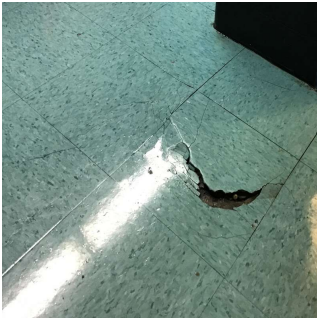
Exit 3
Violations	No violations recorded.
Deficiency	VINYL TILES: DETERIORATED SUBSTRATE
Deficiency Location/Instance	Corridor near Room 219
Deficiency Quantity	10
Quantity Uom	S.F.
Potential Action	REPLACE
Urgency of Action	PRIORITY 5
Purpose of Action	LEVEL 6
Deficiency Photo1

Corridor near Room 219
Violations	No violations recorded.
Deficiency	VINYL TILES: TRIPPING HAZARD - ELECTRICAL OUTLET
Deficiency Location/Instance	Room 225
Deficiency Quantity	10
Quantity Uom	S.F.
Potential Action	REMOVE
Urgency of Action	PRIORITY 5
Purpose of Action	LEVEL 6

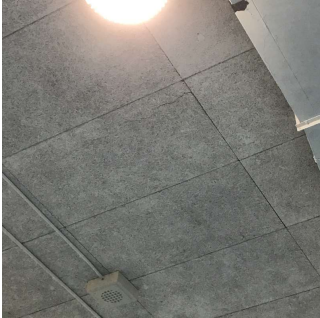
Question	Response
<b>INTERIOR</b>	
<b>GYMNASIUM</b>	
<b>Ceiling</b>	
Instance on Basement	Inspected
Condition	2 - Between Good and Fair
Deficiency	TECTUM: DAMAGED/MISSING
Deficiency Location/Instance	Near center
Deficiency Quantity	25
Quantity Uom	S.F.
Potential Action	REPLACE
Urgency of Action	PRIORITY 3
Purpose of Action	LEVEL 2
Deficiency Photo1

Violations	Near center No violations recorded.
<b>Door(s)</b>	
Instance on Basement	Inspected
Condition	3 - Fair
Deficiency	WOOD: DETERIORATED DOOR
Deficiency Location/Instance	Storage
Deficiency Quantity	1
Quantity Uom	EACH
Potential Action	MAINTENANCE
Urgency of Action	PRIORITY 3
Purpose of Action	LEVEL 2
Deficiency Photo1

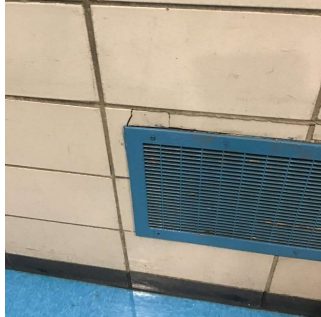
Deficiency Location/Instance	Near water fountain
Deficiency Quantity	10
Quantity Uom	S.F.
Potential Action	REPLACE
Urgency of Action	PRIORITY 3
Purpose of Action	LEVEL 2
Deficiency Photo1

Violations	Near water fountain No violations recorded.
------------	--

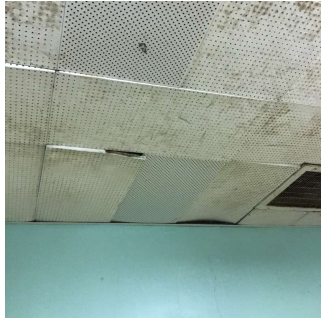
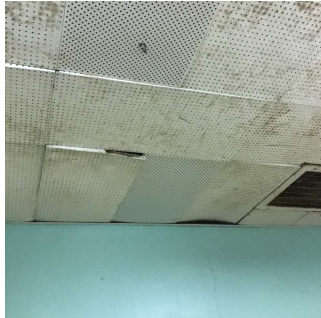
Slop area

Instance on Basement	Inspected
Condition	3 - Fair
Deficiency	METAL PAN: DAMAGED/MISSING
Deficiency Location/Instance	Slop area, center
Deficiency Quantity	50
Quantity Uom	S.F.
Potential Action	REPLACE
Urgency of Action	PRIORITY 3
Purpose of Action	LEVEL 2
Deficiency Photo1

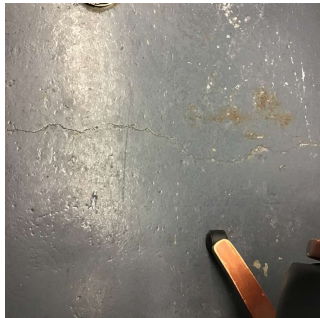
Violations	Entrance No violations recorded.
<b>Floor Finish</b>	
Instance on Basement	Inspected
Condition	5 - Poor
Deficiency	CONCRETE: CRACKS
Deficiency Location/Instance	Office
Deficiency Quantity	10
Quantity Uom	S.F.
Potential Action	REPLACE
Urgency of Action	PRIORITY 3
Purpose of Action	LEVEL 2
Deficiency Photo1

Violations	Office No violations recorded.
Deficiency	CERAMIC TILE: BROKEN/MISSING TILES
Deficiency Location/Instance	Near Entrance, slop area,
Deficiency Quantity	100
Quantity Uom	S.F.

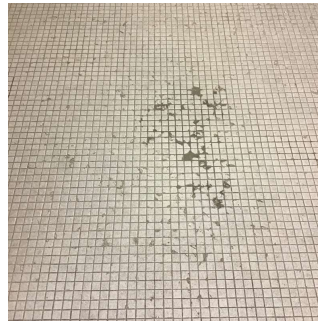
Slop area

Potential Action	REPLACE
Urgency of Action	PRIORITY 3
Purpose of Action	LEVEL 2
Deficiency Photo1

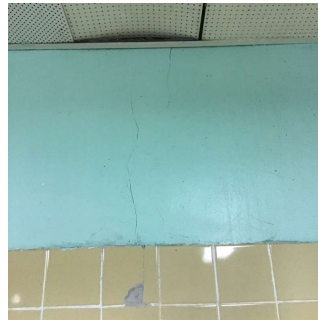
Deficiency	PLASTER: CRACKS/SPALLING
Deficiency Location/Instance	Slop area
Deficiency Quantity	10
Quantity Uom	S.F.
Potential Action	REPLACE
Urgency of Action	PRIORITY 3
Purpose of Action	LEVEL 2
Deficiency Photo1

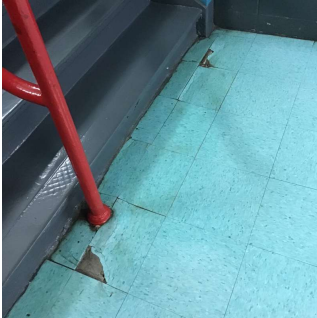
Question	Response
<b>INTERIOR</b>	
<b>STAIRS/RAMPS: INTERIOR</b>	
<b>Stairs and Landings</b>	
Deficiency Location/Instance	Stair B/Basement
Deficiency Quantity	10
Quantity Uom	S.F.
Potential Action	REPLACE
Urgency of Action	PRIORITY 3
Purpose of Action	LEVEL 2
Deficiency Photo1

Violations	Stair B/basement No violations recorded.
Deficiency	TERRAZZO: CRACKS
Deficiency Location/Instance	Near room 133
Deficiency Quantity	10
Quantity Uom	S.F.
Potential Action	REPLACE
Urgency of Action	PRIORITY 5
Purpose of Action	LEVEL 6
Deficiency Photo1

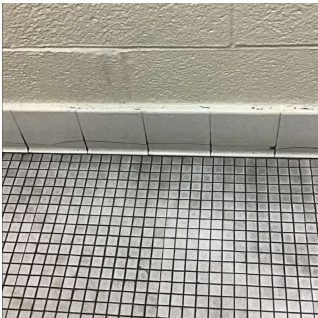
Room 319
Violations	No violations recorded.
Deficiency	CERAMIC TILE: BROKEN/ MISSING
Deficiency Location/Instance	Room 366,364,319,219,111, and others
Deficiency Quantity	50
Quantity Uom	S.F.
Potential Action	REPLACE
Urgency of Action	PRIORITY 3
Purpose of Action	LEVEL 2
Deficiency Photo1

Room 364
Violations	No violations recorded.
<b>TOILET ROOMS - STUDENTS</b>	Inspected
<b>Ceiling</b>	Inspected
Condition	2 - Between Good and Fair
Deficiency	PLASTER: CRACKS/SPALLING
Deficiency Location/Instance	Room 317,257,213

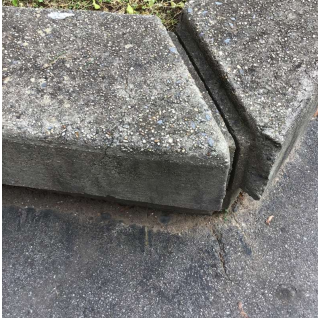
Violations	Courtyard No violations recorded.
<b>SEATING</b>	Inspected
<b>Benches</b>	Inspected
<b>Concrete</b>	Inspected
Condition	3 - Fair
Deficiency	CRACKS/SPALLING - MAJOR
Deficiency Location/Instance	Courtyard
Deficiency Quantity	1
Quantity Uom	EACH
Potential Action	REPLACE
Urgency of Action	PRIORITY 3
Purpose of Action	LEVEL 2
Deficiency Photo1

Violations	Courtyard No violations recorded.
<b>Metal/Wood/Plastic</b>	Does not Exist
<b>Bleachers</b>	Does not Exist
<b>SITE WALLS (NOT RETAINING WALLS)</b>	Does not Exist
<b>STAIRS/RAMPS: EXTERIOR</b>	Inspected
<b>Railings</b>	Inspected
Condition	2 - Between Good and Fair
Deficiency	No deficiencies recorded
<b>Site Cheek/flank Walls</b>	Inspected
Condition	2 - Between Good and Fair
Deficiency	No deficiencies recorded
