NYC Department of Education
Building Condition Assessment Survey 2023 - 2024

Architectural Inspection

Asset: P.S. 46 - BROOKLYN, 100 CLERMONT AVENUE, New York, 11205

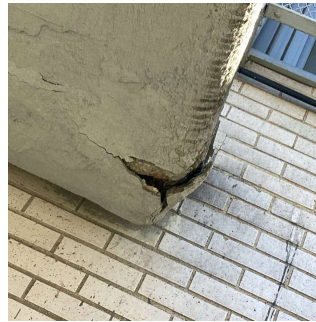
Facade C - Near Exit 2
No violations recorded.

CONCRETE: DETERIORATED

10
S.F.
REPLACE
PRIORITY 5
LEVEL 6

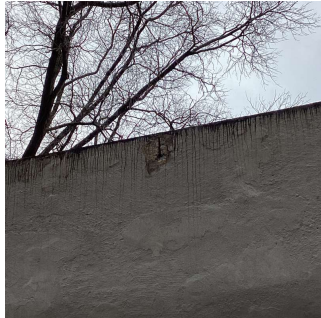
| Question | Response |
|---|---|
| Violations | Facade A - Main Entrance No violations recorded. |

CONCRETE: MAJOR CRACKS/SPALLING

10
S.F.
REPAIR
PRIORITY 4
LEVEL 2

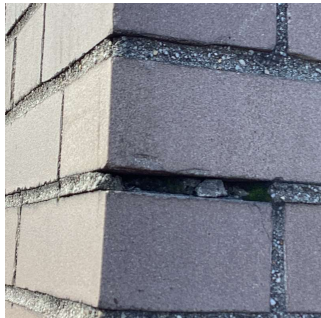
| Question | Response |
|---|---|
| Violations | CH No violations recorded. |

| Question | Response |
|---|---|
| Deficiency | BRICK: DETERIORATED JOINTS |

| Question | Response |
|---|---|
| Urgency of Action | PRIORITY 4 |

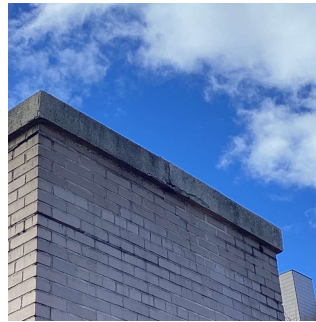
CH
No violations recorded.

| Question | Response |
|---|---|
| Deficiency | BRICK: DETERIORATED CAP |

10
L.F.
REPLACE
PRIORITY 4
LEVEL 2

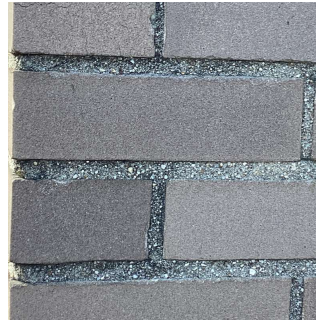
CH

BRICK: DETERIORATED JOINTS

150
S.F.
REPOINT
PRIORITY 3
LEVEL 2

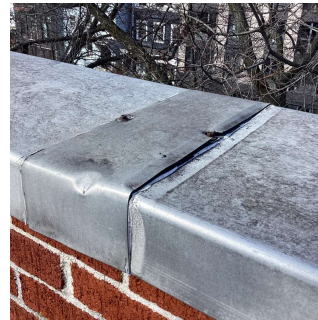
Roof 1 - Facade C
No violations recorded.

METAL: DETERIORATED

20
L.F.
REPLACE-IN-KIND
PRIORITY 4
LEVEL 2

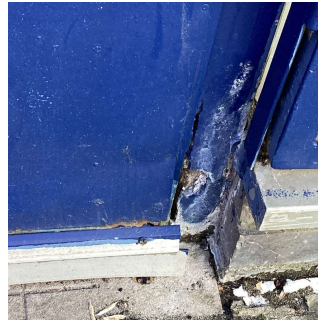
Facade H - Exit 15

METAL CLAD: DETERIORATED DOOR AND FRAME - MAJOR DETERIORATION

1
EACH
REPLACE
PRIORITY 4
LEVEL 2

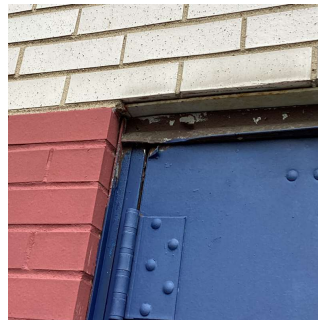
Facade H - Exit 12

METAL: DETERIORATED DOOR AND FRAME - MINOR DETERIORATION

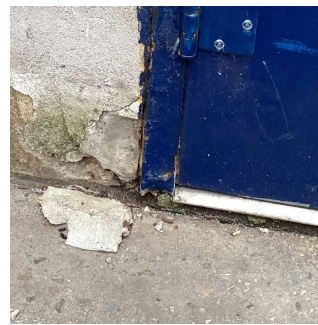
Facade K - Near Exit 8
No violations recorded.

METAL: DETERIORATED DOOR AND FRAME - MAJOR DETERIORATION

3
EACH
REPLACE
PRIORITY 4
LEVEL 2

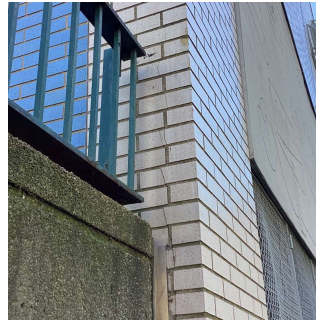
Corner of Facade A and Facade K
No violations recorded.

| Question | Response |
|---|--|
| Deficiency | BRICK: CRACKS/DISPLACED/SPALLED BRICK AT BUILDING CORNERS |

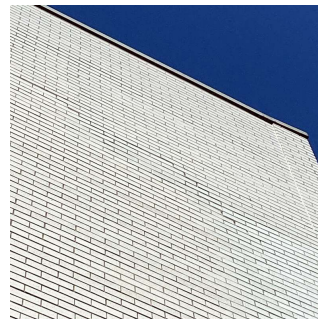
Facade B (step crack)
No violations recorded.

BRICK: MAJOR / THRU CRACKS

30
S.F.
REMOVE AND REBUILD
PRIORITY 4
LEVEL 2

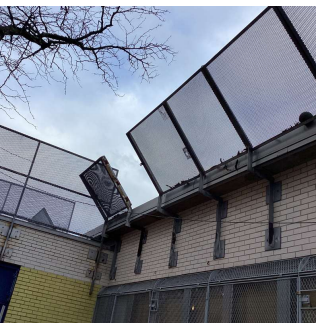
| Deficiency | RAILINGS/PANELS: DETERIORATED, MAJOR RUSTING |

| Question | Response |
|---|--|
| Potential Action | REPLACE |

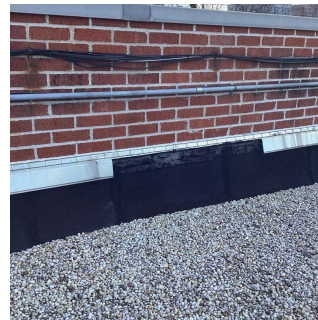
Roof 1 - Facade A

| Question | Response |
|---|--|
| Deficiency | BUILT-UP: FLASHING: CAP FLASHING MISSING |

30
L.F.
INSTALL NEW
PRIORITY 4
LEVEL 4

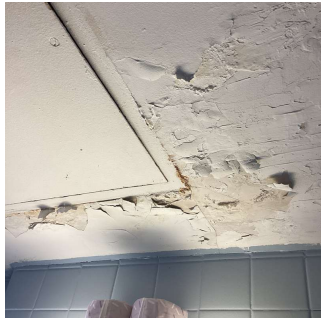
| Question | Response |
|---|--|
| | Roof 2 - Toilet inside Room 138 (shown), Roof 1 - Corridor near Room 301 (similar) |

BUILT-UP: ROOFING: MAJOR ACTIVE ROOF LEAKS IN INSTRUCTIONAL SPACE

200
S.F.
REPLACE ROOFING WITH MAJOR EQUIPMENT REMOVAL
PRIORITY 5
LEVEL 2

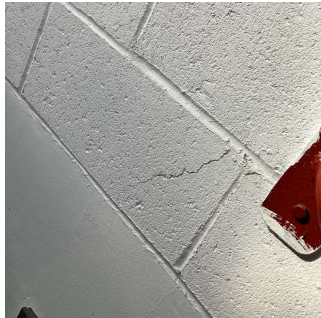
| Question | Response |
|---|--|
| Violations | BH3 No violations recorded. |

| Question | Response |
|---|--|
| Deficiency | BULKHEAD/PENTHOUSE WALLS/INTERIOR: CMU CRACKS/SPALLING |

| Question | Response |
|---|--|
| Potential Action | REPLACE |

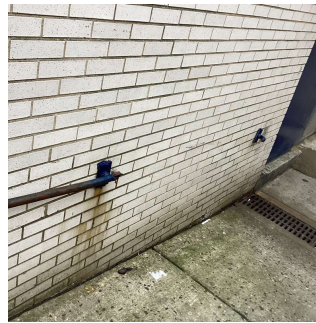
Facade K - Near Exit 8

| Yes | Protruding Elements | Deteriorated handrail is a protruding element hazard. | EXTERIOR STAIRS/RAMP S: EXTERIOR RAILINGS | Exterior driveway ramp near Exit 8 leading out to Clermont Street | Johnathan Forde | Fireman | |

DAMAGED

REPLACE

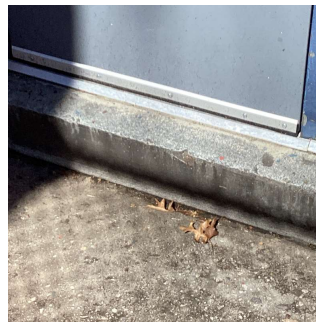
Facade B - Exit 3

STONE: CRACKS/SPALLING - MINOR

REPAIR

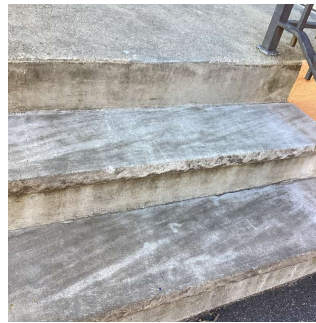
Facade D

CONCRETE: WORN-OUT TREAD/RISER/NOSING

10
S.F.
REPLACE
PRIORITY 4
LEVEL 2

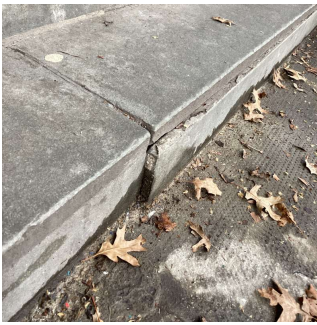
| Question | Response |
|---|--|
| Violations | Facade A - Main Entrance No violations recorded. |

STONE: DETERIORATED SUBSTRATE

10
S.F.
REPLACE SUBSTRATE AND RESET
PRIORITY 4
LEVEL 2

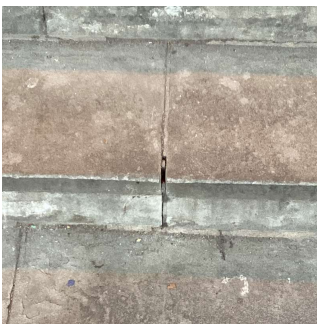
| Question | Response |
|---|--|
| Violations | Facade A - Main Entrance No violations recorded. |

| Question | Response |
|---|--|
| Deficiency | STONE: DETERIORATED JOINTS |

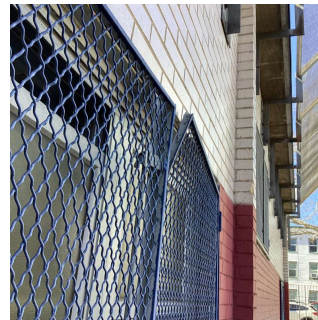
Facade H - Between Exit 13 and Exit 15
No violations recorded.

| Question | Response |
|---|--|
| Deficiency | DETERIORATED/TORN-OUT/MISSING |

60
S.F.
REPLACE
PRIORITY 4
LEVEL 2

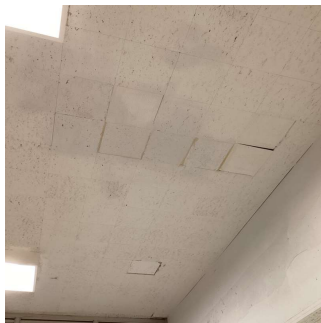
| Question | Response |
|---|--|
| | Near Windows |

| Question | Response |
|---|--|
| Deficiency | ACOUSTIC TILES ON PLASTER: DAMAGED/MISSING |

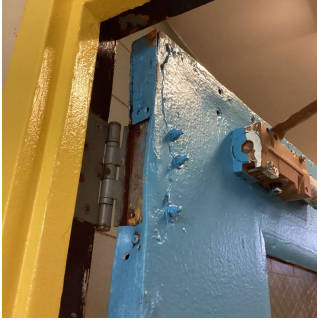
| Question | Response |
|---|---|
| Violations | Stair A/1 No violations recorded. |

| Question | Response |
|---|---|
| Deficiency | METAL: DETERIORATED DOOR |

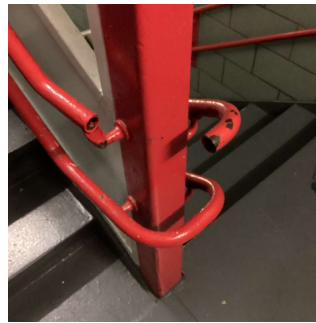
| No | Protruding Elements | Damaged and missing piece of handrail with protruding bracket is a potential safety hazard. | INTERIOR STAIRS/RAMP S: INTERIOR Railings | Stair C/Basement | Johnathan Forde | Fireman | |

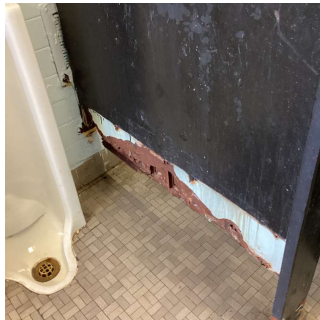
| Question | Response |
|---|--|
| | Room 210 |

| No | Protruding Elements | Severely damaged and rusted stall partition is a potential safety hazard. | INTERIOR TOILET ROOMS - STUDENTS Stalls | Room 210 | Johnathan Forde | Fireman | |

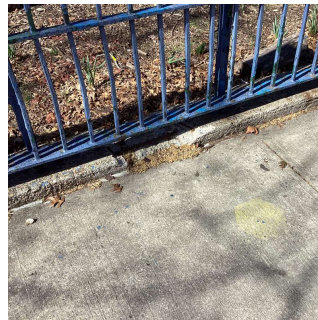
CONCRETE CURB: DAMAGED/DETERIORATED
Clermont Avenue
15
S.F.
REPLACE
PRIORITY 3
LEVEL 2

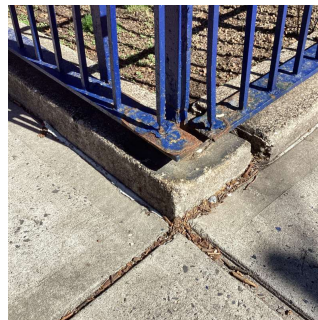
| Yes | Protruding Elements | Severely rusted and broken wrought iron fence gate is a potential safety hazard. | SITE FENCES | Adelphi Street Stairs to Schoolyard, Clermont Avenue Driveway | Johnathan Forde | Fireman | |

WROUGHT IRON: RUST - MAJOR
Adelphi Street, Walkway Near NYC Park, Clermont Avenue
160
S.F.
REPLACE
PRIORITY 3
LEVEL 2
