NYC Department of Education
Building Condition Assessment Survey 2023 - 2024

Architectural Inspection

K051

Asset: I.S. 51 - BROOKLYN, 350 5TH AVENUE, New York, 11215

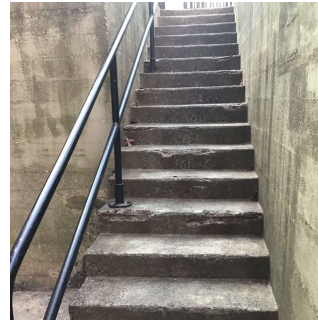
AW5

AREAWAY WALLS: CRACKS AND SPALLING

REPAIR

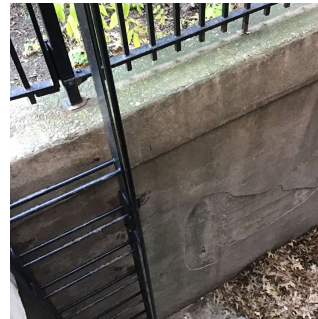
AW7, AW8 - Facade A

AREAWAY SLAB: CRACKS AND SPALLING

REPAIR

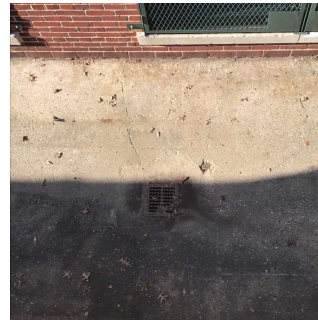
AW3

AREAWAY WALLS: CRACKS AND SPALLING

REPAIR

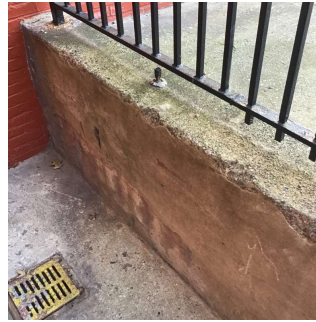
AW3
No violations recorded.

BRICK: DETERIORATED CAP

REPLACE

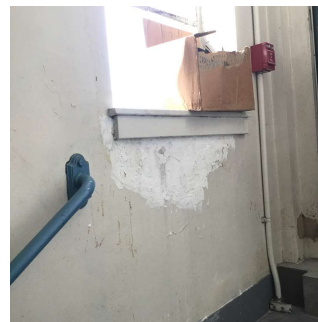
Bulkhead 1

BULKHEAD/PENTHOUSE WINDOWS: DAMAGED, DETERIORATED WINDOWS

90
S.F.
REPLACE
PRIORITY 4
LEVEL 2

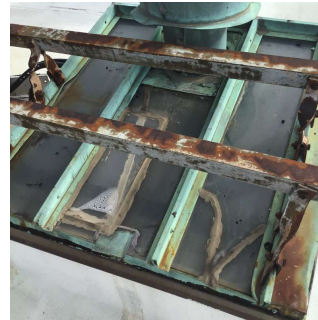
Skylight 1

DAMAGED GUARDS

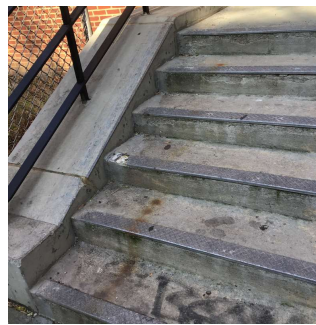
Exit 5
No violations recorded.

CONCRETE: WORN-OUT TREAD/RISER/NOSING

50
S.F.
REPLACE
PRIORITY 4
LEVEL 2

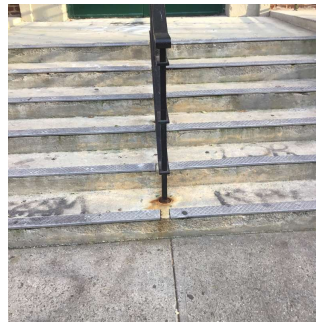
Exit 5

CONCRETE: CRACKS/SPALLING - MINOR

REPAIR

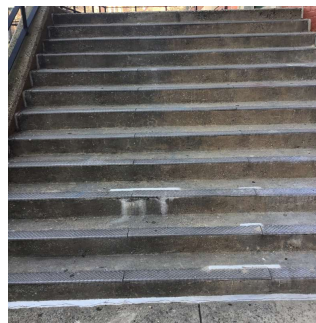
Exit 6

STONE: CRACKS/SPALLING - MAJOR

10
S.F.
REPLACE
PRIORITY 4
LEVEL 2

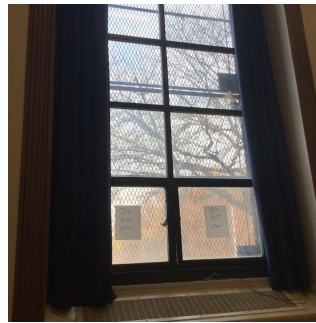
Auditorium Window - similar at Gymnasium

Deficiency	STEEL: BROKEN PANE
Roof Plan reference	K051

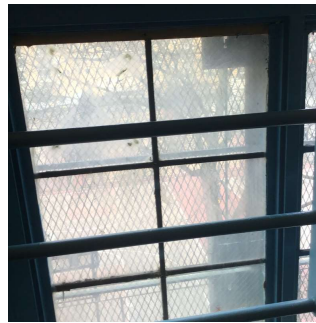
Facade H - Stairwells

Deficiency	WOOD: BROKEN PANE
------------	-------------------

Deficiency Quantity	120
Quantity Uom	S.F.
Potential Action	MAINTENANCE
Urgency of Action	PRIORITY 3
Purpose of Action	LEVEL 2

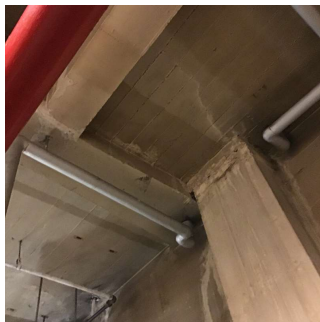
Violations	Basement Mechanical Equipment Room No violations recorded.
FLOOR STRUCTURE	Inspected
Condition	3 - Fair
Deficiency	CONCRETE: CRACKS/SPALLED/REINFORCEMENT EXPOSED
Deficiency Location/Instance	Basement Mechanical Room, Boiler Room, Tool Room
Deficiency Quantity	150
Quantity Uom	S.F.
Potential Action	REPAIR
Urgency of Action	PRIORITY 3
Purpose of Action	LEVEL 5

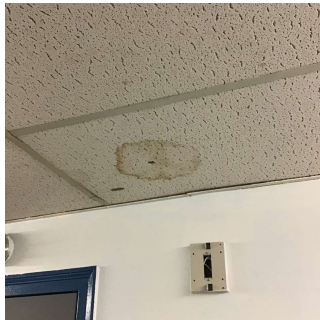
Violations	Corridor near Room 223 No violations recorded.
Deficiency	METAL PAN: DAMAGED/MISSING
Deficiency Location/Instance	Corridor near Rooms 103, 118, 240, 305, 340, and others
Deficiency Quantity	250
Quantity Uom	S.F.
Potential Action	REPLACE
Urgency of Action	PRIORITY 3
Purpose of Action	LEVEL 2

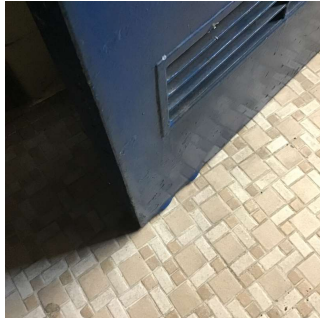
Violations	No violations recorded.
Deficiency	METAL: DETERIORATED DOOR AND FRAME
Deficiency Location/Instance	Supply Closet
Deficiency Quantity	1
Quantity Uom	EACH
Potential Action	MAINTENANCE

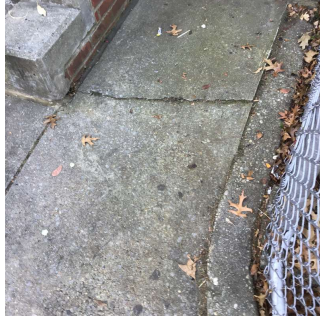
4th Street
Violations	No violations recorded.
Pavers	Does not Exist
DOT Sidewalk	Inspected
Asphalt	Does not Exist
Concrete	Inspected
Condition	4 - Between Fair and Poor
Deficiency	DAMAGED/DETERIORATED/MISSING SECTIONS
Deficiency Location/Instance	4th Street
Deficiency Quantity	500
Quantity Uom	S.F.
Potential Action	REPLACE
Urgency of Action	PRIORITY 5
Purpose of Action	LEVEL 6
Deficiency Photo1

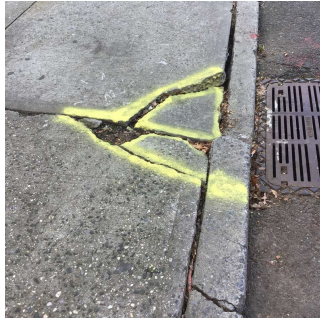
4th Street
Violations	No violations recorded.
Deficiency	HEAVING
Deficiency Location/Instance	4th Street, 5th Street
Deficiency Quantity	625
Quantity Uom	S.F.
Potential Action	REPLACE
Urgency of Action	PRIORITY 3
Purpose of Action	LEVEL 2
