**NYC Department of Education**  
**Building Condition Assessment Survey 2023 - 2024**

Architectural Inspection

**K056**

**Asset:** P.S. 56 - BROOKLYN, 170 GATES AVENUE, New York, 11238

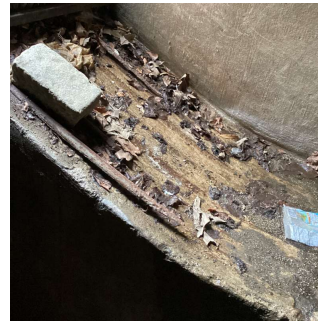
AW1  
No violations recorded.

Question	Response
<b>Architectural</b>	
<b>EXTERIOR</b>	Inspected
<b>AREAWAY</b>	Inspected
Instance on AW1-AW2	Inspected
Instance Condition	3 - Fair
Instance Quantity	2
Instance Quantity Uom	EACH
Deficiency	AREAWAY STAIRS: DETERIORATED MATERIAL SLIDE

20  
S.F.  
REPAIR  
PRIORITY 3  
LEVEL 2

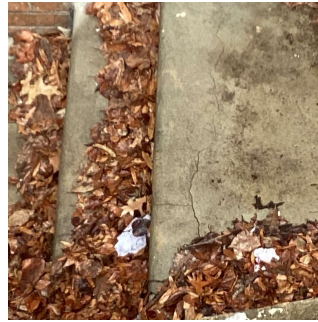
AW1

**AREAWAY STAIRS: DETERIORATED TREADS/RISERS/NOSINGS**

20  
S.F.  
REPAIR  
PRIORITY 3  
LEVEL 2

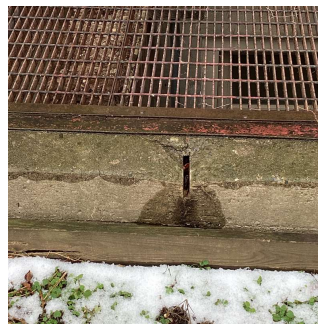
AW2

**AREAWAY WALLS: CRACKS AND SPALLING**

REPLACE

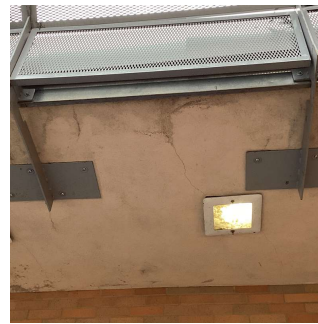
Facade A - Main Entrance

CONCRETE: DETERIORATED

20  
 S.F.  
 REPLACE  
 PRIORITY 4  
 LEVEL 2

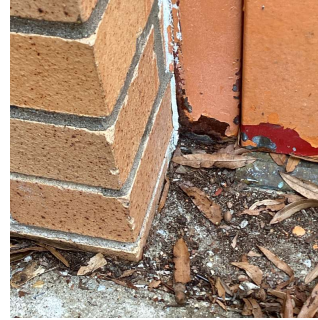
Facade B - Exit 4

METAL: DETERIORATED DOOR AND FRAME - MINOR DETERIORATION

MAINTENANCE  
PRIORITY 3  
LEVEL 2

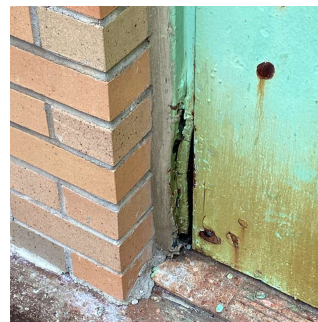
Facade E - Near Exit 10

METAL: DETERIORATED DOOR AND FRAME - MAJOR DETERIORATION

10  
EACH  
REPLACE  
PRIORITY 4  
LEVEL 2

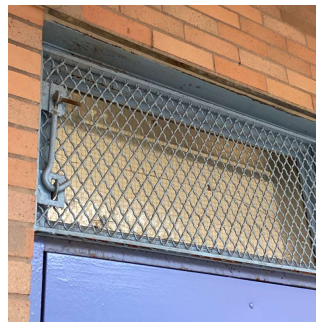
Facade A - Main Entrance

Deficiency	METAL: BROKEN GLASS
------------	---------------------

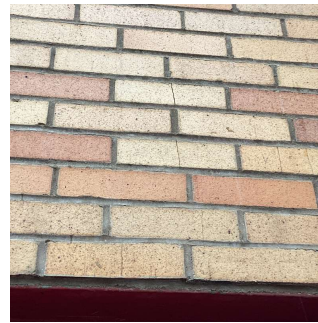
Facade J

**BRICK: MINOR CRACKS AND SPALLING**

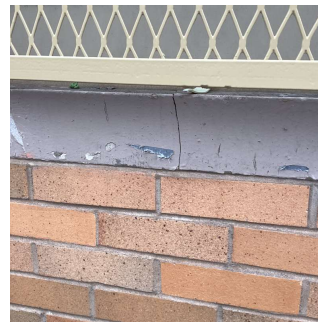
Facade F - Near HC Ramp

**BRICK: DETERIORATED MASONRY SILLS - MINOR**

100  
 L.F.  
 REPAIR  
 PRIORITY 3  
 LEVEL 2

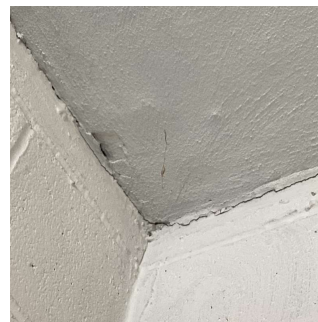
Roof 1 - BH2

Sustainable Roof Type	White Roof
Sustainable Roof Location (Roof Number)	Roofs 1st - 8th Floors
Do solar panels exist on these roofs?	No
Is/Are the roof(s) suitable for Solar Panel installation?	Yes
Installation Year	2022
Source of Installation	Custodial Staff
Deficiency	No deficiencies recorded
<b>ROOFING DRAINS</b>	Inspected
Condition	1 - Good
Deficiency	No deficiencies recorded
<b>Specialties</b>	Inspected
<b>BULKHEAD/PENTHOUSE</b>	Inspected
Condition	3 - Fair
Deficiency	BULKHEAD/PENTHOUSE CEILING: PLASTER DAMAGED/DETERIORATED

20  
S.F.  
REPLACE  
PRIORITY 3  
LEVEL 2

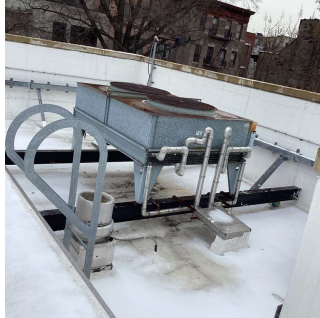
Violations	Roof 1 - BH2 No violations recorded.
<b>CUPOLA/ SPIRES/ TOWERS</b>	Does not Exist
<b>DORMER</b>	Does not Exist
<b>DUNNAGE STEEL</b>	Inspected
Condition	2 - Between Good and Fair
Deficiency	HEIGHT LESS THAN 18"
Roof Plan reference

Deficiency Quantity	24
Quantity Uom	L.F.
Potential Action	REPLACE
Urgency of Action	PRIORITY 3
Purpose of Action	LEVEL 2

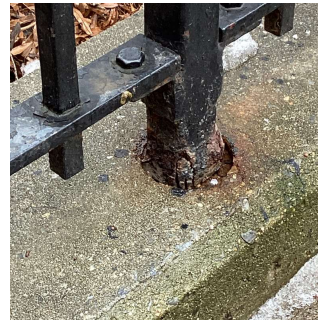
Facade F - Exit 12

Violations	Facade C No violations recorded.
<b>RAILINGS</b>	Inspected
Condition	4 - Between Fair and Poor
Deficiency	RUST - MAJOR

16  
L.F.  
REPLACE  
PRIORITY 4  
LEVEL 2

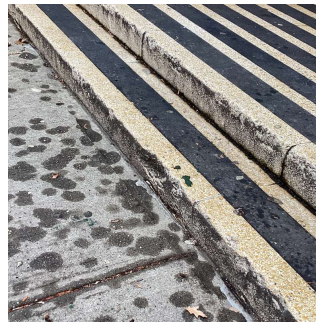
Facade A - Main Entrance

**CONCRETE: CRACKS/SPALLING - MAJOR**

100  
S.F.  
REPLACE  
PRIORITY 4  
LEVEL 2

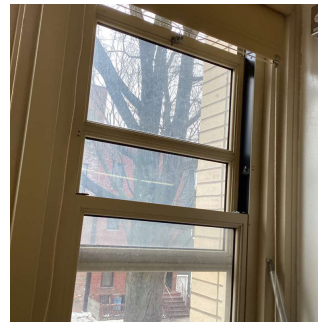
Room 210 (shown), Room 110, Corridor near Elevator/1,2 (similar)

Violations	Facade K No violations recorded.
<b>LINTELS</b>	Inspected
Condition	2 - Between Good and Fair
Deficiency	No deficiencies recorded
<b>WINDOWS</b>	Inspected
Material Type(s)	Aluminum
Instance on Aluminum - Double Hung: All Facades	Inspected
Instance Condition	3 - Fair
Instance Quantity	9,000
Instance Quantity Uom	S.F.
Are these windows insulated	No
Installation Year	2000
Source of Installation	Custodial Staff
Deficiency	ALUMINUM - DOUBLE HUNG: INOPERABLE BALANCE
Roof Plan reference	K056

Deficiency Quantity	300
Quantity Uom	EACH
Potential Action	REPLACE BALANCES
Urgency of Action	PRIORITY 3
Purpose of Action	LEVEL 2

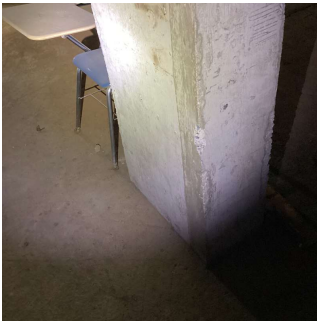
<b>Question</b>	<b>Response</b>
<b>EXTERIOR</b>	
<b>WINDOWS</b>	
<b>WINDOWS</b>	
Deficiency Photo1	 
Violations	Facade G - Near Lobby No violations recorded.
Instance on Aluminum - Other: Facades A,C,D	Inspected
Instance Condition	3 - Fair
Instance Quantity	1,000
Instance Quantity Uom	S.F.
Are these windows insulated	No
Installation Year	2000
Source of Installation	Custodial Staff
Deficiency	No deficiencies recorded
Instance on Aluminum - Other: Facades B,D	Inspected
Instance Condition	3 - Fair
Instance Quantity	700
Instance Quantity Uom	S.F.
Are these windows insulated	No
Installation Year	1996
Source of Installation	Custodial Staff
Deficiency	No deficiencies recorded
<b>INTERIOR</b>	Inspected
<b>POOLS</b>	Does not Exist
<b>STRUCTURAL</b>	Inspected
<b>COLUMNS/BEAMS/BEARING WALLS</b>	Inspected
Condition	2 - Between Good and Fair
Deficiency	STEEL COLUMNS/BEAMS: DETERIORATED CONCRETE FIREPROOFING
Deficiency Location/Instance	Basement - Crawlspace

Deficiency Quantity	20
Quantity Uom	S.F.
Potential Action	REPLACE
Urgency of Action	PRIORITY 3
Purpose of Action	LEVEL 5

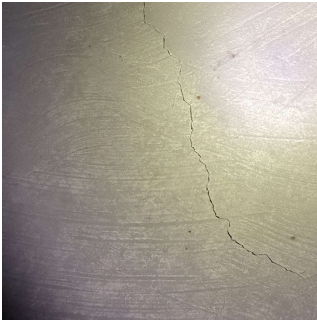
Violations	Basement - Crawlspace No violations recorded.
<b>FLOOR STRUCTURE</b>	Inspected
Condition	3 - Fair
Deficiency	CONCRETE SLAB ON GRADE: THRU CRACKS
Deficiency Location/Instance	Basement- Crawlspace, Boiler Room, Storage Room
Deficiency Quantity	50
Quantity Uom	S.F.
Potential Action	REPAIR
Urgency of Action	PRIORITY 3
Purpose of Action	LEVEL 5
Deficiency Photo1

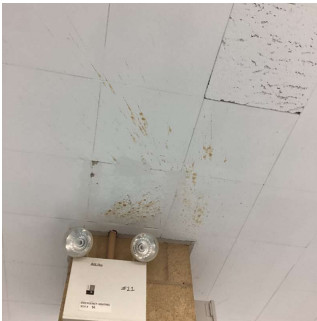
Condition	2 - Between Good and Fair
Deficiency	ACOUSTIC TILES: DAMAGED/MISSING
Deficiency Location/Instance	Near center
Deficiency Quantity	10
Quantity Uom	S.F.
Potential Action	REPLACE
Urgency of Action	PRIORITY 3
Purpose of Action	LEVEL 2

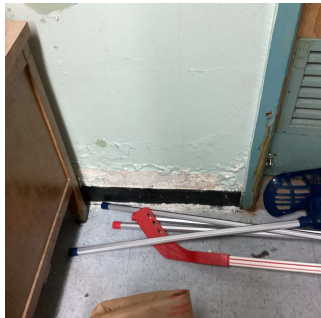
Deficiency	PLASTER: CRACKS/SPALLING
Deficiency Location/Instance	Gymnasium Office
Deficiency Quantity	10
Quantity Uom	S.F.
Potential Action	REPLACE
Urgency of Action	PRIORITY 3
Purpose of Action	LEVEL 2
Deficiency Photo1

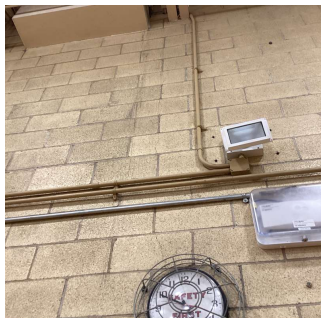
Deficiency	MASONRY: CRACKS/SPALLING
Deficiency Location/Instance	Near gymnasium office
Deficiency Quantity	10
Quantity Uom	S.F.
Potential Action	REPLACE
Urgency of Action	PRIORITY 3
Purpose of Action	LEVEL 2
Deficiency Photo1

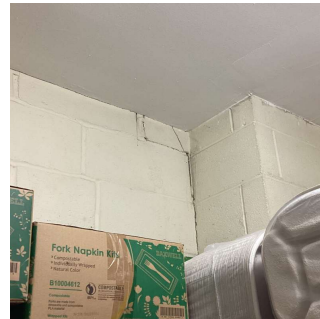
Instance on 1st Floor	Inspected
Condition	2 - Between Good and Fair
Deficiency	MASONRY: CRACKS/SPALLING
Deficiency Location/Instance	Room 119
Deficiency Quantity	10
Quantity Uom	S.F.
Potential Action	REPLACE
Urgency of Action	PRIORITY 3
Purpose of Action	LEVEL 2
Deficiency Photo1

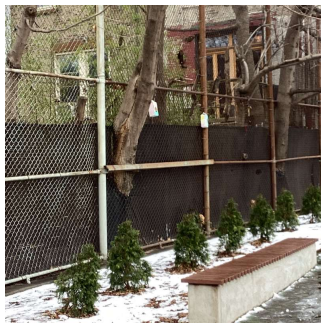
Condition	2 - Between Good and Fair
Deficiency	No deficiencies recorded
<b>Culverts - Soil Covering</b>	Does not Exist
<b>DRINKING FOUNTAINS</b>	Does not Exist
<b>FENCES</b>	Inspected
Condition	4 - Between Fair and Poor
Deficiency	CHAIN LINK: DAMAGED POST/RAIL
Deficiency Location/Instance	Schoolyard
Deficiency Quantity	40
Quantity Uom	L.F.
Potential Action	REPLACE
Urgency of Action	PRIORITY 3
Purpose of Action	LEVEL 2
Deficiency Photo1

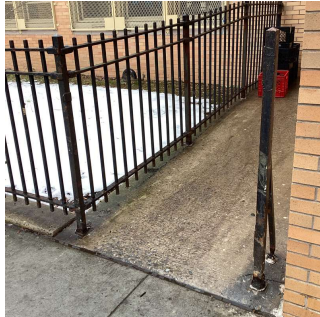
<b>Question</b>	<b>Response</b>
<b>SITE</b>	
<b>FENCES</b>	
Deficiency Location/Instance	Along Downing Street
Deficiency Quantity	40
Quantity Uom	S.F.
Potential Action	REPLACE
Urgency of Action	PRIORITY 3
Purpose of Action	LEVEL 2
Deficiency Photo1
