NYC Department of Education
Building Condition Assessment Survey 2023 - 2024

Architectural Inspection

Asset: J.H.S. 57 - BROOKLYN, 125 STUYVESANT AVENUE, New York, 11221

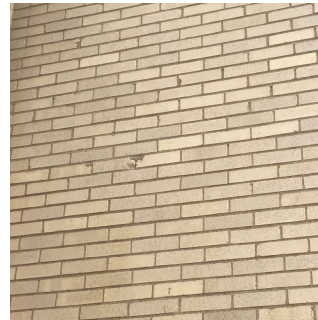
Question	Response
EXTERIOR	
AREAWAY	
Deficiency Photo1	 
Violations	AW7 No violations recorded.
AWNINGS AND CANOPIES	
Condition	Inspected 2 - Between Good and Fair
Deficiency	No deficiencies recorded
CHIMNEY	
Material Type(s)	Inspected Masonry
Condition	3 - Fair
Deficiency	BRICK: DETERIORATED JOINTS
Roof Plan reference	 
Deficiency Quantity	80
Quantity Uom	S.F.
Potential Action	REPOINT
Urgency of Action	PRIORITY 3
Purpose of Action	LEVEL 2
Deficiency Photo1	 
Violations	Chimney No violations recorded.
Deficiency	BRICK: MINOR CRACKS AND SPALLING

10
S.F.
RESTITCH
PRIORITY 3
LEVEL 2

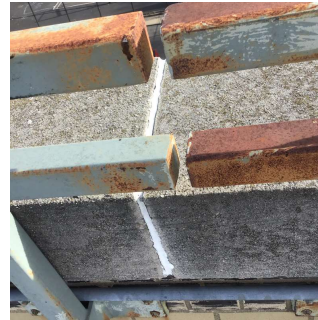
Roof 1 - Facade

CAST STONE: DETERIORATED TRANSVERSE JOINTS

100
L.F.
MAINTENANCE
PRIORITY 3
LEVEL 2

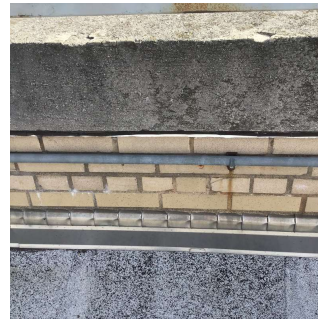
Roof 1 - Facade D

CAST STONE: CRACKED/BROKEN PIECES

REPLACE-IN-KIND

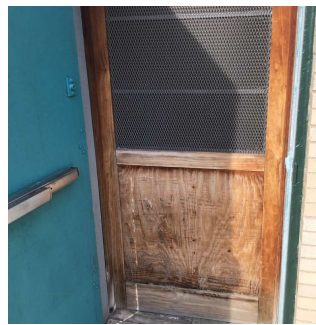
Cafeteria Kitchen Door 8
35671781R

WOOD: DETERIORATED DOOR - MAJOR DETERIORATION

1
EACH
REPLACE
PRIORITY 4
LEVEL 4

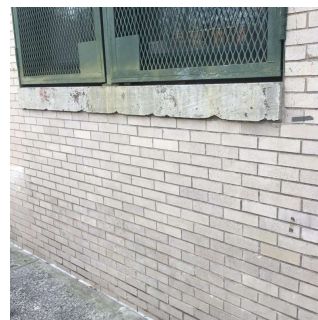
Facade B

BRICK: DETERIORATED MASONRY SILLS - MINOR

50
L.F.
REPAIR
PRIORITY 3
LEVEL 2

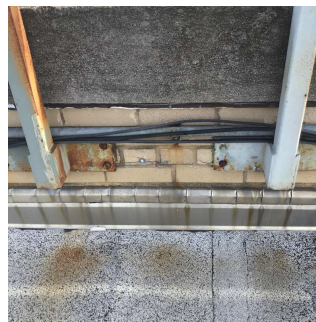
Roof 1 - Facade D

BRICK: MINOR CRACKS, SPALLING

REPAIR

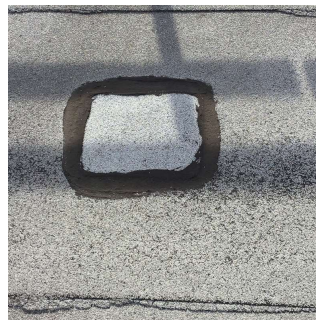
Roof 1 - Rooms 301, 302, 308

Deficiency	MODIFIED BITUMEN: ROOFING: MAJOR ACTIVE ROOF LEAKS IN INSTRUCTIONAL SPACE
------------	---

Potential Action	REPLACE ROOFING WITHOUT MAJOR EQUIPMENT REMOVAL
------------------	---

Question	Response
INTERIOR	
CLASSROOMS/CORRIDORS/ADMIN SPACES	
Ceiling	
Violations	No violations recorded.
Deficiency	PLASTER: CRACKS/SPALLING - ACTIVE LEAK
Deficiency Location/Instance	Rooms 301, 302, 308
Deficiency Quantity	40
Quantity Uom	S.F.
Potential Action	REPLACE
Urgency of Action	PRIORITY 5
Purpose of Action	LEVEL 2
Deficiency Photo1	 
	Room 308
Violations	No violations recorded.
Door(s)	Inspected
Condition	5 - Poor
Deficiency	WOOD: DETERIORATED DOOR
Deficiency Location/Instance	Rooms 110, 201, 222, 307, 308, and others
Deficiency Quantity	15
Quantity Uom	EACH
Potential Action	MAINTENANCE
Urgency of Action	PRIORITY 3
Purpose of Action	LEVEL 2
Deficiency Photo1	 
	Room 308
Violations	No violations recorded.
Floor Finish	Inspected
Condition	2 - Between Good and Fair
Deficiency	CONCRETE: CRACKS
Deficiency Location/Instance	Corridor near Room B3
Deficiency Quantity	10
Quantity Uom	S.F.
Potential Action	REPLACE
Urgency of Action	PRIORITY 3

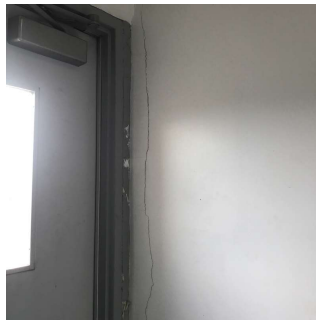
Penthouse
No violations recorded.

BULKHEAD/PENTHOUSE WALLS/INTERIOR: PLASTER CRACKS/SPALLING

10
S.F.
REPLACE
PRIORITY 3
LEVEL 2

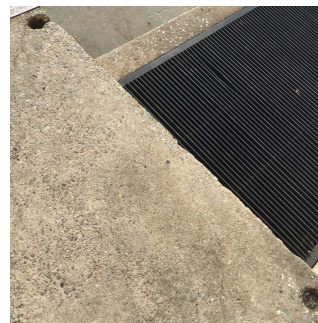
MISSING RAILING

Missing Railing at Loading Dock

REPLACE

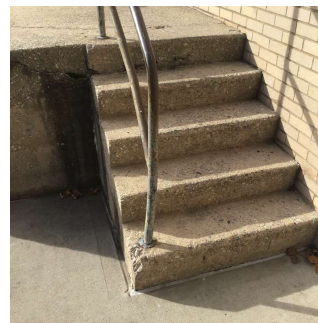
stairs at Loading Dock
No violations recorded.

CONCRETE: CRACKS/SPALLING - MINOR

30
S.F.
REPAIR
PRIORITY 3
LEVEL 2

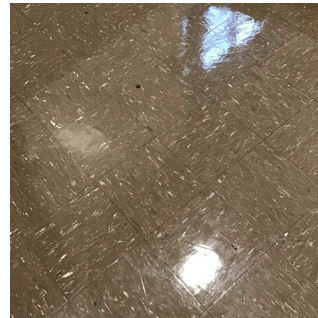
Near Stage Left

VINYL TILES: BROKEN/DETERIORATED/MISSING TILES

REPLACE

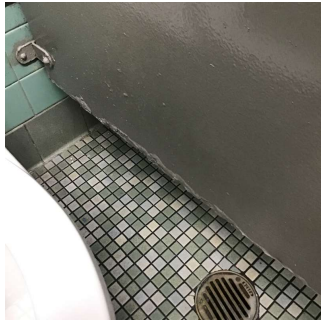
Question	Response
INTERIOR	
TOILET ROOMS - STAFF	Inspected
Stalls	
Condition	5 - Poor
Deficiency	RUST - MAJOR
Deficiency Location/Instance	In Rooms 207, 307
Deficiency Quantity	2
Quantity Uom	EACH
Potential Action	REPLACE
Urgency of Action	PRIORITY 3
Purpose of Action	LEVEL 2
Deficiency Photo1

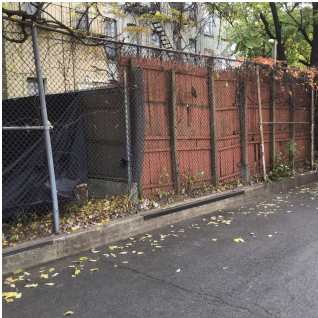
Question	Response
SITE	
FENCES	
Deficiency Location/Instance	Near Parking Lot
Deficiency Quantity	170
Quantity Uom	L.F.
Potential Action	REPLACE
Urgency of Action	PRIORITY 3
Purpose of Action	LEVEL 2
Deficiency Photo1
