**NYC Department of Education**  
**Building Condition Assessment Survey 2023 - 2024**

Architectural Inspection

**K058**

**Asset:** P.S. 58 - BROOKLYN, 330 SMITH STREET, New York, 11231

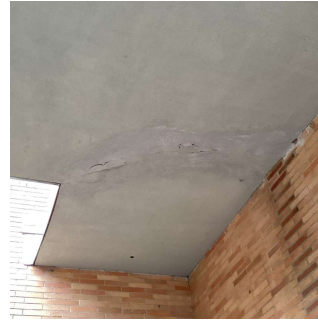
Facade K - Near AW3

**AWNINGS AND CANOPIES**

REPLACE

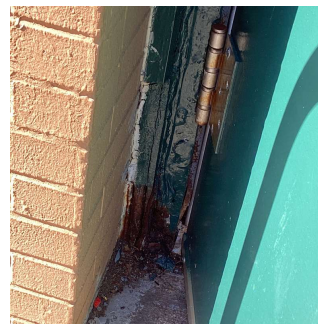
Facade C

**METAL: DETERIORATED DOOR AND FRAME - MAJOR DETERIORATION**

5  
EACH  
REPLACE  
PRIORITY 4  
LEVEL 2

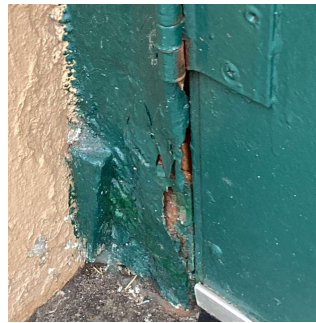
Facade B - Exit 1

**METAL CLAD: DETERIORATED DOOR AND FRAME - MAJOR DETERIORATION**

6  
EACH  
REPLACE  
PRIORITY 4  
LEVEL 2

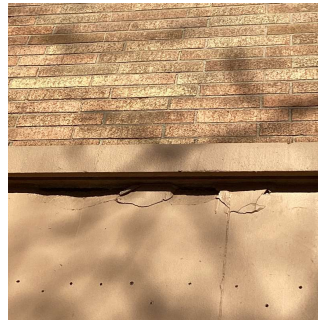
Facade D - Exit 3

STONE: CHIPPED/SPALLED/BROKEN PIECES - MAJOR

REPLACE

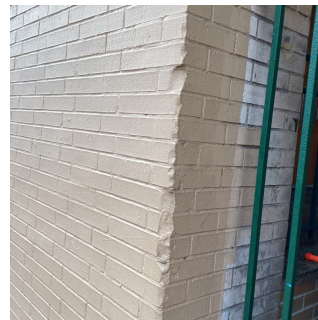
Corner of Facade B and Facade A

**BRICK: CRACKS/DISPLACED/SPALLED BRICK AT BUILDING  
CORNERS**

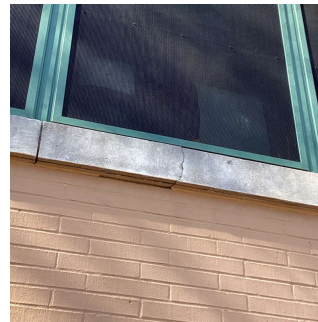
Facade C  
No violations recorded.

**BRICK: DETERIORATED MASONRY SILLS - MAJOR**

50  
L.F.  
REMOVE AND REPLACE  
PRIORITY 4  
LEVEL 2

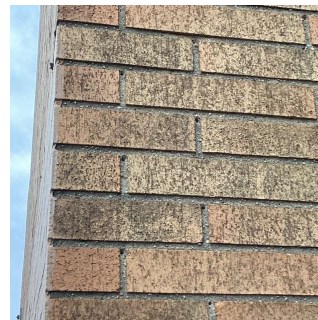
Facade H

**BRICK: DETERIORATED JOINTS**

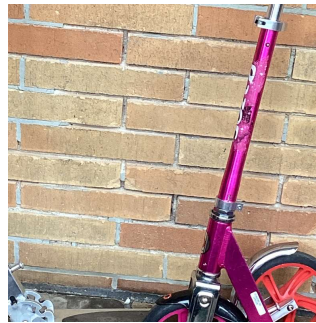
Facade A - Main Entrance

**BRICK: DETERIORATED JOINTS**

20  
 S.F.  
 REPOINT  
 PRIORITY 4  
 LEVEL 2

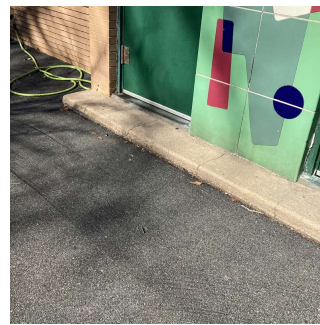
Facade F

**CONCRETE: CRACKS/SPALLING - MAJOR**

10  
S.F.  
REPLACE  
PRIORITY 4  
LEVEL 2

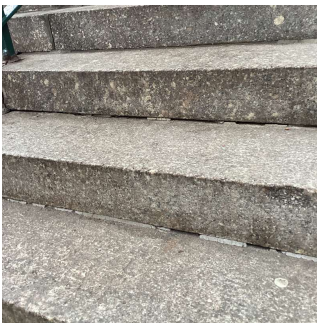
Violations	Facade A - Main Entrance No violations recorded.
Deficiency	<b>STONE: CRACKS/SPALLING - MAJOR</b>
Roof Plan reference

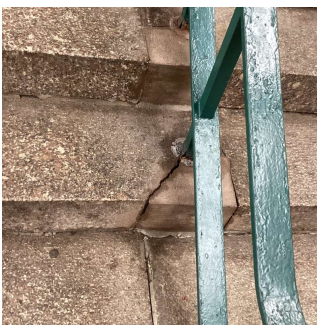
Violations	Facade A - Main Entrance No violations recorded.
<b>WINDOWS</b>	Inspected
Replacement Quantity	10,000
Replacement Uom	S.F.
<b>EXTERIOR GUARDS</b>	Inspected
Condition	2 - Between Good and Fair
Deficiency	No deficiencies recorded
<b>LINTELS</b>	Inspected
Condition	2 - Between Good and Fair
Deficiency	No deficiencies recorded

Deficiency Quantity	60
Quantity Uom	S.F.
Potential Action	REPLACE
Urgency of Action	PRIORITY 4
Purpose of Action	LEVEL 2
Deficiency Photo1

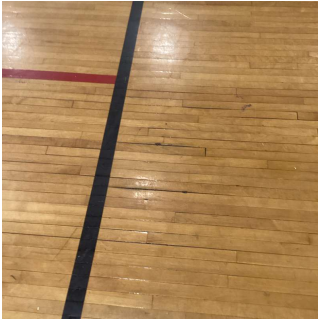
Violations	Storage No violations recorded.
Deficiency	WOOD: DAMAGED/DETERIORATED
Deficiency Location/Instance	Near Windows
Deficiency Quantity	250
Quantity Uom	S.F.
Potential Action	REPLACE
Urgency of Action	PRIORITY 3
Purpose of Action	LEVEL 2
Deficiency Photo1

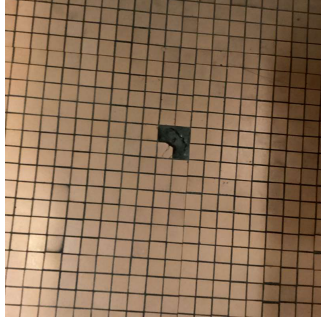
Room 107

Deficiency	CERAMIC TILE: BROKEN/MISSING TILES
Deficiency Location/Instance	Room 222, 107
Deficiency Quantity	20
Quantity Uom	S.F.
Potential Action	REPLACE
Urgency of Action	PRIORITY 3
Purpose of Action	LEVEL 2
Deficiency Photo1

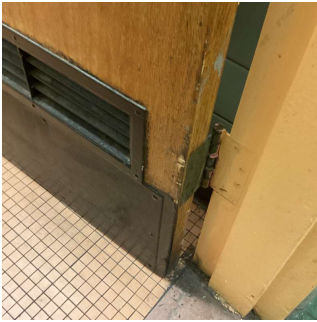
Room 125
Violations	No violations recorded.
<b>Door(s)</b>	Inspected
Condition	5 - Poor
Deficiency	WOOD: DETERIORATED DOOR
Deficiency Location/Instance	Room 325, 317, 225, 217, 125, and others
Deficiency Quantity	7
Quantity Uom	EACH
Potential Action	MAINTENANCE
Urgency of Action	PRIORITY 3
Purpose of Action	LEVEL 2
Deficiency Photo1
