**NYC Department of Education**  
**Building Condition Assessment Survey 2023 - 2024**

Architectural Inspection

**Asset:** P.S. 59 - BROOKLYN, 211 THROOP AVENUE, New York, 11206

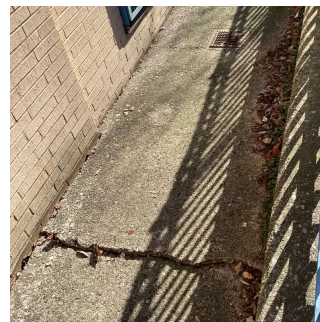
AW2

AREAWAY WALLS: CRACKS AND SPALLING

10  
 S.F.  
 REPLACE  
 PRIORITY 4  
 LEVEL 2

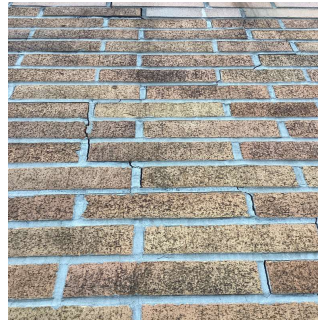
CH  
 No violations recorded.

BRICK: MAJOR / THRU CRACKS

30  
 S.F.  
 REMOVE AND REBUILD  
 PRIORITY 4  
 LEVEL 2

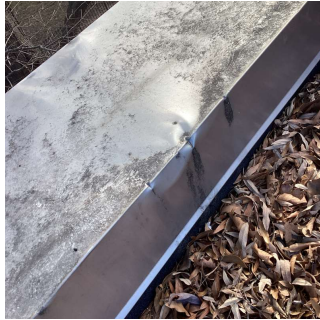
METAL: DETERIORATED

10  
 L.F.  
 REPLACE-IN-KIND  
 PRIORITY 4  
 LEVEL 2

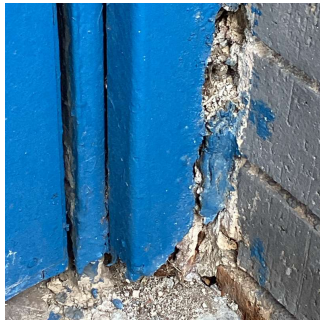
Violations	Roof 3 No violations recorded.
<b>CORNICE</b>	Does not Exist
<b>DOORS</b>	Inspected
<b>DOORS AND FRAMES</b>	Inspected
Condition	3 - Fair
Deficiency	METAL: DETERIORATED DOOR AND FRAME - MAJOR DETERIORATION
Roof Plan reference	K059

Deficiency Quantity	1
Quantity Uom	EACH
Potential Action	REPLACE
Urgency of Action	PRIORITY 4
Purpose of Action	LEVEL 2
Deficiency Photo1

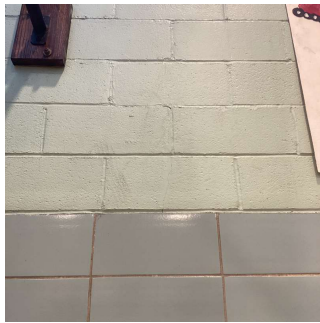
Violations	Near Windows No violations recorded.
Deficiency	GLAZED BLOCK: CRACKS/SPALLING
Deficiency Location/Instance	Near Windows, by Main Entrance
Deficiency Quantity	20
Quantity Uom	S.F.
Potential Action	REPLACE
Urgency of Action	PRIORITY 3
Purpose of Action	LEVEL 2
Deficiency Photo1

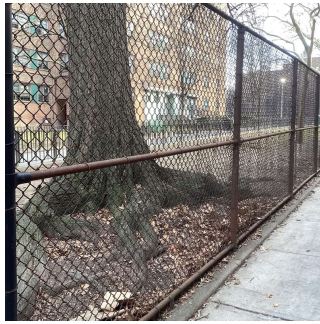
Violations	Near Exit 1 No violations recorded.
Deficiency	CHAIN LINK: DAMAGED POST/RAIL
Deficiency Location/Instance	Near Exit 1
