NYC Department of Education
Building Condition Assessment Survey 2023 - 2024

Architectural Inspection

**Asset: PRE-K CENTER @ 1340 EAST 29TH STREET - BROOKLYN, 1340 EAST 29TH STREET,
 New York, 11210**

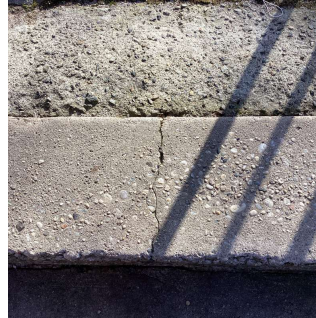
AW1

AREAWAY SLAB: CRACKS AND SPALLING

REPLACE

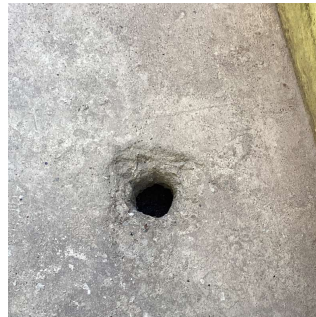
AW1

AREAWAY DRAINS: DETERIORATED

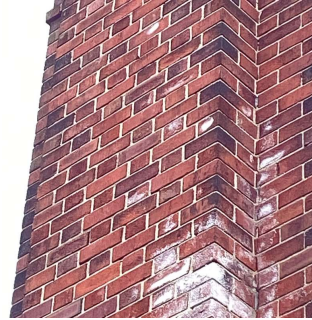
CH1

BRICK: MINOR CRACKS AND SPALLING

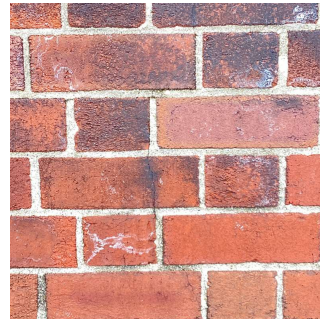
CH3

BRICK: MAJOR / THRU CRACKS

K063
25
S.F.
REMOVE AND REBUILD
PRIORITY 4
LEVEL 2

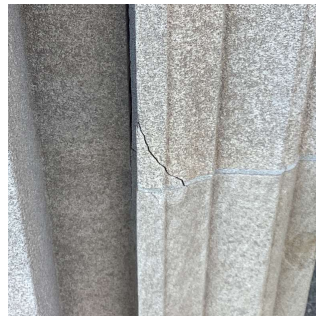
STONE: CHIPPED/SPALLED/BROKEN PIECES - MINOR

REPAIR

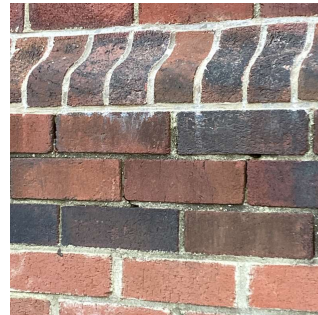
Facade A

BRICK: DETERIORATED JOINTS

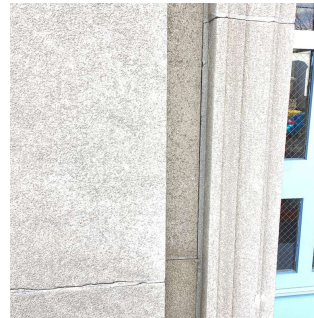
Facade A

STONE: DETERIORATED JOINTS

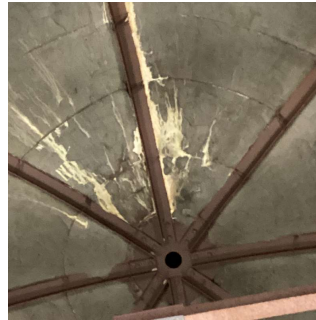
Cupola

WATER INFILTRATION

REPAIR

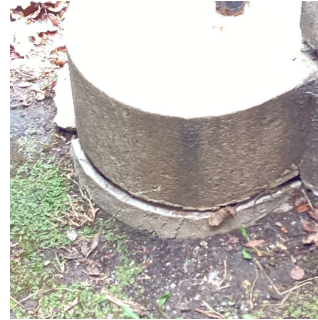
Facade A

STONE: DETERIORATED JOINTS

S.F.
 REPOINT
 PRIORITY 4
 LEVEL 2

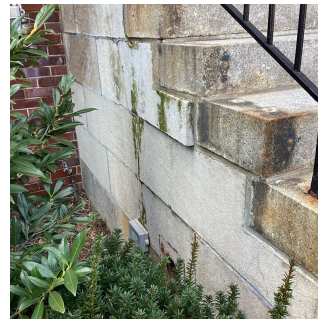
Facade A

MASONRY UNIT: BULGING/DISPLACED

25
 S.F.
 REPLACE
 PRIORITY 4
 LEVEL 2

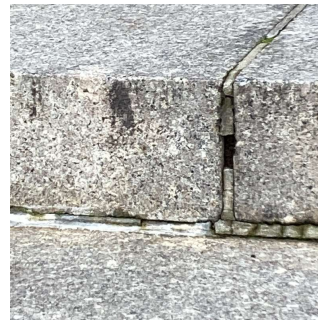
Facade A

STONE: DETERIORATED JOINTS

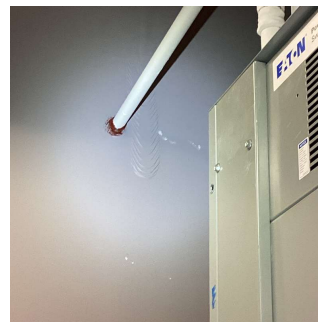
Electrical Panel Room

CONCRETE: WATER INFILTRATION IN ELECTRICAL PANEL ROOM

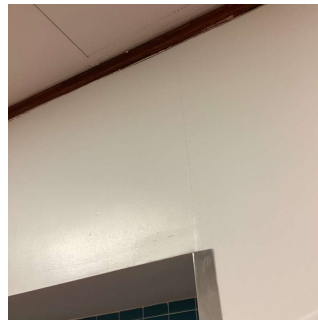
Corridor near Main Office
No violations recorded.

GYPSUM BOARD: DETERIORATED
Corridor near Main Office
10
S.F.
REPLACE
PRIORITY 3
LEVEL 2

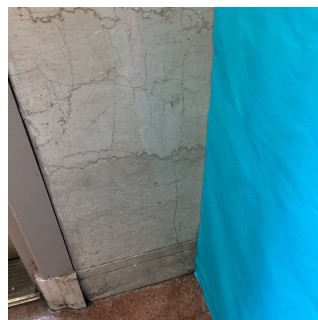
STONE: CRACKS/SPALLING
Main Entrance Vestibule
20
S.F.
REPLACE
PRIORITY 3
LEVEL 2

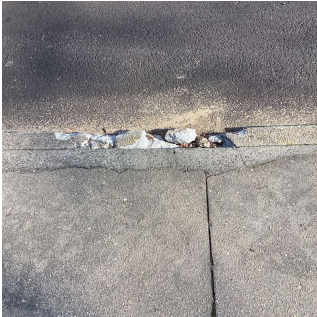
Violations	E.29th Street No violations recorded.
Deficiency	HEAVING
Deficiency Location/Instance	E.29th Street
Deficiency Quantity	100
Quantity Uom	S.F.
Potential Action	REPLACE
Urgency of Action	PRIORITY 3
Purpose of Action	LEVEL 2
Deficiency Photo1
