**NYC Department of Education**  
**Building Condition Assessment Survey 2023 - 2024**

Architectural Inspection

**K065**

**Asset:** P.S. 65 - BROOKLYN, 158 RICHMOND STREET, New York, 11208

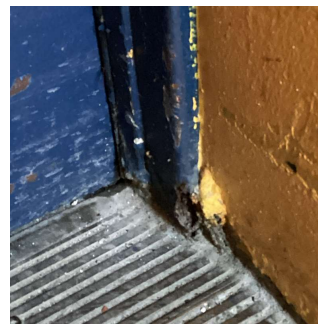
Facade F

Question	Response
<b>Architectural</b>	
<b>EXTERIOR</b>	Inspected
<b>AREAWAY</b>	Does not Exist
<b>AWNINGS AND CANOPIES</b>	Does not Exist
<b>CHIMNEY</b>	Inspected
Material Type(s)	Masonry
Condition	2 - Between Good and Fair
Deficiency	No deficiencies recorded
<b>COPING</b>	Inspected
Condition	2 - Between Good and Fair
Deficiency	No deficiencies recorded
<b>CORNICE</b>	Inspected
Condition	2 - Between Good and Fair
Deficiency	No deficiencies recorded
<b>DOORS</b>	Inspected
<b>DOORS AND FRAMES</b>	Inspected
Condition	5 - Poor
Deficiency	METAL: DETERIORATED DOOR AND FRAME - MAJOR DETERIORATION

3  
EACH  
REPLACE  
PRIORITY 4  
LEVEL 2

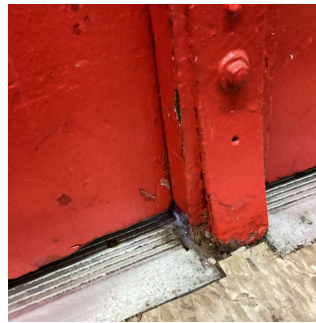
Facade A

**METAL: DETERIORATED DOOR AND FRAME - MINOR DETERIORATION**

3  
EACH  
MAINTENANCE  
PRIORITY 3  
LEVEL 2

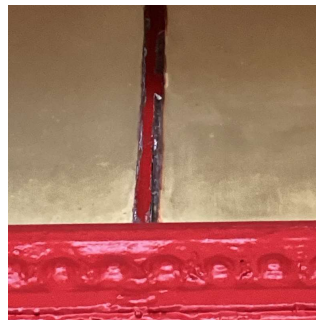
Facade A

WOOD: EXCESSIVELY WEATHERED

Deficiency Quantity

10

REPLACE

PRIORITY 4

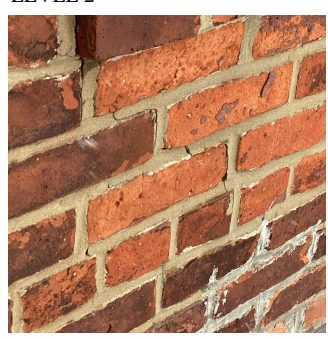
Question	Response
<b>EXTERIOR</b>	
<b>EXTERIOR WALLS</b>	
Replacement Uom	S.F.
Instance on All Facades	Under Construction
Instance Quantity	19,000
Instance Quantity Uom	S.F.
<b>EXTERIOR SOFFITS</b>	
	Does not Exist
<b>LOADING DOCK</b>	
	Does not Exist
<b>LOUVER</b>	
Condition	2 - Between Good and Fair
Deficiency	No deficiencies recorded
<b>PARAPETS</b>	
Material Type(s)	Masonry
Replacement Quantity	500
Replacement Uom	C.F.
Instance on Facades C, K	Inspected
Instance Condition	4 - Between Fair and Poor
Instance Quantity	500
Instance Quantity Uom	C.F.
Deficiency	BRICK: MAJOR DETERIORATION/CRACKS
Roof Plan reference

Violations	Facade C No violations recorded.
<b>PLAZA DECK</b>	
	Does not Exist
<b>ROOF</b>	
<b>Roofing</b>	Inspected

Deficiency Quantity	10
Quantity Uom	S.F.
Potential Action	REMOVE AND REBUILD
Urgency of Action	PRIORITY 4
Purpose of Action	LEVEL 2
Deficiency Photo1

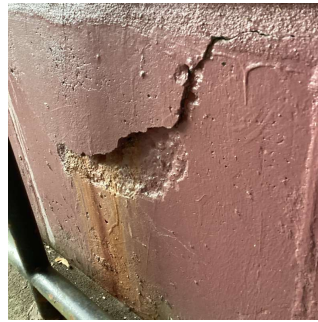
Facade H

<b>ROOF/GRAVITY TANK</b>	Does not Exist
<b>STAIRS/RAMPS: EXTERIOR</b>	Inspected
<b>BUILDING CHEEK/FLANK WALLS</b>	Inspected
Condition	5 - Poor
Deficiency	CAST IN PLACE CONCRETE: CRACKS/SPALLING - MAJOR
Roof Plan reference

Deficiency Quantity	25
Quantity Uom	S.F.
Potential Action	REPLACE
Urgency of Action	PRIORITY 4
Purpose of Action	LEVEL 2
Deficiency Photo1

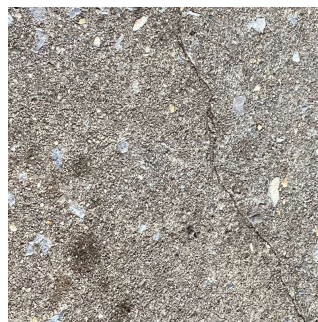
Facade H

Deficiency CONCRETE: CRACKS/SPALLING - MINOR

Deficiency Quantity	20
Quantity Uom	S.F.
Potential Action	REPAIR
Urgency of Action	PRIORITY 3
Purpose of Action	LEVEL 2
Deficiency Photo1

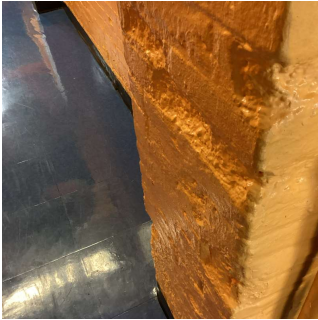
Question	Response
<b>EXTERIOR</b>	
<b>STAIRS/RAMPS: EXTERIOR</b>	Inspected
<b>STAIRS/RAMPS</b>	
Violations	No violations recorded.
<b>WINDOWS</b>	Inspected
Replacement Quantity	3,000
Replacement Uom	S.F.
<b>EXTERIOR GUARDS</b>	Inaccessible
<b>LINTELS</b>	Inaccessible
<b>WINDOWS</b>	Inspected
Material Type(s)	Solid Wood
Instance on Wood: All Facades	Inspected
Instance Condition	2 - Between Good and Fair
Instance Quantity	3,000
Instance Quantity Uom	S.F.
Are these windows insulated	No
Installation Year	2010
Source of Installation	Custodial Staff
Deficiency	No deficiencies recorded
<b>INTERIOR</b>	Inspected
<b>POOLS</b>	Does not Exist
<b>STRUCTURAL</b>	Inspected
<b>COLUMNS/BEAMS/BEARING WALLS</b>	Inspected
Condition	3 - Fair
Deficiency	MASONRY BEARING WALL: CRACKED/SPALLED
Deficiency Location/Instance	Basement - Corridor, Custodial Closet
Deficiency Quantity	40
Quantity Uom	S.F.
Potential Action	RESTITCH
Urgency of Action	PRIORITY 4

Violations	Basement - Corridor No violations recorded.
<b>FLOOR STRUCTURE</b>	Inspected
Condition	3 - Fair
Deficiency	CONCRETE SLAB ON GRADE: THRU CRACKS
Deficiency Location/Instance	Basement - Boiler Room
Deficiency Quantity	10
Quantity Uom	S.F.
Potential Action	REPLACE

Purpose of Action	LEVEL 5
Deficiency Photo1

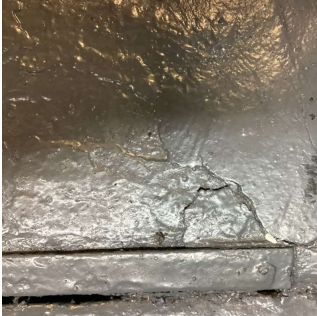
Violations	Basement - Boiler Room No violations recorded.
<b>FOUNDATION WALLS</b>	
Material Type(s)	Inspected Masonry
Condition	4 - Between Fair and Poor
Deficiency	BRICK: DETERIORATED JOINTS
Deficiency Location/Instance	Basement - Boiler Room
Deficiency Quantity	120
Quantity Uom	S.F.
Potential Action	REPOINT
Urgency of Action	PRIORITY 4
Purpose of Action	LEVEL 5
Deficiency Photo1

Question	Response
<b>INTERIOR</b>	
<b>STRUCTURAL</b>	
<b>FLOOR STRUCTURE</b>	
Urgency of Action	PRIORITY 4
Purpose of Action	LEVEL 5
Deficiency Photo1

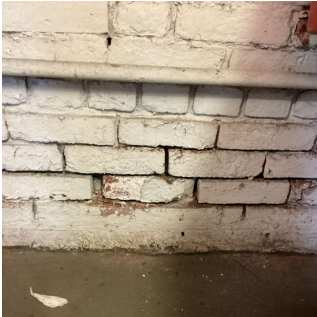
Violations	Basement - Boiler Room No violations recorded.
Deficiency	BRICK: CRACKED/SPALLED
Deficiency Location/Instance	Basement - Custodial Closet, Boiler Room
Deficiency Quantity	30
Quantity Uom	S.F.
Potential Action	RESTITCH
Urgency of Action	PRIORITY 4
Purpose of Action	LEVEL 5

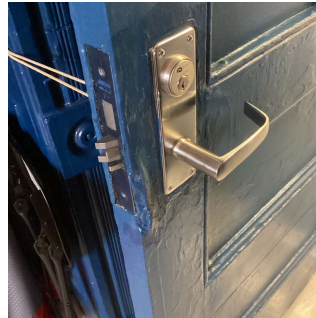
Room 201

5 - Poor

METAL CLAD WOOD: DETERIORATED DOOR

MAINTENANCE

PRIORITY 3

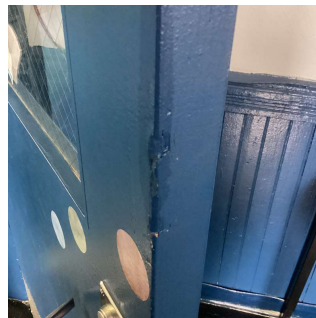
WOOD: DETERIORATED DOOR

Rooms 102, 105, 106, 109, 200C and others

MAINTENANCE

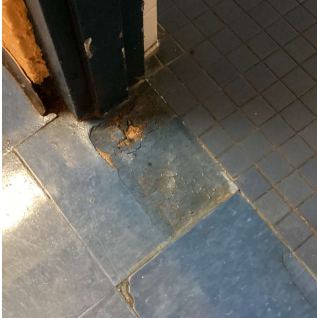
Question	Response
<b>INTERIOR</b>	
<b>CLASSROOMS/CORRIDORS/ADMIN SPACES</b>	
<b>Door(s)</b>	Inspected
	Room 106
Violations	No violations recorded.
<b>Floor Finish</b>	Inspected
Condition	5 - Poor
Deficiency	VINYL TILES: BROKEN/DETERIORATED/MISSING TILES
Deficiency Location/Instance	Rooms 202, 201, 200C, Corridor 2nd Floor, by Girls Toilet Room - Basement and others
Deficiency Quantity	600
Quantity Uom	S.F.
Potential Action	REPLACE
Urgency of Action	PRIORITY 3
Purpose of Action	LEVEL 2
Deficiency Photo1

Corridor near Girls Toilet Room - Basement
Violations	No violations recorded.
Deficiency	CONCRETE: CRACKS
Deficiency Location/Instance	Main Entrance Lobby
Deficiency Quantity	20
Quantity Uom	S.F.
Potential Action	REPLACE
Urgency of Action	PRIORITY 3
Purpose of Action	LEVEL 2
Deficiency Photo1

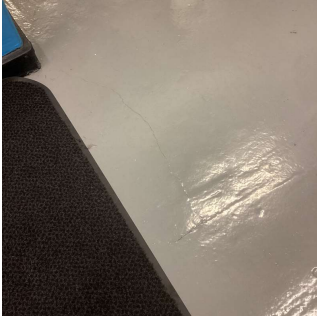
Main Entrance Lobby
Violations	No violations recorded.
Deficiency	VINYL TILES: DETERIORATED SUBSTRATE
Deficiency Location/Instance	Rooms 201, 202, 203, 204, 207 and others

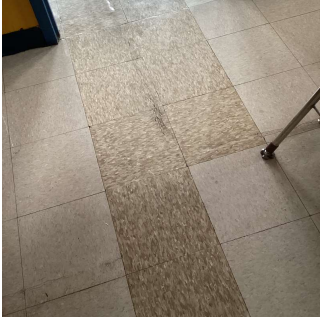
Deficiency Quantity	1,200
Quantity Uom	S.F.
Potential Action	REPLACE
Urgency of Action	PRIORITY 3

Room 201
Violations	No violations recorded.
<b>Walls</b>	Inspected
Condition	2 - Between Good and Fair
Deficiency	PLASTER: CRACKS/SPALLING - ACTIVE LEAK
Deficiency Location/Instance	3rd Floor - Principals Office
Deficiency Quantity	20
Quantity Uom	S.F.
Potential Action	REPLACE
Urgency of Action	PRIORITY 5
Purpose of Action	LEVEL 2
Deficiency Photo1

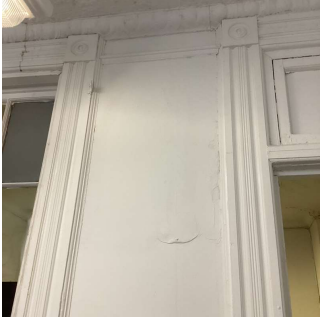
3rd Floor - Principals Office
Violations	No violations recorded.
Deficiency	PLASTER: CRACKS/SPALLING
Deficiency Location/Instance	Corridor near Stair B/2
Deficiency Quantity	20
Quantity Uom	S.F.
Potential Action	REPLACE
Urgency of Action	PRIORITY 3
Purpose of Action	LEVEL 2

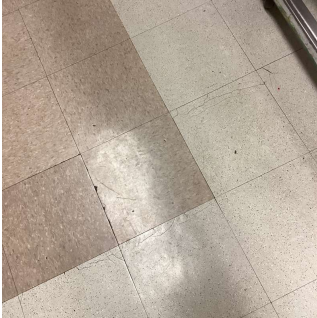
Question	Response
<b>INTERIOR</b>	
<b>KITCHEN</b>	
<b>Floor Finish</b>	
Instance on Basement (200 SF)	Inspected
Condition	5 - Poor
Deficiency	VINYL TILES: BROKEN/DETERIORATED/MISSING TILES
Deficiency Location/Instance	Preparation Area, near Main Entrance, by Sink
Deficiency Quantity	80
Quantity Uom	S.F.
Potential Action	REPLACE
Urgency of Action	PRIORITY 3
Purpose of Action	LEVEL 2
Deficiency Photo1

Violations	Preparation Area No violations recorded.
<b>Walls</b>	
Instance on Basement (200 SF)	Inspected
Condition	3 - Fair
Deficiency	CERAMIC TILE: BROKEN/ MISSING
Deficiency Location/Instance	Near Main Entrance
Deficiency Quantity	10
Quantity Uom	S.F.
Potential Action	REPLACE
Urgency of Action	PRIORITY 3
Purpose of Action	LEVEL 2
Deficiency Photo1

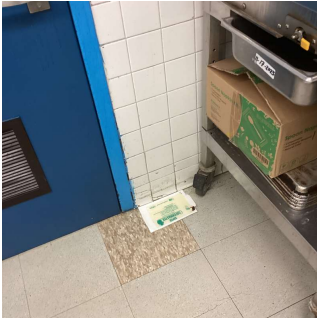
Violations	Near Main Entrance No violations recorded.
<b>LIBRARY</b>	
Instance on Room 209	Inspected
<b>Built-in Furnishing</b>	
Instance on Room 209	Does not Exist
<b>Ceiling</b>

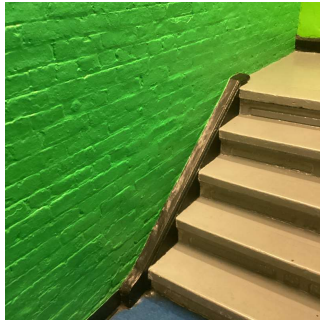
<b>Question</b>	<b>Response</b>
<b>INTERIOR</b>	
<b>LIBRARY</b>	Inspected
<b>Walls</b>	
Condition	2 - Between Good and Fair
Deficiency	No deficiencies recorded
<b>LOCKER ROOM</b>	Does not Exist
<b>MULTI-PURPOSE ROOM</b>	Does not Exist
<b>SCIENCE DEMO ROOM</b>	Does not Exist
<b>SCIENCE LAB</b>	Does not Exist
<b>SCIENCE PREP ROOM</b>	Does not Exist
<b>SHOWER ROOM</b>	Does not Exist
<b>STAIRS/RAMPS: INTERIOR</b>	Inspected
Do Letter Stair Signs Exist?	Yes
<b>Ceiling</b>	Inspected
Condition	2 - Between Good and Fair
Deficiency	No deficiencies recorded
<b>Door(s)</b>	Inspected
Condition	2 - Between Good and Fair
Deficiency	No deficiencies recorded
<b>Partition</b>	Inspected
Condition	2 - Between Good and Fair
Deficiency	No deficiencies recorded
<b>Railings</b>	Inspected
Condition	4 - Between Fair and Poor
Deficiency	METAL: MISSING
Deficiency Location/Instance	Stair D/Basement, Exit 8 - Vestibule
Deficiency Quantity	20
Quantity Uom	L.F.

Violations	Stair D/Basement No violations recorded.
Deficiency	METAL: BROKEN BRACKET
Deficiency Location/Instance	Main Entrance
Deficiency Quantity	1
Quantity Uom	EACH
Potential Action	REPLACE
Urgency of Action	PRIORITY 3
Purpose of Action	LEVEL 2

Potential Action	REPLACE
Urgency of Action	PRIORITY 5
Purpose of Action	LEVEL 6
Deficiency Photo1

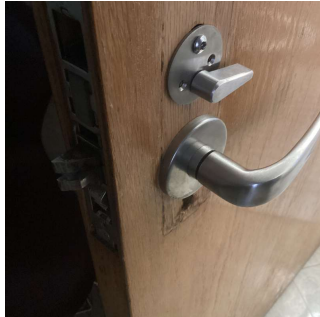
Question	Response
<b>INTERIOR</b>	
<b>TOILET ROOMS - STAFF</b>	
<b>Ceiling</b>	
Deficiency Photo1	 
Violations	In Room 201 No violations recorded.
<b>Door(s)</b>	
Condition	Inspected 5 - Poor
Deficiency	WOOD: DETERIORATED DOOR
Deficiency Location/Instance	In Nurse Office, In Room 201
Deficiency Quantity	2
Quantity Uom	EACH
Potential Action	MAINTENANCE
Urgency of Action	PRIORITY 3
Purpose of Action	LEVEL 2
Deficiency Photo1

Violations	In Nurse Office No violations recorded.
<b>Floor Finish</b>	
Condition	Inspected 2 - Between Good and Fair
Deficiency	No deficiencies recorded
<b>Stalls</b>	
Does not Exist	
<b>Walls</b>	
Condition	Inspected 2 - Between Good and Fair
Deficiency	PLASTER: CRACKS/SPALLING
Deficiency Location/Instance	Staff Toilet Room - 2nd Floor
Deficiency Quantity	10
Quantity Uom	S.F.
Potential Action	REPLACE
Urgency of Action	PRIORITY 3
Purpose of Action	LEVEL 2

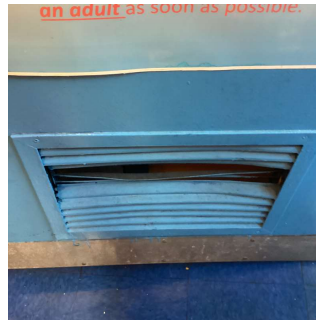
Boys Toilet Room - Basement

5 - Poor

METAL: DAMAGED LOUVER

MAINTENANCE

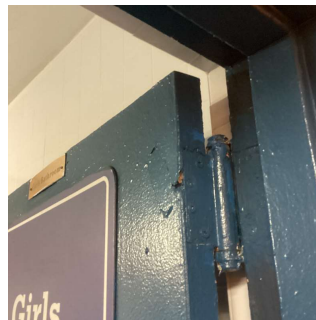
WOOD: DETERIORATED DOOR

Girls Toilet Room - Basement

<b>Question</b>	<b>Response</b>
<b>INTERIOR</b>	
<b>TOILET ROOMS - STUDENTS</b>	
<b>Door(s)</b>	Inspected
	Girls Toilet Room - Basement
Violations	No violations recorded.
<b>Floor Finish</b>	Inspected
Condition	2 - Between Good and Fair
Deficiency	No deficiencies recorded
<b>Stalls</b>	Inspected
Condition	5 - Poor
Deficiency	RUST - MAJOR
Deficiency Location/Instance	Girls Toilet Room - Basement, Boys Toilet Room - Basement
Deficiency Quantity	4
Quantity Uom	EACH
Potential Action	REPLACE
Urgency of Action	PRIORITY 3
Purpose of Action	LEVEL 2
Deficiency Photo1	 
Violations	Boys Toilet Room - Basement No violations recorded.
<b>Walls</b>	Inspected
Condition	2 - Between Good and Fair
Deficiency	CERAMIC TILE: BROKEN/ MISSING
Deficiency Location/Instance	Boys Toilet Room - Basement
Deficiency Quantity	10
Quantity Uom	S.F.
Potential Action	REPLACE
Urgency of Action	PRIORITY 3
Purpose of Action	LEVEL 2
Deficiency Photo1

MAINTENANCE

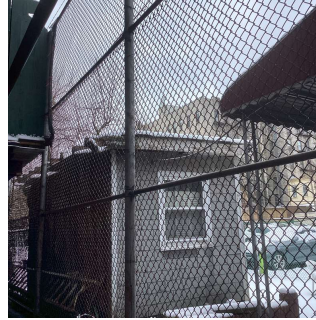
Potential Action	REPLACE
Urgency of Action	PRIORITY 3
Purpose of Action	LEVEL 2
Deficiency Photo1	 
	Richmond Street
Violations	No violations recorded.
Deficiency	CHAIN LINK: RUST - MAJOR
Deficiency Location/Instance	Schoolyard
Deficiency Quantity	1,000
Quantity Uom	S.F.
Potential Action	REPLACE
Urgency of Action	PRIORITY 3
Purpose of Action	LEVEL 2

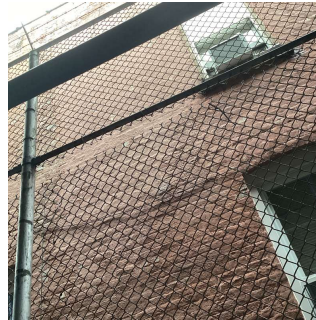
Schoolyard

**CHAIN LINK: DAMAGED/DETERIORATED**

REPLACE

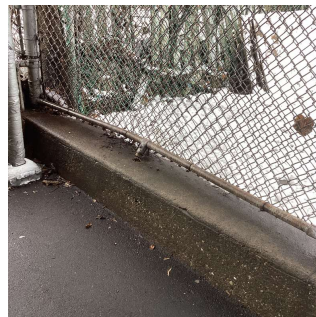
Near Exit 7

**CHAIN LINK: DAMAGED POST/RAIL**

REPLACE

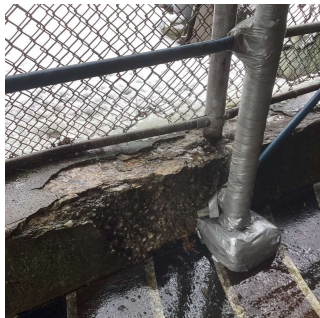
**WROUGHT IRON: MISSING SECTIONS**

<b>Question</b>	<b>Response</b>
<b>SITE</b>	
<b>FENCES</b>	
Deficiency Location/Instance	Richmond Street
Deficiency Quantity	120
Quantity Uom	S.F.
Potential Action	REPLACE
Urgency of Action	PRIORITY 3
Purpose of Action	LEVEL 2
Deficiency Photo1	 
Violations	Richmond Street No violations recorded.
Deficiency	<b>CONCRETE CURB: DAMAGED/DETERIORATED</b>
Deficiency Location/Instance	Near Exit 7, Richmond Street
Deficiency Quantity	50
Quantity Uom	S.F.
Potential Action	REPLACE
Urgency of Action	PRIORITY 3
Purpose of Action	LEVEL 2
Deficiency Photo1

Violations	Near Exit 7 No violations recorded.
<b>IRRIGATION SYSTEM</b>	Does not Exist
<b>PAVING</b>	Inspected
<b>Student Non-Use</b>	Inspected
Gravel Exists?	No
<b>Asphalt</b>	Does not Exist
<b>Concrete</b>	Inspected
Condition	2 - Between Good and Fair
Deficiency	<b>CRACKS - MAJOR</b>
Deficiency Location/Instance	Richmond Street
Deficiency Quantity	25
Quantity Uom	S.F.
Potential Action	REPLACE

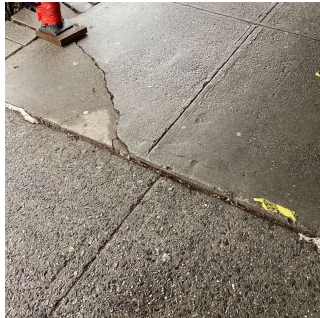
Question	Response
<b>SITE</b>	
<b>PAVING</b>	
<b>Site Sidewalks &amp; Walkways</b>	
<b>Asphalt</b>	
Purpose of Action	LEVEL 2
Deficiency Photo1	 
	Rear of the Building
Violations	No violations recorded.
<b>Concrete</b>	Does not Exist
<b>Pavers</b>	Does not Exist
<b>DOT Sidewalk</b>	Inspected
<b>Asphalt</b>	Does not Exist
<b>Concrete</b>	Inspected
Condition	4 - Between Fair and Poor
Deficiency	HEAVING
Deficiency Location/Instance	Richmond Street
Deficiency Quantity	125
Quantity Uom	S.F.
Potential Action	REPLACE
Urgency of Action	PRIORITY 3
Purpose of Action	LEVEL 2
Deficiency Photo1

Richmond Street
Violations	No violations recorded.
Deficiency	DAMAGED CURBS
Deficiency Location/Instance	Richmond Street
Deficiency Quantity	80
Quantity Uom	L.F.
Potential Action	REPLACE
Urgency of Action	PRIORITY 3
Purpose of Action	LEVEL 2

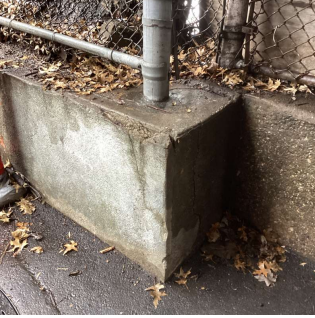
Question	Response
<b>SITE</b>	
<b>RETAINING WALLS</b>	
Deficiency Photo1           Violations

<p data-bbox="917 604 1015 630">Schoolyard</p> <p data-bbox="917 640 1112 665">No violations recorded.</p>
<b>SEATING</b>	
Inspected	
<b>Benches</b>	
Inspected	
<b>Concrete</b>	
Inspected	
Condition	2 - Between Good and Fair
Deficiency	No deficiencies recorded
<b>Metal/Wood/Plastic</b>	
Inspected	
Condition	2 - Between Good and Fair
Deficiency	No deficiencies recorded
<b>Bleachers</b>	
Does not Exist	
<b>SITE WALLS (NOT RETAINING WALLS)</b>	
Does not Exist	
<b>STAIRS/RAMPS: EXTERIOR</b>	
Does not Exist	
<b>ARTWORK</b>	
Does not Exist
