NYC Department of Education
Building Condition Assessment Survey 2023 - 2024

Architectural Inspection

K066

Asset: P.S. 66 - BROOKLYN, 845 EAST 96TH STREET, New York, 11236

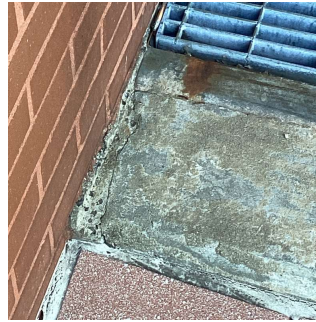
AW1
No violations recorded.

Deficiency	AREAWAY WALLS: CRACKS AND SPALLING
Roof Plan reference

10
 S.F.
 REPAIR
 PRIORITY 3
 LEVEL 2

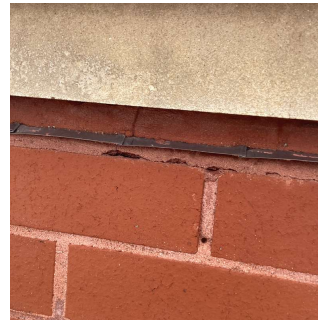
CH
No violations recorded.

BRICK: DETERIORATED JOINTS

10
S.F.
REPOINT
PRIORITY 3
LEVEL 2

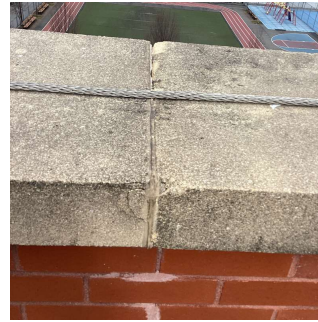
Facade D

CAST STONE: CRACKED/BROKEN PIECES

10
L.F.
REPLACE-IN-KIND
PRIORITY 4
LEVEL 2

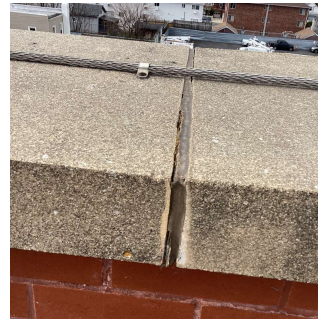
Facade C

CAST STONE: DETERIORATED TRANSVERSE JOINTS

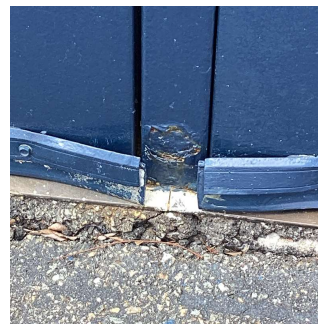
Facade M - Exit 8

METAL: DETERIORATED DOOR AND FRAME - MINOR DETERIORATION

2
EACH
MAINTENANCE
PRIORITY 3
LEVEL 2

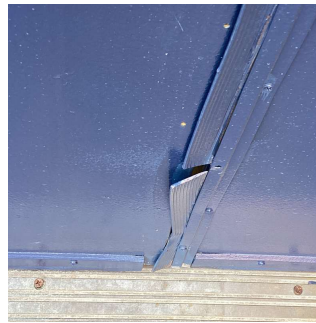
Facade G - Exit 12

METAL: DETERIORATED DOOR - MINOR DETERIORATION

2
EACH
MAINTENANCE
PRIORITY 3
LEVEL 2

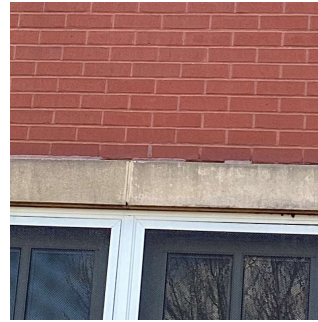
Facade D

BRICK: DETERIORATED JOINTS

20
S.F.
REPOINT
PRIORITY 4
LEVEL 2

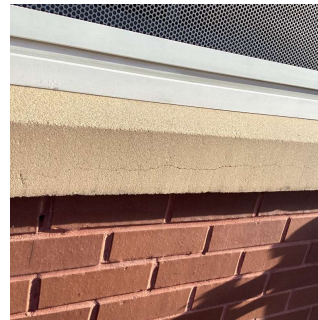
Facade O

BRICK: DETERIORATED MASONRY SILLS - MINOR

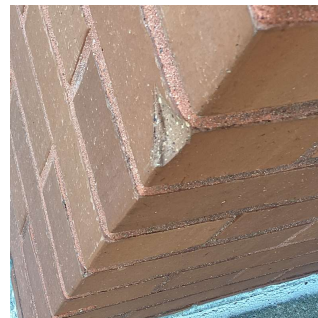
Facade A - Exit 1

BRICK: MINOR CRACKS AND SPALLING

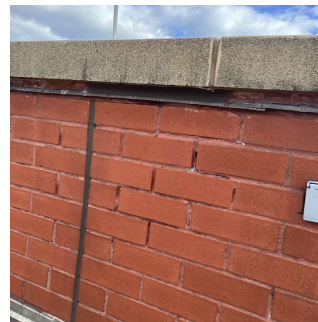
Roof 1 - PH1 Roof

BRICK: DETERIORATED JOINTS

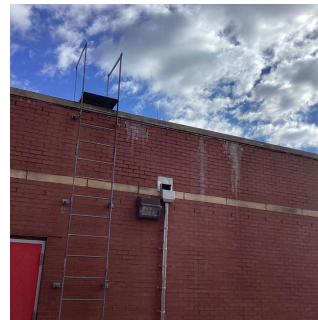
Roof 1 - BH1

<p>Roof 2 - Near Facade O</p>
Violations	No violations recorded.
Specialties	
	Inspected
BULKHEAD/PENTHOUSE	
	Inspected
Condition	3 - Fair
Deficiency	BULKHEAD/PENTHOUSE WALLS/EXTERIOR: EFFLORESCENCE

30
S.F.
MAINTENANCE
PRIORITY 1
LEVEL 1

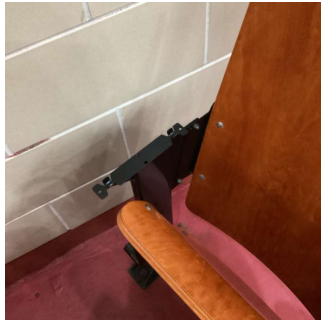
Seat K/14

Deficiency	DAMAGED/BROKEN/INOPERABLE
Deficiency Location/Instance	Seats B/7, K/14
Deficiency Quantity	2
Quantity Uom	EACH
Potential Action	REPLACE
Urgency of Action	PRIORITY 5
Purpose of Action	LEVEL 6
Deficiency Photo1

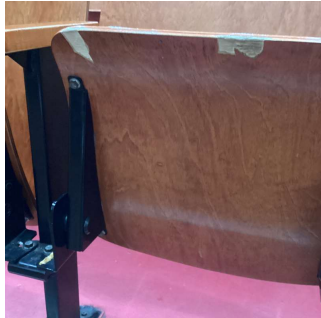
Seat A/107

Deficiency	DAMAGED/BROKEN/INOPERABLE
Deficiency Location/Instance	Seats A/107, 108, C/2, G/107
Deficiency Quantity	4
Quantity Uom	EACH
Potential Action	REPLACE
Urgency of Action	PRIORITY 3
Purpose of Action	LEVEL 2
Deficiency Photo1

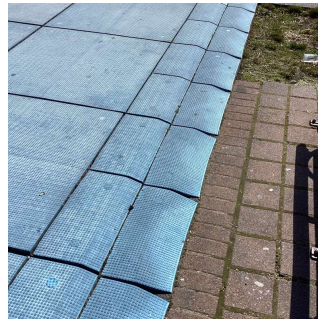
Instance on Main Schoolyard North	Inspected
Condition	3 - Fair
Deficiency	DETERIORATED/MISSING
Deficiency Location/Instance	Perimeter Edges
Deficiency Quantity	50
Quantity Uom	S.F.
Potential Action	REPLACE
Urgency of Action	PRIORITY 3
Purpose of Action	LEVEL 2
Deficiency Photo1
