**NYC Department of Education**  
**Building Condition Assessment Survey 2023 - 2024**

Architectural Inspection

**K069**

**Asset:** P.S. 69 - BROOKLYN, 6302 9TH AVENUE, New York, 11220

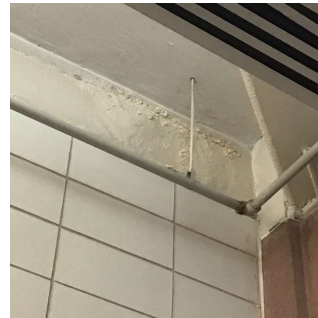
Facade D - Exit 5 Vestibule

CAST IN PLACE / PRE-CAST CONCRETE: DETERIORATED JOINTS

REPAIR

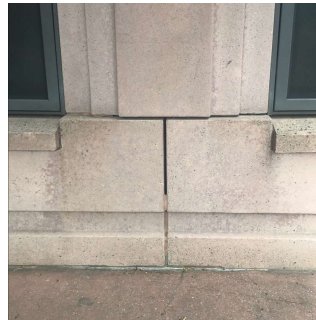
Facade E

BRICK: CRACKS/DISPLACED/SPALLED BRICK AT BUILDING CORNERS

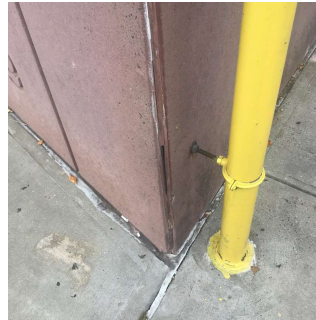
Corner of Facades A and H  
No violations recorded.

CAST IN PLACE / PRE-CAST CONCRETE: MINOR  
CRACKS/SPALLING

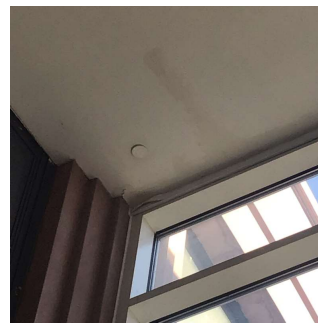
Facade A - 3rd Floor Atrium East Side

STUCCO/PLASTER: MAJOR CRACKS/SPALLING

REPAIR

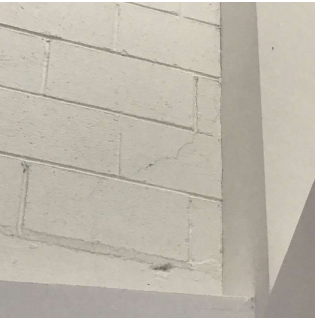
Question	Response
<b>EXTERIOR</b>	
<b>ROOF</b>	
<b>Specialties</b>	
<b>BULKHEAD/PENTHOUSE</b>	
Deficiency	BULKHEAD/PENTHOUSE WALLS/INTERIOR: CMU CRACKS/SPALLING
Roof Plan reference

Stair B/PH	No violations recorded.
Violations	
<b>CUPOLA/ SPIRES/ TOWERS</b>	Does not Exist
<b>DORMER</b>	Does not Exist
<b>DUNNAGE STEEL</b>	Inspected
Condition	2 - Between Good and Fair
Deficiency	No deficiencies recorded
<b>SKYLIGHT/ROOF VENT</b>	Does not Exist
<b>ROOF/GRAVITY TANK</b>	Does not Exist
<b>STAIRS/RAMPS: EXTERIOR</b>	Inspected
<b>BUILDING CHEEK/FLANK WALLS</b>	Inspected
Condition	3 - Fair
Deficiency	CAST IN PLACE CONCRETE: CRACKS/SPALLING - MINOR

Deficiency Quantity	10
Quantity Uom	S.F.
Potential Action	REPLACE
Urgency of Action	PRIORITY 3
Purpose of Action	LEVEL 2
Deficiency Photo1

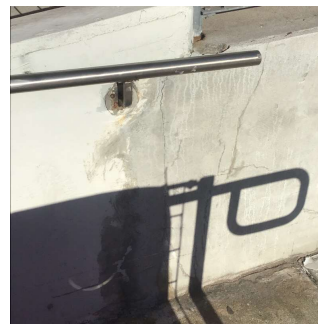
Facade A - HC Ramp  
No violations recorded.

**CAST IN PLACE CONCRETE: CRACKS/SPALLING - MAJOR**

10  
S.F.  
REPAIR  
PRIORITY 3  
LEVEL 2

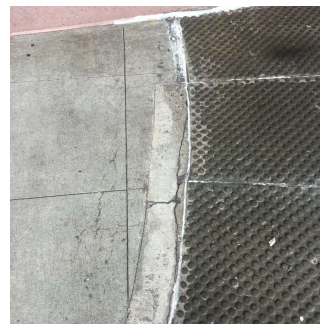
Facade A - Main Entrance  
No violations recorded.

**CONCRETE: WATER INFILTRATION IN NON-INSTRUCTIONAL SPACE BELOW**

20  
S.F.  
REPLACE  
PRIORITY 4  
LEVEL 2

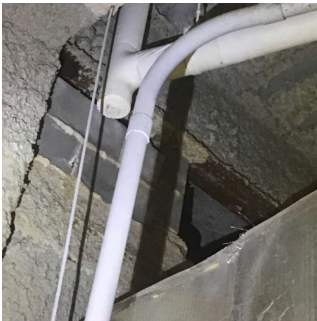
Violations	Basement - Room C06 (leak from Main Entrance Stairs) No violations recorded.
Deficiency	<b>CONCRETE: CRACKS/SPALLING - MINOR</b>
Roof Plan reference

100  
S.F.  
REPLACE  
PRIORITY 5  
LEVEL 2

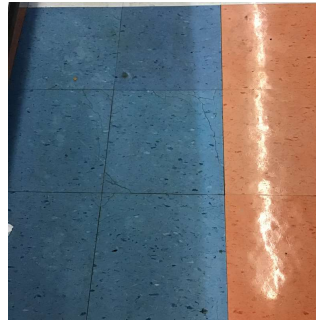
Near Room 111

VINYL TILES: BROKEN/DETERIORATED/MISSING TILES

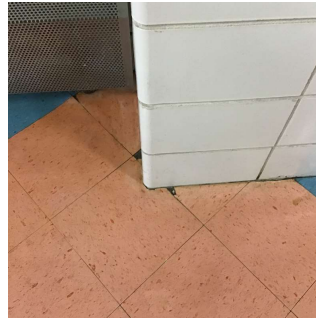
Near Entrance

CERAMIC TILE: BROKEN/ MISSING

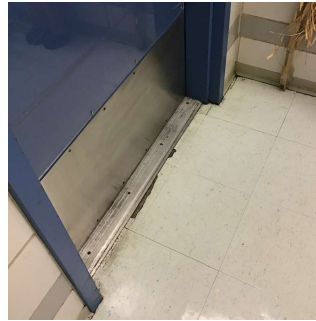
Corridor near Room 121

**EPOXY FLOORING: CRACKS/SPALLING**

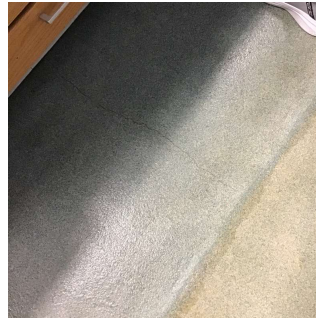
Room 321

**VINYL TILES: DETERIORATED SUBSTRATE**

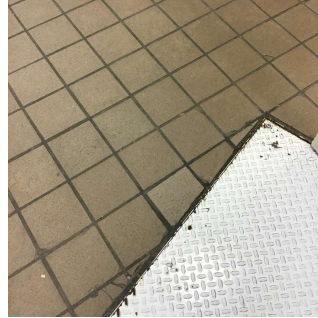
Servery

CERAMIC TILE: BROKEN/MISSING TILES  
Slop Room  
10  
S.F.  
REPLACE  
PRIORITY 3  
LEVEL 2
