NYC Department of Education
Building Condition Assessment Survey 2023 - 2024

Architectural Inspection

Asset: P.S. 72 - BROOKLYN, 605 SHEPHERD AVENUE, New York, 11208

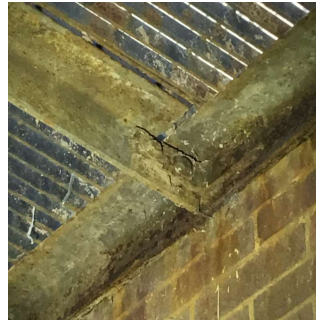
AW1
No violations recorded.

Question	Response
Architectural	
EXTERIOR	Inspected
AREAWAY	Inspected
Instance on AW1	Inspected
Instance Condition	4 - Between Fair and Poor
Instance Quantity	1
Instance Quantity Uom	EACH
Deficiency	AREAWAY GRATINGS: MAJOR RUSTING AND / OR BROKEN SUPPORTS
Roof Plan reference	K072
	<p>The diagram is a smaller version of the roof plan above, but with a red rectangular box highlighting the area labeled 'AW1' on the top edge of the building, near the courtyard.</p>
Deficiency Quantity	100
Quantity Uom	L.F.
Potential Action	REPLACE
Urgency of Action	PRIORITY 4
Purpose of Action	LEVEL 2

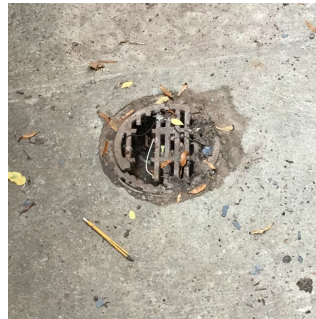
AW1
No violations recorded.

AREAWAY DRAINS: DETERIORATED

2
EACH
REPLACE
PRIORITY 4
LEVEL 2

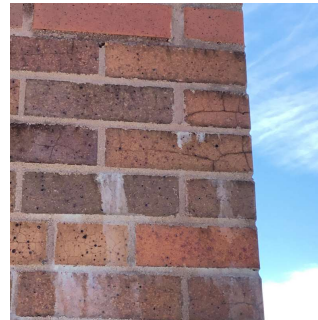
CH
No violations recorded.

BRICK: MINOR CRACKS AND SPALLING

30
S.F.
RESTITCH
PRIORITY 3
LEVEL 2

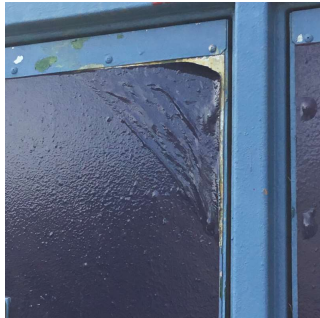
METAL CLAD: DETERIORATED DOOR - MAJOR DETERIORATION

5
EACH
REPLACE
PRIORITY 4

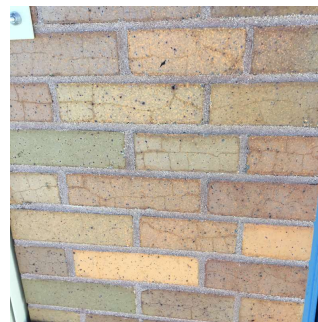
BH1
 No violations recorded.

Installation Year	2023
Source of Installation	Custodial Staff
Deficiency	No deficiencies recorded
ROOFING DRAINS	Inspected
Condition	1 - Good
Deficiency	No deficiencies recorded
Specialties	Inspected
BULKHEAD/PENTHOUSE	Inspected
Condition	3 - Fair
Deficiency	BULKHEAD/PENTHOUSE WALLS/EXTERIOR: CRACKS/SPALLING - MINOR

25
 S.F.
 REPAIR
 PRIORITY 3
 LEVEL 2

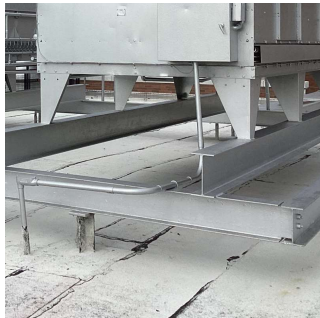
Violations	BH1 No violations recorded.
CUPOLA/ SPIRES/ TOWERS	Does not Exist
DORMER	Does not Exist
DUNNAGE STEEL	Inspected
Condition	3 - Fair
Deficiency	HEIGHT LESS THAN 18"
Roof Plan reference	K072 Berriman Street

Deficiency Quantity	60
Quantity Uom	L.F.
Potential Action	REPLACE
Urgency of Action	PRIORITY 3
Purpose of Action	LEVEL 2
Deficiency Photo1

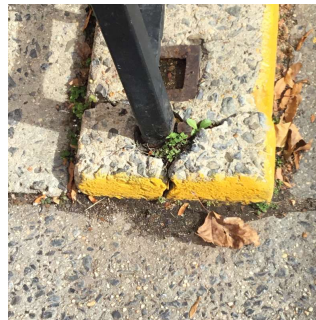
Facade D

CAST IN PLACE CONCRETE: CRACKS/SPALLING - MAJOR
K072

30
S.F.
REPLACE
PRIORITY 4
LEVEL 2

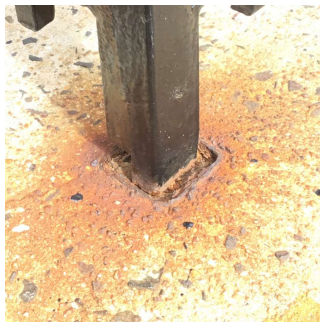
Violations	Facade D No violations recorded.
RAILINGS	Inspected
Condition	5 - Poor
Deficiency	RUST - MAJOR
Roof Plan reference	K072 Berriman Street

Blake Avenue Shepherd Avenue
Deficiency Quantity	10
Quantity Uom	L.F.
Potential Action	REPLACE
Urgency of Action	PRIORITY 4
Purpose of Action	LEVEL 2
Deficiency Photo1

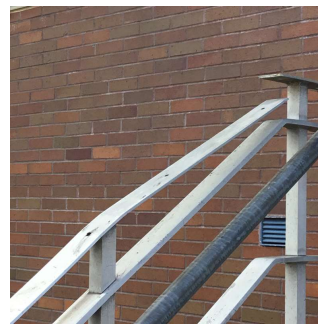
Facade C
No violations recorded.

Violations	Facade D No violations recorded.
Deficiency	DAMAGED

35
L.F.
REPLACE
PRIORITY 4
LEVEL 2

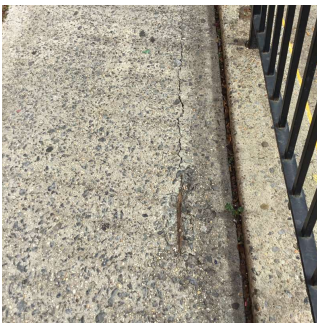
Violations	Facade D No violations recorded.
Deficiency	CONCRETE: CRACKS/SPALLING - MAJOR
Roof Plan reference	K072 Berriman Street

Blake Avenue Shepherd Avenue
Deficiency Quantity	45
Quantity Uom	S.F.
Potential Action	REPLACE
Urgency of Action	PRIORITY 4
Purpose of Action	LEVEL 2
Deficiency Photo1

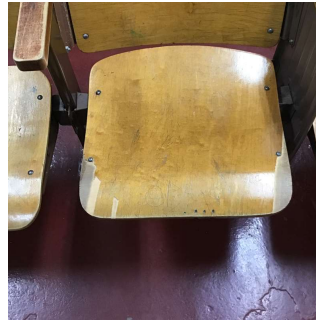
Seat A/6

Violations	No violations recorded.
FOUNDATION WALLS	
Material Type(s)	Inspected Concrete
Condition	2 - Between Good and Fair
Deficiency	No deficiencies recorded
ROOF STRUCTURE	
Condition	Inspected 2 - Between Good and Fair
Deficiency	No deficiencies recorded
VAULTS-BUNKERS	
Does not Exist	
AUDITORIUM	
Instance on 1st Floor (216 seats)	Inspected Inspected
Ceiling	
Instance on 1st Floor (216 seats)	Inspected
Condition	2 - Between Good and Fair
Deficiency	No deficiencies recorded
Door(s)	
Instance on 1st Floor (216 seats)	Inspected
Condition	2 - Between Good and Fair
Deficiency	No deficiencies recorded
Fixed H/C Lift	
Instance on 1st Floor (216 seats)	Does not Exist
Fixed Seating	
Instance on 1st Floor (216 seats)	Inspected
Condition	5 - Poor
Deficiency	DAMAGED/BROKEN/INOPERABLE
Deficiency Location/Instance	Seats A/6, B/2, D/8, E/22, F/18, and others

Deficiency Quantity	12
Quantity Uom	EACH
Potential Action	REPLACE
Urgency of Action	PRIORITY 3
Purpose of Action	LEVEL 2

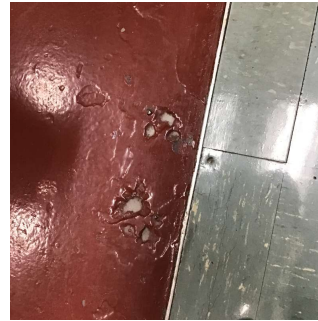
Near Entrance

VINYL TILES: DETERIORATED SUBSTRATE

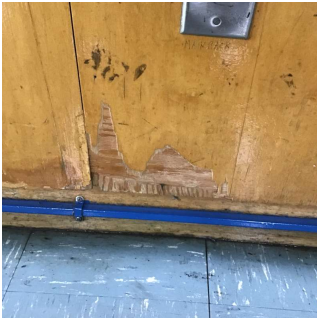
Question	Response
INTERIOR	
AUDITORIUM	
Stage	
Stage	
Violations	No violations recorded.
Deficiency	DAMAGED FASCIA
Deficiency Location/Instance	Near center, left side , right side
Deficiency Quantity	10
Quantity Uom	S.F.
Potential Action	REPLACE
Urgency of Action	PRIORITY 3
Purpose of Action	LEVEL 2
Deficiency Photo1

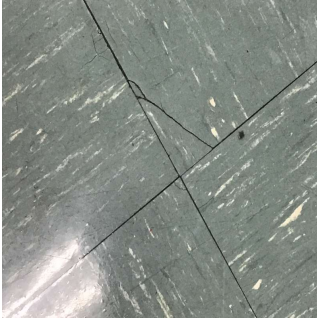
Question	Response
INTERIOR	
CAFETERIA	
Fixed Equipment	
Instance on 1st Floor	Does not Exist
Floor Finish	
Instance on 1st Floor	Inspected
Condition	2 - Between Good and Fair
Deficiency	VINYL TILES: BROKEN/DETERIORATED/MISSING TILES
Deficiency Location/Instance	Near entrance, center, windows, left side, right side
Deficiency Quantity	20
Quantity Uom	S.F.
Potential Action	REPLACE
Urgency of Action	PRIORITY 3
Purpose of Action	LEVEL 2
Deficiency Photo1

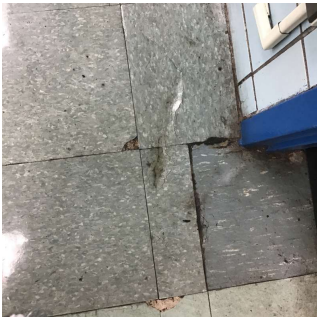
Violations	Near Entrance No violations recorded.
Deficiency	VINYL TILES: DETERIORATED SUBSTRATE
Deficiency Location/Instance	Near storage
Deficiency Quantity	50
Quantity Uom	S.F.
Potential Action	REPLACE
Urgency of Action	PRIORITY 3
Purpose of Action	LEVEL 2
Deficiency Photo1

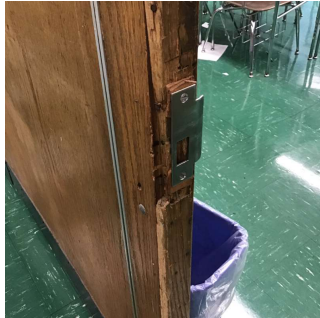
Corridor near Room 403
Violations	No violations recorded.
Door(s)	Inspected
Condition	5 - Poor
Deficiency	WOOD: DETERIORATED DOOR AND FRAME
Deficiency Location/Instance	Room 205, 203
Deficiency Quantity	2
Quantity Uom	EACH
Potential Action	MAINTENANCE
Urgency of Action	PRIORITY 3
Purpose of Action	LEVEL 2
Deficiency Photo1

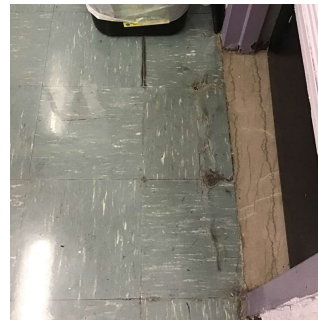
Corridor near Room 226

VINYL TILES: DETERIORATED SUBSTRATE

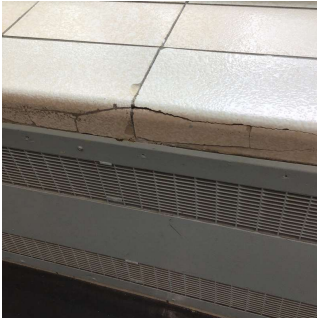
Exit 5
Violations	No violations recorded.
Walls	Inspected
Condition	2 - Between Good and Fair
Deficiency	GLAZED BLOCK: CRACKS/SPALLING
Deficiency Location/Instance	Corridor near Stair B/3, 2, Exit 8 Vestibule
Deficiency Quantity	20
Quantity Uom	S.F.
Potential Action	REPLACE
Urgency of Action	PRIORITY 3
Purpose of Action	LEVEL 2
Deficiency Photo1

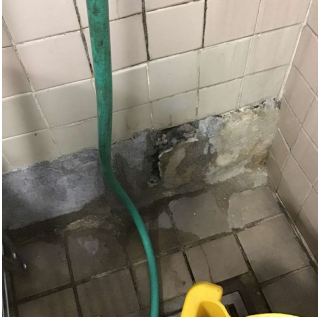
Violations	Storage No violations recorded.
Walls	
Instance on 1st Floor	Inspected
Condition	3 - Fair
Deficiency	CERAMIC TILE: BROKEN/ MISSING - ACTIVE LEAK
Deficiency Location/Instance	Kitchen Slop Sink
Deficiency Quantity	20
Quantity Uom	S.F.
Potential Action	REPLACE
Urgency of Action	PRIORITY 5
Purpose of Action	LEVEL 2
Deficiency Photo1

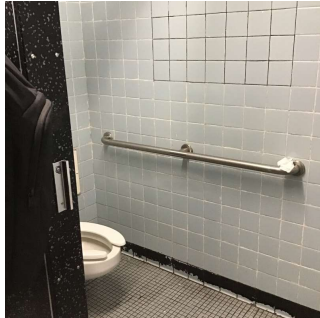
Violations	Room 406 No violations recorded.
Stalls	Inspected
Condition	2 - Between Good and Fair
Deficiency	BROKEN/MISSING
Deficiency Location/Instance	Near Room 421 - Boys, Rooms 226, 224
Deficiency Quantity	3
Quantity Uom	EACH
Potential Action	REPLACE
Urgency of Action	PRIORITY 3
Purpose of Action	LEVEL 2
Deficiency Photo1

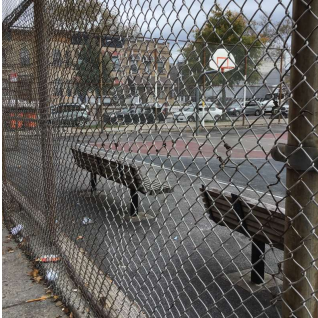
Violations	Schoolyard No violations recorded.
Deficiency	CHAIN LINK: MISSING SECTIONS
Deficiency Location/Instance	Schoolyard
Deficiency Quantity	50
Quantity Uom	S.F.
Potential Action	REPLACE
Urgency of Action	PRIORITY 3
Purpose of Action	LEVEL 2
Deficiency Photo1

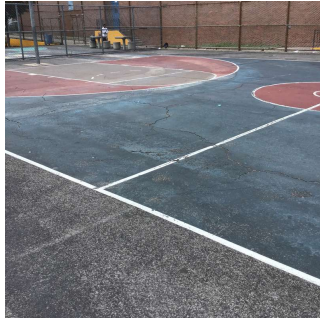
Violations	Schoolyard No violations recorded.
Deficiency	CRACKS - MAJOR
Deficiency Location/Instance	Schoolyard
Deficiency Quantity	1,800
Quantity Uom	S.F.
Potential Action	REPLACE
Urgency of Action	PRIORITY 3
Purpose of Action	LEVEL 2
Deficiency Photo1

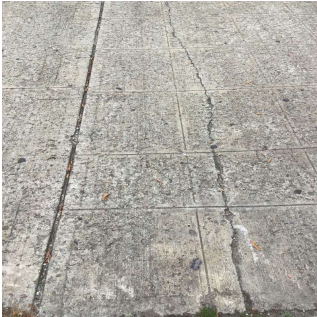
Violations	Along Blake Avenue No violations recorded.
Deficiency	DAMAGED/DETERIORATED/MISSING SECTIONS
Deficiency Location/Instance	Along Berriman Street, Blake Avenue, Shepherd Avenue, Dumont Avenue
Deficiency Quantity	2,100
Quantity Uom	S.F.
Potential Action	REPLACE
Urgency of Action	PRIORITY 3
Purpose of Action	LEVEL 2
Deficiency Photo1

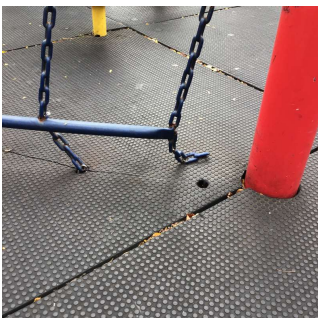
No	Protruding Elements	Severely damaged fence is a potential safety hazard.	SITE FENCES	Schoolyard	Jerry Torres	Fireman	 
No	Protruding Elements	Severely damaged play equipment is a potential safety hazard.	SITE PLAYGROUNDS Play Equipment	Center	Jerry Torres	Fireman

Near Equipment
Violations	No violations recorded.
Play Equipment	
Instance on Schoolyard	Inspected
Condition	5 - Poor
Deficiency	BROKEN/DETERIORATED/MISSING
Deficiency Location/Instance	Center
Deficiency Quantity	1
Quantity Uom	EACH
Potential Action	REPLACE
Urgency of Action	PRIORITY 5
Purpose of Action	LEVEL 6
Deficiency Photo1
