NYC Department of Education
Building Condition Assessment Survey 2023 - 2024

Architectural Inspection

K075

Asset: P.S. 75 - BROOKLYN, 95 GROVE STREET, New York, 11221

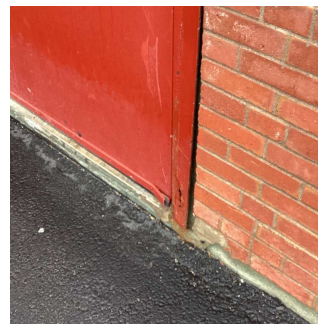
Facade C

Violations	Facade A - Main Entrance Vestibule No violations recorded.
CHIMNEY	Inspected
Material Type(s)	Masonry
Condition	2 - Between Good and Fair
Deficiency	No deficiencies recorded
COPING	Inspected
Condition	2 - Between Good and Fair
Deficiency	No deficiencies recorded
CORNICE	Inspected
Condition	2 - Between Good and Fair
Deficiency	No deficiencies recorded
DOORS	Inspected
DOORS AND FRAMES	Inspected
Condition	4 - Between Fair and Poor
Deficiency	METAL: DETERIORATED DOOR AND FRAME - MAJOR DETERIORATION

1
EACH
REPLACE
PRIORITY 4
LEVEL 2

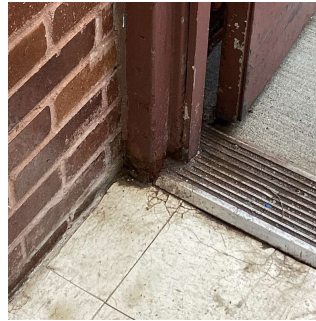
Facade C

METAL CLAD: DETERIORATED DOOR AND FRAME - MAJOR DETERIORATION

1
EACH
REPLACE
PRIORITY 4
LEVEL 2

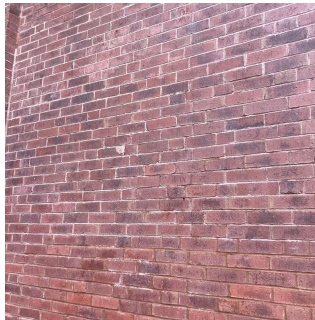
Facade C

BRICK: DETERIORATED JOINTS

150

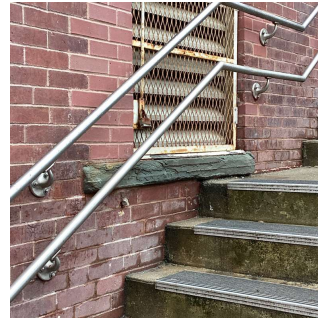
Facade C

BRICK: DETERIORATED MASONRY SILLS - MAJOR

REMOVE AND REPLACE

PRIORITY 4
LEVEL 2

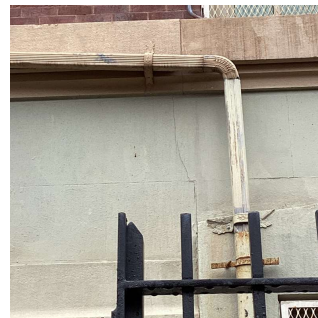
Facade A

STONE: CHIPPED/SPALLED/BROKEN PIECES - MINOR

REPAIR

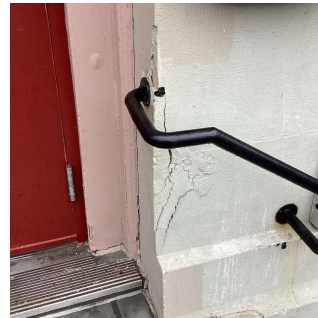
Facade A

STONE: CHIPPED/SPALLED/BROKEN PIECES - MAJOR

REPLACE

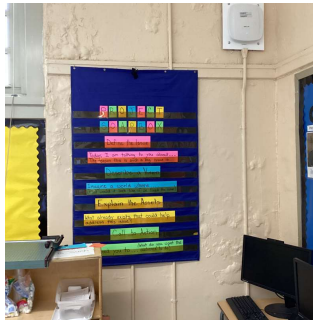
Facade A - Room 404

BRICK: WATER INFILTRATION IN INSTRUCTIONAL SPACE

REPAIR

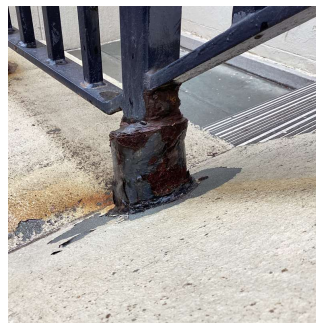
Facade A

STAIRS/RAMPS: EXTERIOR	Inspected
BUILDING CHEEK/FLANK WALLS	Inspected
Condition	2 - Between Good and Fair
Deficiency	No deficiencies recorded
RAILINGS	Inspected
Condition	3 - Fair
Deficiency	RUST - MAJOR

10
L.F.
REPLACE
PRIORITY 4
LEVEL 2

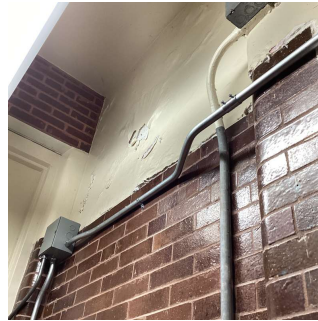
Facade C - Cafeteria Exit 9 Vestibule shown, Cafeteria Exit 8 Vestibule similar

CONCRETE: WATER INFILTRATION IN INSTRUCTIONAL SPACE BELOW

200
S.F.
REPLACE
PRIORITY 5
LEVEL 2

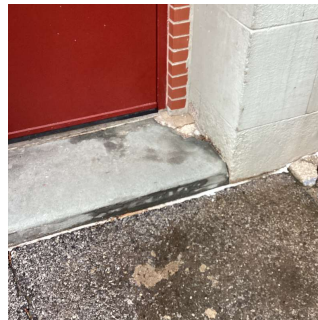
Facade B

STONE: CRACKS/SPALLING - MAJOR

REPLACE

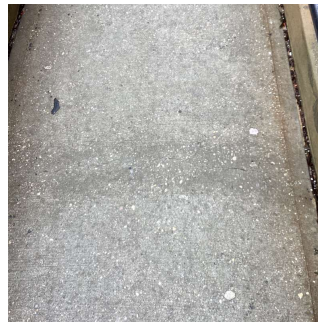
Facade C

CONCRETE: CRACKS/SPALLING - MINOR

20
S.F.
REPAIR
PRIORITY 3
LEVEL 2

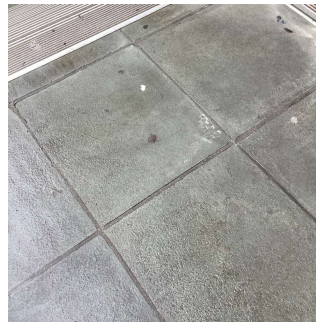
Facade A

STONE: DETERIORATED JOINTS

10
L.F.
REPOINT
PRIORITY 3
LEVEL 2

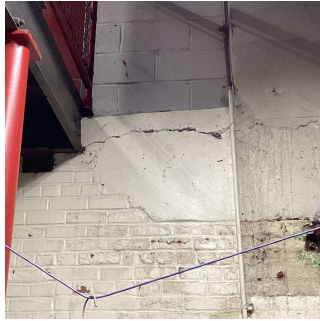
Violations	Boiler Room No violations recorded.
FOUNDATION WALLS	
Material Type(s)	Inspected Masonry
Condition	5 - Poor
Deficiency	BRICK: CRACKED/SPALLED
Deficiency Location/Instance	Basement - Boiler Room
Deficiency Quantity	20
Quantity Uom	S.F.
Potential Action	RESTITCH
Urgency of Action	PRIORITY 3
Purpose of Action	LEVEL 5
Deficiency Photo1

Violations	Boiler Room No violations recorded.
Deficiency	BRICK: WATER INFILTRATION IN NON- INSTRUCTIONAL SPACE
Deficiency Location/Instance	Basement - Boiler Room, Oil Tank Room, Room 010
Deficiency Quantity	500
Quantity Uom	S.F.
Potential Action	INSTALL WATERPROOFING
Urgency of Action	PRIORITY 5
Purpose of Action	LEVEL 5

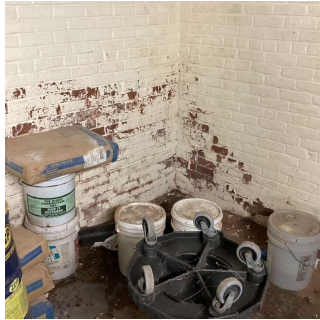
Boiler Room
	35672001L
Violations	
ROOF STRUCTURE	Inspected
Condition	2 - Between Good and Fair
Deficiency	No deficiencies recorded
VAULTS-BUNKERS	Inspected
Foundation Walls	Inspected
Condition	4 - Between Fair and Poor
Deficiency	WATER INFILTRATION IN NON- INSTRUCTIONAL SPACE
Deficiency Location/Instance	Basement - Vault
Deficiency Quantity	100
Quantity Uom	S.F.
Potential Action	INSTALL WATERPROOFING
Urgency of Action	PRIORITY 5
Purpose of Action	LEVEL 5
Deficiency Photo1

Vault
Violations	No violations recorded.
Deficiency	CRACKS, SPALLING
Deficiency Location/Instance	Basement - Electrical Panel Room
Deficiency Quantity	20
Quantity Uom	S.F.
Potential Action	REPAIR
Urgency of Action	PRIORITY 3
Purpose of Action	LEVEL 5

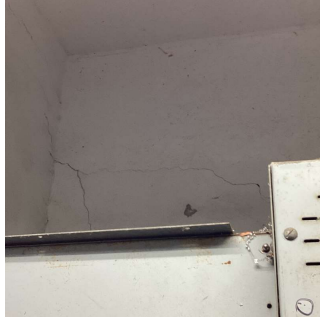
Question	Response
INTERIOR	
STRUCTURAL	
VAULTS-BUNKERS	
Foundation Walls	
Deficiency Photo1

Violations	Electrical Panel Room No violations recorded.
Deficiency	DETERIORATED JOINTS
Deficiency Location/Instance	Basement - Electrical Panel Room
Deficiency Quantity	50
Quantity Uom	S.F.
Potential Action	REPOINT
Urgency of Action	PRIORITY 3
Purpose of Action	LEVEL 5
Deficiency Photo1	 
Violations	Electrical Panel Room No violations recorded.
Slab Structure	Inspected
Condition	3 - Fair
Deficiency	CONCRETE SLAB ON GRADE: THRU CRACKS
Deficiency Location/Instance	Basement - Electrical Panel Room
Deficiency Quantity	30
Quantity Uom	S.F.
Potential Action	REPAIR
Urgency of Action	PRIORITY 3
Purpose of Action	LEVEL 5

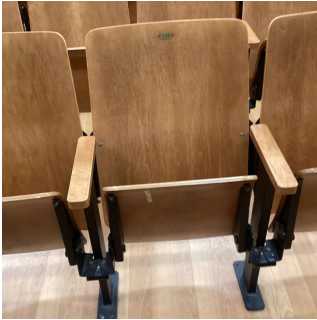
Question	Response
INTERIOR	
AUDITORIUM	
Fixed H/C Lift	
Deficiency Quantity	1
Quantity Uom	EACH
Potential Action	REPLACE
Urgency of Action	PRIORITY 3
Purpose of Action	LEVEL 2
Deficiency Photo1	No photo recorded
Violations	No violations recorded.
Fixed Seating	
Instance on 1st Floor (372 Seats)	Inspected
Condition	2 - Between Good and Fair
Deficiency	DAMAGED/BROKEN/INOPERABLE
Deficiency Location/Instance	Seat B/14,
Deficiency Quantity	1
Quantity Uom	EACH
Potential Action	REPLACE
Urgency of Action	PRIORITY 3
Purpose of Action	LEVEL 2
Deficiency Photo1

Seat B/101
Violations	No violations recorded.
Deficiency	DAMAGED/BROKEN/INOPERABLE
Deficiency Location/Instance	Seat A/1, C/101, E/6,103 J/124,
Deficiency Quantity	5
Quantity Uom	EACH
Potential Action	REPLACE
Urgency of Action	PRIORITY 5
Purpose of Action	LEVEL 6
Deficiency Photo1

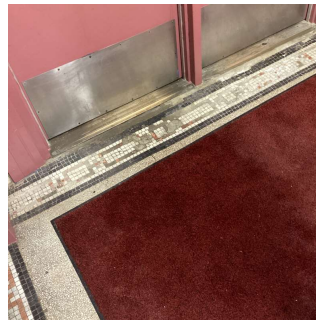
Main Entrance Vestibule

CERAMIC TILE: BROKEN/MISSING TILES

REPLACE

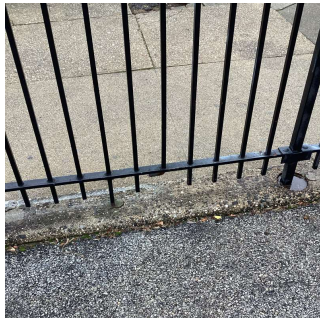
Question	Response
SITE	
FENCES	Inspected
Condition	4 - Between Fair and Poor
Deficiency	WROUGHT IRON: DAMAGED/DETERIORATED
Deficiency Location/Instance	Menahan Street
Deficiency Quantity	40
Quantity Uom	S.F.
Potential Action	REPLACE
Urgency of Action	PRIORITY 3
Purpose of Action	LEVEL 2
Deficiency Photo1

Violations	Menahan Street No violations recorded.
Deficiency	CHAIN LINK: RUST - MAJOR
Deficiency Location/Instance	Schoolyard
Deficiency Quantity	750
Quantity Uom	S.F.
Potential Action	REPLACE
Urgency of Action	PRIORITY 3
Purpose of Action	LEVEL 2
Deficiency Photo1

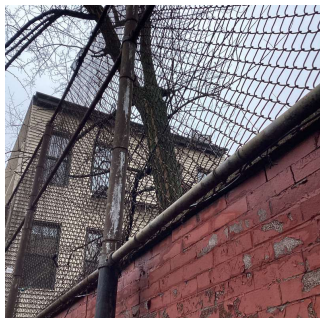
Violations	Schoolyard No violations recorded.
Deficiency	CONCRETE CURB: DAMAGED/DETERIORATED
Deficiency Location/Instance	Grove Street, Menahan Street , Evergreen Avenue
Deficiency Quantity	30
Quantity Uom	S.F.
Potential Action	REPLACE
Urgency of Action	PRIORITY 3
Purpose of Action	LEVEL 2

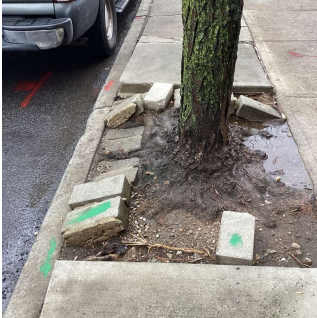
Violations	Exit 5 No violations recorded.
Pavers	Does not Exist
DOT Sidewalk	Inspected
Asphalt	Does not Exist
Concrete	Inspected
Condition	4 - Between Fair and Poor
Deficiency	HEAVING
Deficiency Location/Instance	Evergreen Avenue
Deficiency Quantity	50
Quantity Uom	S.F.
Potential Action	REPLACE
Urgency of Action	PRIORITY 5
Purpose of Action	LEVEL 6
Deficiency Photo1

Violations	Evergreen Avenue No violations recorded.
Deficiency	HEAVING

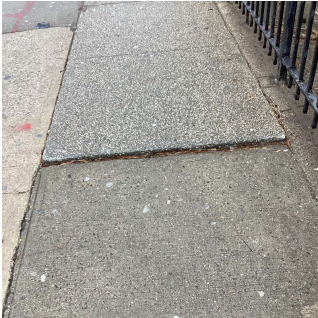
Question	Response
SITE	
PAVING	
DOT Sidewalk	
Concrete	
Deficiency Location/Instance	Menahan Street , Evergreen Avenue
Deficiency Quantity	150
Quantity Uom	S.F.
Potential Action	REPLACE
Urgency of Action	PRIORITY 3
Purpose of Action	LEVEL 2
Deficiency Photo1

Violations	Evergreen Avenue No violations recorded.
Deficiency	DAMAGED/DETERIORATED/MISSING SECTIONS
Deficiency Location/Instance	Grove Street, Menahan Street , Evergreen Avenue
Deficiency Quantity	925
Quantity Uom	S.F.
Potential Action	REPLACE
Urgency of Action	PRIORITY 3
Purpose of Action	LEVEL 2
Deficiency Photo1

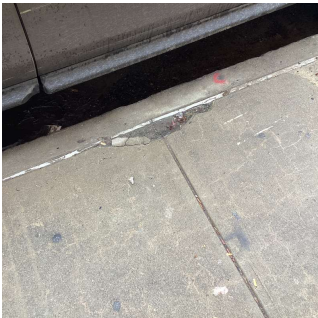
Violations	Grove Street No violations recorded.
Deficiency	DAMAGED CURBS
Deficiency Location/Instance	Grove Street
Deficiency Quantity	100
Quantity Uom	L.F.
Potential Action	REPLACE
Urgency of Action	PRIORITY 3
Purpose of Action	LEVEL 2
