NYC Department of Education
Building Condition Assessment Survey 2023 - 2024

Architectural Inspection

Asset: P.S. 86 - BROOKLYN, 220 IRVING AVENUE, New York, 11237

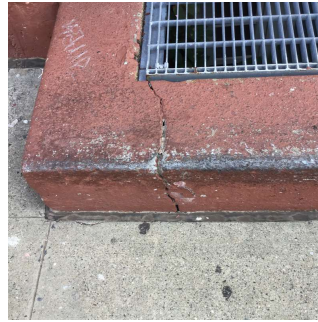
AW7

AREAWAY WALLS: DETERIORATED COPING STONE

10

REPAIR

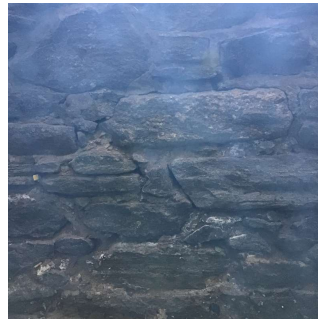
Areaway 5, 6

AREAWAY WALLS: DETERIORATED JOINTS

100

REPAIR

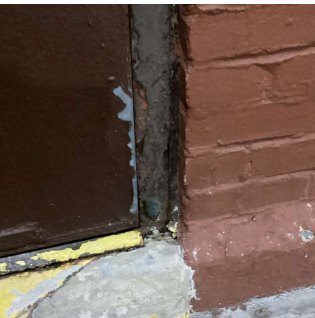
Question	Response
EXTERIOR	
DOORS	
DOORS AND FRAMES	Inspected
Condition	5 - Poor
Deficiency	METAL: DETERIORATED DOOR AND FRAME - MAJOR DETERIORATION
Roof Plan reference	<p>K086 Harman Street</p>

<p>Facade C - Exit 1</p>
Violations	No violations recorded.
Deficiency	METAL: DETERIORATED DOOR - MINOR DETERIORATION
Roof Plan reference	<p>K086 Harman Street</p>

Deficiency Quantity	3
Quantity Uom	EACH
Potential Action	REPLACE
Urgency of Action	PRIORITY 4
Purpose of Action	LEVEL 2
Deficiency Photo1

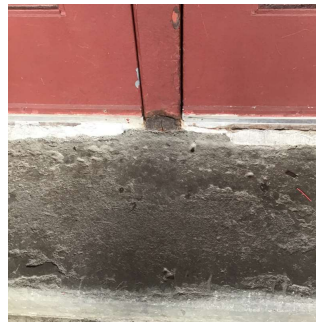
Facade A - Main Entrance

Deficiency Quantity	2
Quantity Uom	EACH
Potential Action	MAINTENANCE
Urgency of Action	PRIORITY 3
Purpose of Action	LEVEL 2

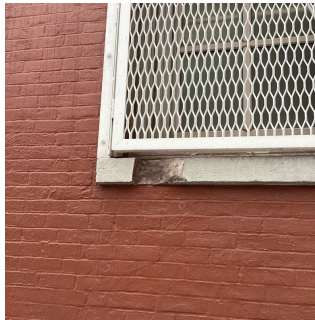
Facade F

BRICK: DETERIORATED MASONRY SILLS - MAJOR

10

REMOVE AND REPLACE

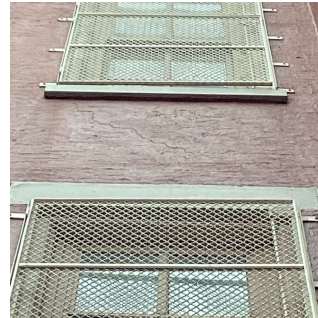
Facade E

BRICK: MINOR CRACKS AND SPALLING

30

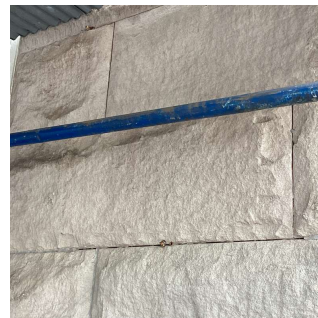
Facade A

STONE: DETERIORATED JOINTS

50

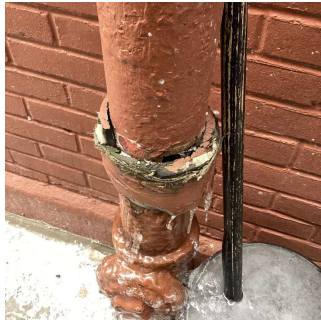
Question	Response
EXTERIOR	
ROOF	
Roofing	
Replacement Uom	S.F.
ROOF HATCH/SMOKE HATCH	
Condition	2 - Between Good and Fair
Deficiency	No deficiencies recorded
LEADERS, GUTTERS, DOWNSPOUTS, SCUPPERS	
Condition	3 - Fair
Deficiency	DAMAGED/MISSING
Roof Plan reference	<div style="display: flex; align-items: center;"> <div style="margin-right: 20px;"> <p>K086</p> <p>Harman Street</p> <p>Irving Avenue</p> </div>

<p>Facade E</p>
Violations	No violations recorded.
ROOF BARRIER/FENCE	
	Does not Exist
ROOF CAGE	
	Does not Exist
ROOFING	
	Inspected
Instance on Asphalt Shingle: Roofs 1 - 3	Inspected
Instance Condition	4 - Between Fair and Poor
Instance Photo

</div>
Deficiency Quantity	10
Quantity Uom	L.F.
Potential Action	REPLACE
Urgency of Action	PRIORITY 4
Purpose of Action	LEVEL 2
Deficiency Photo1

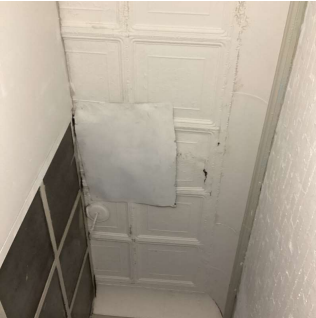
Question	Response
EXTERIOR	
ROOF	
Roofing	
ROOFING	
Does the roof have major mechanical equipment sitting on Dunnage Steel less than 18" above the Roofing?	No
Does this roof instance have a Sustainable Roof System?	No
Do solar panels exist on these roofs?	No
Is/Are the roof(s) suitable for Solar Panel installation?	No
Installation Year	2013
Source of Installation	Custodial Staff
Deficiency	ASPHALT SHINGLE: ROOFING: MAJOR ACTIVE ROOF LEAKS IN INSTRUCTIONAL SPACE
Roof Plan reference	K086

Violations	Roof 2 - Stair C/4 (shown), Roof 3 - Room 401 (similar) No violations recorded.
ROOFING DRAINS	Does not Exist
Specialties	Inspected
BULKHEAD/PENTHOUSE	Does not Exist
CUPOLA/ SPIRES/ TOWERS	Does not Exist
DORMER	Inspected
Condition	2 - Between Good and Fair
Deficiency	No deficiencies recorded

Deficiency Quantity	200
Quantity Uom	S.F.
Potential Action	REPLACE ROOFING
Urgency of Action	PRIORITY 5
Purpose of Action	LEVEL 2
Deficiency Photo1

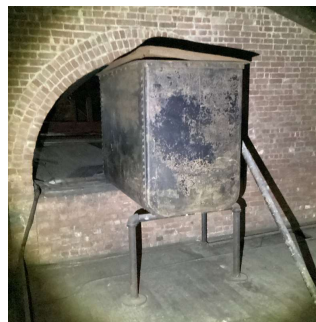
Attic
No violations recorded.

DUNNAGE STEEL	Does not Exist
SKYLIGHT/ROOF VENT	Does not Exist
ROOF/GRAVITY TANK	Inspected
Condition	3 - Fair
Deficiency	TANK: NOT IN USE - MAJOR DETERIORATION

ROOF/GRAVITY TANK

2
EACH
REMOVE
PRIORITY 1
LEVEL 1

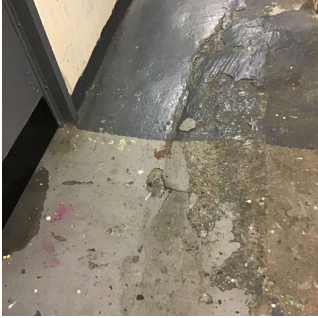
Question	Response
INTERIOR	
POOLS	Does not Exist
STRUCTURAL	Inspected
COLUMNS/BEAMS/BEARING WALLS	Inspected
Condition	3 - Fair
Deficiency	STEEL COLUMNS/BEAMS: DETERIORATED CONCRETE FIREPROOFING
Deficiency Location/Instance	Basement - Oil Tank Room
Deficiency Quantity	10
Quantity Uom	S.F.
Potential Action	REPLACE
Urgency of Action	PRIORITY 4
Purpose of Action	LEVEL 5
Deficiency Photo1	 
	Oil Tank Room
Violations	No violations recorded.
FLOOR STRUCTURE	Inspected
Condition	3 - Fair
Deficiency	CONCRETE SLAB ON GRADE: THRU CRACKS
Deficiency Location/Instance	Basement Entrance
Deficiency Quantity	10
Quantity Uom	S.F.
Potential Action	REPAIR
Urgency of Action	PRIORITY 3
Purpose of Action	LEVEL 5
Deficiency Photo1

Basement Entrance
Violations	No violations recorded.
Deficiency	CONCRETE: CRACKS/SPALLED/REINFORCEMENT EXPOSED
Deficiency Location/Instance	Basement Main Storage Room
Deficiency Quantity	10
Quantity Uom	S.F.
Potential Action	REPAIR

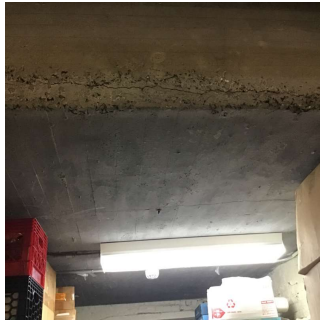
Basements Main Storage Room
Violations	No violations recorded.
FOUNDATION WALLS	
Material Type(s)	Inspected Masonry
Condition	5 - Poor
Deficiency	STONE RUBBLE: WATER INFILTRATION IN ELECTRICAL PANEL ROOM
Deficiency Location/Instance	Basement - Electrical Panel Room
Deficiency Quantity	100
Quantity Uom	S.F.
Potential Action	INSTALL WATERPROOFING
Urgency of Action	PRIORITY 5
Purpose of Action	LEVEL 6
Deficiency Photo1

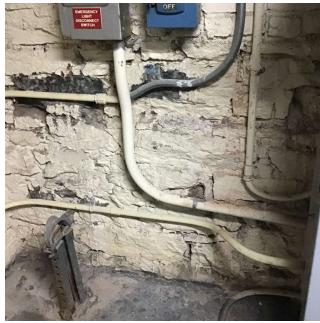
Electrical Panel Room
Violations	35672518Y
Deficiency	BRICK: DETERIORATED JOINTS
Deficiency Location/Instance	Basement - Gas Meter Room
Deficiency Quantity	100
Quantity Uom	S.F.
Potential Action	REPOINT
Urgency of Action	PRIORITY 3
Purpose of Action	LEVEL 5

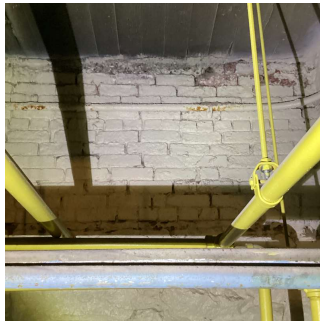
Violations	Gas Meter Room No violations recorded.
Deficiency	STONE RUBBLE: WATER INFILTRATION IN NON-INSTRUCTIONAL SPACE
Deficiency Location/Instance	Kitchen Storage Room, Area Outside Kitchen Storage near Areaway 7, Boiler Room, Corridor Outside Boiler Room, Paint Room, Oil Tank Room
Deficiency Quantity	600
Quantity Uom	S.F.
Potential Action	INSTALL WATERPROOFING
Urgency of Action	PRIORITY 5
Purpose of Action	LEVEL 5
Deficiency Photo1

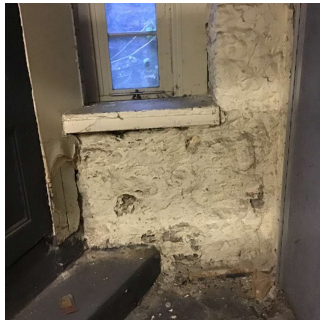
Violations	Area Outside Kitchen Storage near Areaway No violations recorded.
ROOF STRUCTURE	Inspected
Condition	2 - Between Good and Fair
Deficiency	No deficiencies recorded
VAULTS-BUNKERS	Inspected
Foundation Walls	Inspected
Condition	2 - Between Good and Fair
Deficiency	No deficiencies recorded
Slab Structure	Inspected
Condition	2 - Between Good and Fair
Deficiency	No deficiencies recorded
Vault/Ash Hoist Doors and Framing	Inspected

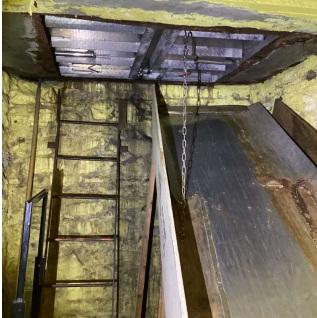
Condition	5 - Poor
Deficiency	WATER INFILTRATION
Deficiency Location/Instance	Basement - Kitchen Storage Room Vault
Deficiency Quantity	10
Quantity Uom	S.F.

Question	Response
INTERIOR	
STRUCTURAL	
VAULTS-BUNKERS	
Vault/Ash Hoist Doors and Framing	
Potential Action	REPAIR
Urgency of Action	PRIORITY 5
Purpose of Action	LEVEL 2
Deficiency Photo1

Violations	Basement - Kitchen Storage Room Vault No violations recorded.
Deficiency	DETERIORATED/DAMAGED VAULT/ASH HOIST DOORS AND FRAMING
Deficiency Location/Instance	Basement - Boiler Room Vault
Deficiency Quantity	2
Quantity Uom	EACH
Potential Action	REPLACE
Urgency of Action	PRIORITY 4
Purpose of Action	LEVEL 2
Deficiency Photo1

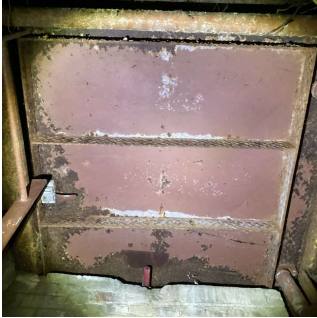
Violations	Basement - Boiler Room Vault No violations recorded.
AUDITORIUM	Does not Exist
CAFETERIA	Inspected
Instance on 1st Floor (800 SF)	Inspected
Ceiling	
Instance on 1st Floor (800 SF)	Inspected
Condition	2 - Between Good and Fair
Deficiency	No deficiencies recorded
Door(s)	
Instance on 1st Floor (800 SF)	Inspected
Condition	2 - Between Good and Fair
Deficiency	No deficiencies recorded
Fixed Equipment

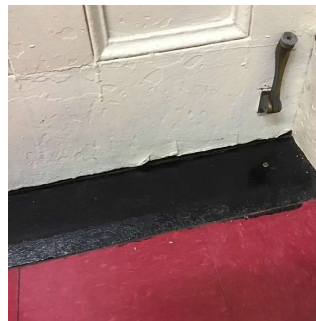
Room 408

METAL CLAD WOOD: DETERIORATED DOOR

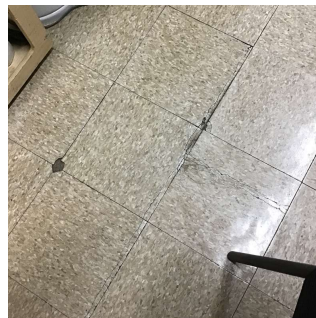
VINYL TILES: DETERIORATED SUBSTRATE

Question	Response
INTERIOR	
CLASSROOMS/CORRIDORS/ADMIN SPACES	
Floor Finish	
Violations	Room 310 No violations recorded.
Deficiency	VINYL TILES: BROKEN/DETERIORATED/MISSING TILES
Deficiency Location/Instance	Room 203
Deficiency Quantity	15
Quantity Uom	S.F.
Potential Action	REPLACE
Urgency of Action	PRIORITY 3
Purpose of Action	LEVEL 2
Deficiency Photo1

REPLACE

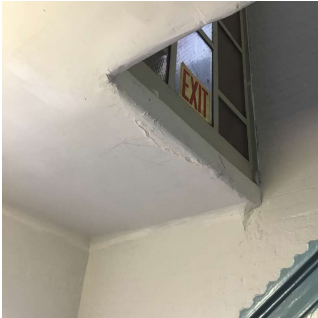
Question	Response
INTERIOR	
STAIRS/RAMPS: INTERIOR	
Ceiling	Inspected
Condition	2 - Between Good and Fair
Deficiency	PLASTER: CRACKS/SPALLING
Deficiency Location/Instance	Stair C/4
Deficiency Quantity	10
Quantity Uom	S.F.
Potential Action	REPLACE
Urgency of Action	PRIORITY 3
Purpose of Action	LEVEL 2
Deficiency Photo1

Violations	Stair C/4 No violations recorded.
Deficiency	METAL PAN: DAMAGED/MISSING - ACTIVE LEAK
Deficiency Location/Instance	Stair C/4
Deficiency Quantity	10
Quantity Uom	S.F.
Potential Action	REPLACE
Urgency of Action	PRIORITY 5
Purpose of Action	LEVEL 2
Deficiency Photo1

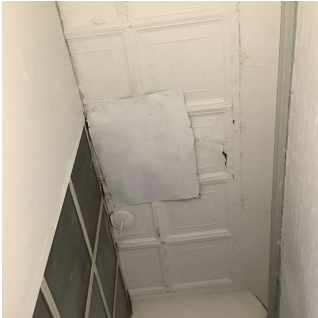
Violations	Stair C/4 No violations recorded.
Door(s)	Inspected
Condition	2 - Between Good and Fair
Deficiency	No deficiencies recorded
Partition	Inspected
Condition	2 - Between Good and Fair
Deficiency	GLASS PANEL: DAMAGED/DETERIORATED
Deficiency Location/Instance	Stair C/1,3
Deficiency Quantity	10
Quantity Uom	S.F.
Potential Action	REPLACE

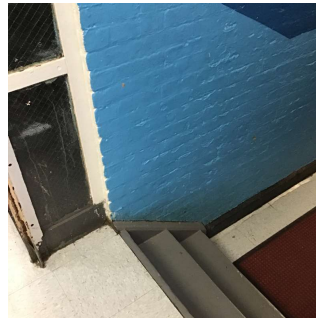
Stair D/1

METAL: MISSING

REPLACE

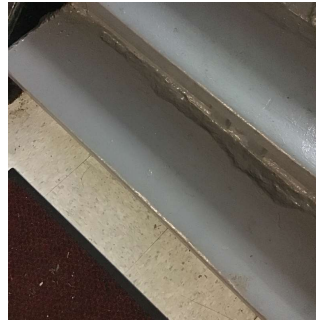
Stair C/1

STONE: BROKEN/MISSING

REPLACE

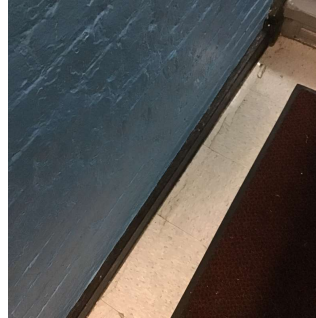
Stair C/1

VINYL TILES: BROKEN/DETERIORATED/MISSING TILES

REPLACE

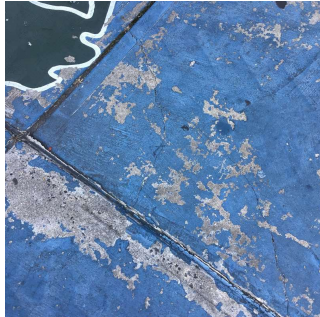
Question	Response
SITE	
FENCES	Inspected
Violations	No violations recorded.
IRRIGATION SYSTEM	Does not Exist
PAVING	Inspected
Student Non-Use	Inspected
Gravel Exists?	No
Asphalt	Does not Exist
Concrete	Inspected
Condition	3 - Fair
Deficiency	DAMAGED/DETERIORATED/MISSING SECTIONS
Deficiency Location/Instance	Rear of Building
Deficiency Quantity	50
Quantity Uom	S.F.
Potential Action	REPLACE
Urgency of Action	PRIORITY 3
Purpose of Action	LEVEL 2
Deficiency Photo1	 
Violations	Rear of Building No violations recorded.
Pavers	Does not Exist
Student Use	Inspected
Gravel Exists?	No
Asphalt	Does not Exist
Concrete	Inspected
Condition	3 - Fair
Deficiency	DAMAGED/DETERIORATED/MISSING SECTIONS
Deficiency Location/Instance	Harman Street Schoolyard, East Schoolyard
Deficiency Quantity	325
Quantity Uom	S.F.
Potential Action	REPLACE
Urgency of Action	PRIORITY 3
Purpose of Action	LEVEL 2

Violations	Harman Street Schoolyard No violations recorded.
Pavers	Does not Exist
Site Sidewalks & Walkways	Inspected
Asphalt	Does not Exist
Concrete	Inspected
Condition	2 - Between Good and Fair
Deficiency	No deficiencies recorded
Pavers	Does not Exist
DOT Sidewalk	Inspected
Asphalt	Does not Exist
Concrete	Inspected
Condition	4 - Between Fair and Poor
Deficiency	HEAVING
Deficiency Location/Instance	Harman Street
Deficiency Quantity	50
Quantity Uom	S.F.
Potential Action	REPLACE
Urgency of Action	PRIORITY 4
Purpose of Action	LEVEL 4
Deficiency Photo1

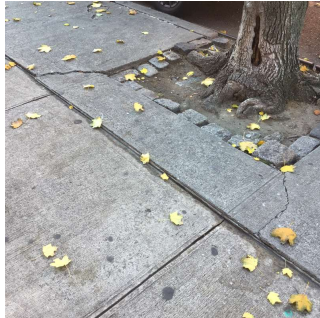
Violations	Harman Street 56730
Deficiency	DAMAGED CURBS
Deficiency Location/Instance	Irving Avenue, Harman Street
Deficiency Quantity	75
Quantity Uom	L.F.
Potential Action	REPLACE
Urgency of Action	PRIORITY 4

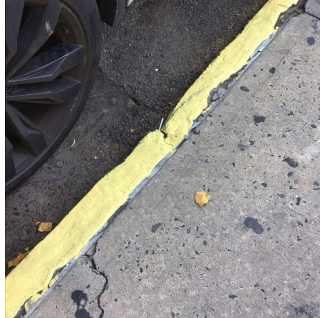
Irving Avenue
	56730
Violations	
Deficiency	DAMAGED/DETERIORATED/MISSING SECTIONS
Deficiency Location/Instance	Irving Avenue, Harman Street
Deficiency Quantity	475
Quantity Uom	S.F.
Potential Action	REPLACE
Urgency of Action	PRIORITY 4
Purpose of Action	LEVEL 4
Deficiency Photo1

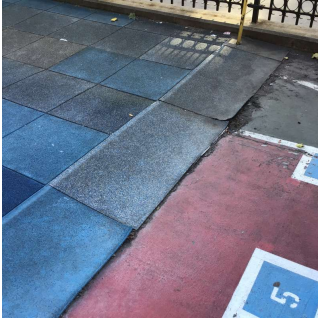
Question	Response
SITE	
PLAYGROUNDS	
Safety Surfacing	
Deficiency	DETERIORATED/MISSING
Deficiency Location/Instance	Right Side, Left Side, Center
Deficiency Quantity	30
Quantity Uom	S.F.
Potential Action	REPLACE
Urgency of Action	PRIORITY 3
Purpose of Action	LEVEL 2
Deficiency Photo1

Violations	Right Side No violations recorded.
Unpaved Area	
Instance on North Schoolyard	Does not Exist
PLAYING SURFACE	Does not Exist
RETAINING WALLS	Does not Exist
SEATING	Inspected
Benches	Inspected
Concrete	Does not Exist
Metal/Wood/Plastic	Inspected
Condition	1 - Good
Deficiency	No deficiencies recorded
Bleachers	Does not Exist
SITE WALLS (NOT RETAINING WALLS)	Inspected
Condition	2 - Between Good and Fair
Deficiency	No deficiencies recorded
STAIRS/RAMPS: EXTERIOR	Does not Exist
ARTWORK	Does not Exist
