NYC Department of Education
Building Condition Assessment Survey 2023 - 2024

Architectural Inspection

Asset: I.S. 88 - BROOKLYN, 544 7TH AVENUE, New York, 11215

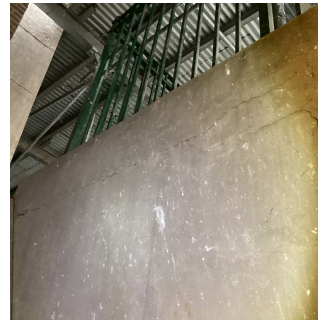
AW2
No violations recorded.

Question	Response
Architectural	
EXTERIOR	Inspected
AREAWAY	Inspected
Instance on AW1 - AW2	Inspected
Instance Condition	3 - Fair
Instance Quantity	2
Instance Quantity Uom	EACH
Deficiency	AREAWAY WALLS: CRACKS AND SPALLING

30
S.F.
REPAIR
PRIORITY 3
LEVEL 2

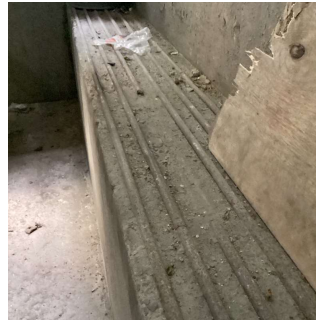
AW1
No violations recorded.

AREAWAY STAIRS: DETERIORATED MATERIAL SLIDE

10
S.F.
REPLACE
PRIORITY 3
LEVEL 2

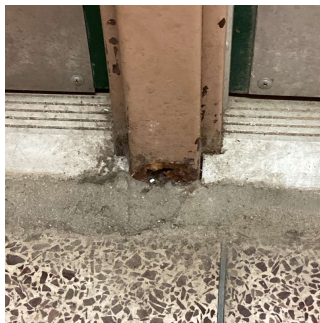
Deficiency METAL: DETERIORATED DOOR AND FRAME - MAJOR DETERIORATION

Violations	Facade B - Stair D Exit No violations recorded.
Deficiency	METAL: DETERIORATED DOOR AND FRAME - MINOR DETERIORATION
Roof Plan reference

Deficiency Quantity	4
Quantity Uom	EACH
Potential Action	REPLACE
Urgency of Action	PRIORITY 4
Purpose of Action	LEVEL 2

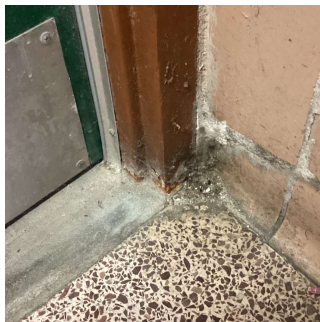
Violations	Facade A - Exit E No violations recorded.
DOOR HARDWARE	
Condition	Inspected
Deficiency	3 - Fair
LINTELS	
Condition	Inspected
Deficiency	2 - Between Good and Fair
TRANSOM/SIDE LIGHT	
Condition	Inspected
Deficiency	2 - Between Good and Fair
Deficiency	No deficiencies recorded

Deficiency Quantity	6
Quantity Uom	EACH
Potential Action	MAINTENANCE
Urgency of Action	PRIORITY 3
Purpose of Action	LEVEL 2
Deficiency Photo1

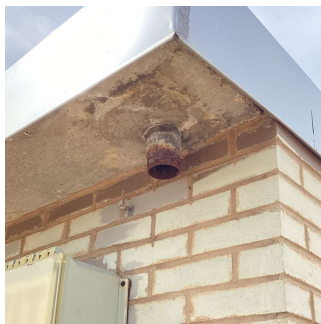
Question	Response
EXTERIOR	
PARAPETS	Inspected
Material Type(s)	Masonry
Replacement Quantity	12,000
Replacement Uom	C.F.
Instance on All Roofs	Under Construction
Instance Quantity	12,000
Instance Quantity Uom	C.F.
PLAZA DECK	Does not Exist
ROOF	Inspected
Roofing	Inspected
Replacement Quantity	60,000
Replacement Uom	S.F.
ROOF HATCH/SMOKE HATCH	Inspected
Condition	2 - Between Good and Fair
Deficiency	No deficiencies recorded
LEADERS, GUTTERS, DOWNSPOUTS, SCUPPERS	Inspected
Condition	3 - Fair
Deficiency	DAMAGED/MISSING
Roof Plan reference

Deficiency Quantity	10
Quantity Uom	L.F.
Potential Action	REPLACE
Urgency of Action	PRIORITY 4
Purpose of Action	LEVEL 2
Deficiency Photo1

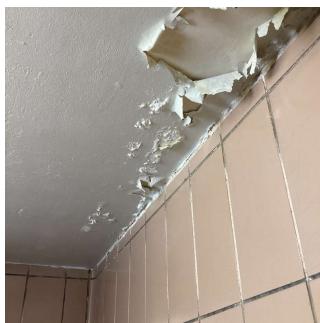
Roof 1
Instance Quantity	60,000
Instance Quantity Uom	S.F.
ROOFING DRAINS	Inspected
Condition	2 - Between Good and Fair
Deficiency	No deficiencies recorded
Specialties	Inspected
BULKHEAD/PENTHOUSE	Inspected
Condition	3 - Fair
Deficiency	BULKHEAD/PENTHOUSE CEILING: PLASTER DAMAGED/DETERIORATED
Roof Plan reference

BH4
Violations	No violations recorded.
Deficiency	BULKHEAD/PENTHOUSE ROOF: MINOR LEAKAGE

Deficiency Quantity	20
Quantity Uom	S.F.
Potential Action	REPLACE
Urgency of Action	PRIORITY 3
Purpose of Action	LEVEL 2
Deficiency Photo1

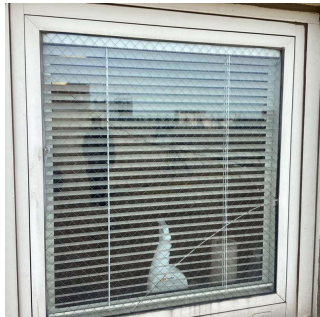
BH2
Violations	No violations recorded.
Deficiency	BULKHEAD/PENTHOUSE WINDOWS: DAMAGED, DETERIORATED WINDOWS
Roof Plan reference

BH2
Violations	No violations recorded.
CUPOLA/ SPIRES/ TOWERS	Does not Exist
DORMER	Does not Exist
DUNNAGE STEEL	Does not Exist
SKYLIGHT/ROOF VENT	Inspected
Material Type(s)	Glass
Condition	2 - Between Good and Fair
Deficiency	No deficiencies recorded

Deficiency Quantity	10
Quantity Uom	S.F.
Potential Action	REPLACE
Urgency of Action	PRIORITY 4
Purpose of Action	LEVEL 2
Deficiency Photo1

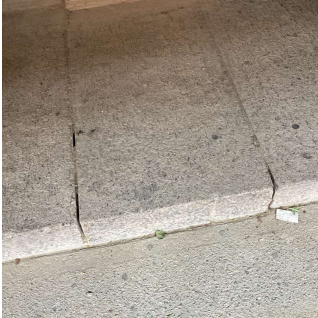
Deficiency	STONE: DETERIORATED JOINTS
RooF Plan reference

Violations	Facade B - Stair D Exit No violations recorded.
Deficiency	STONE: DETERIORATED JOINTS
Roof Plan reference

Question	Response
EXTERIOR	
STAIRS/RAMPS: EXTERIOR	Inspected
STAIRS/RAMPS	
Quantity Uom	L.F.
Potential Action	REPOINT
Urgency of Action	PRIORITY 3
Purpose of Action	LEVEL 2
Deficiency Photo1

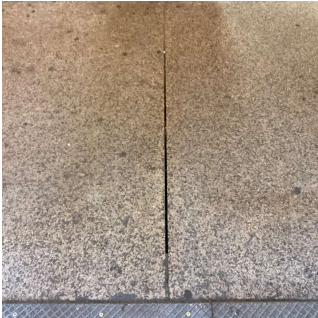
Violations	Facade A - Main Entrance No violations recorded.
WINDOWS	Inspected
Replacement Quantity	20,000
Replacement Uom	S.F.
EXTERIOR GUARDS	Under Construction
LINTELS	Inaccessible

Deficiency Quantity	10
Quantity Uom	L.F.
Potential Action	REPOINT
Urgency of Action	PRIORITY 4
Purpose of Action	LEVEL 2
Deficiency Photo1

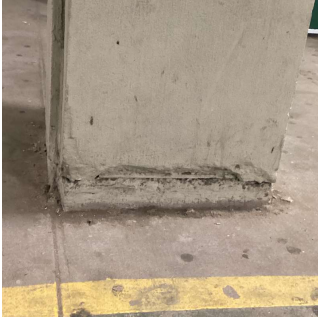
Deficiency	STEEL COLUMNS/BEAMS: DETERIORATED CONCRETE FIREPROOFING
------------	--

Question	Response
INTERIOR	
STRUCTURAL	
COLUMNS/BEAMS/BEARING WALLS	
Deficiency Location/Instance	Schoolyard facing 19th Street
Deficiency Quantity	10
Quantity Uom	S.F.
Potential Action	REPLACE
Urgency of Action	PRIORITY 4
Purpose of Action	LEVEL 5
Deficiency Photo1

Violations	Schoolyard facing 19th Street No violations recorded.
FLOOR STRUCTURE	
Condition	Inspected
Deficiency	3 - Fair
Deficiency Location/Instance	CONCRETE: CRACKS/SPALLED/REINFORCEMENT EXPOSED Mechanical Equipment Room 233A, Basement - Room B59
Deficiency Quantity	30
Quantity Uom	S.F.
Potential Action	REPAIR
Urgency of Action	PRIORITY 3
Purpose of Action	LEVEL 5
Deficiency Photo1

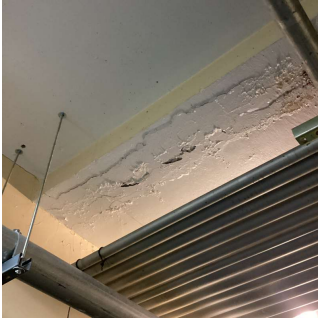
Violations	Basement - Room B59 No violations recorded.
Deficiency	CONCRETE SLAB ON GRADE: THRU CRACKS
Deficiency Location/Instance	Basement - Boiler Room, Rooms B2, B59B, Corridor
Deficiency Quantity	250
Quantity Uom	S.F.
Potential Action	REPAIR
Urgency of Action	PRIORITY 3

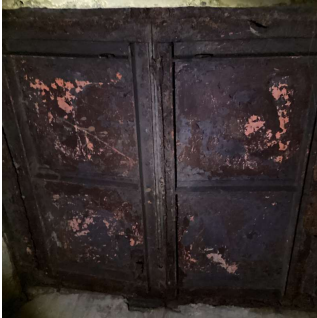
Violations	Facade B - Vault No violations recorded.
Slab Structure	
Condition	Inspected 2 - Between Good and Fair
Deficiency	No deficiencies recorded
Vault/Ash Hoist Doors and Framing	
Condition	Inspected 5 - Poor
Deficiency	DETERIORATED/DAMAGED VAULT/ASH HOIST DOORS AND FRAMING

Question	Response
INTERIOR	
STRUCTURAL	
VAULTS-BUNKERS	
Vault/Ash Hoist Doors and Framing	
Deficiency Quantity	2
Quantity Uom	EACH
Potential Action	REPLACE
Urgency of Action	PRIORITY 4
Purpose of Action	LEVEL 2
Deficiency Photo1

Violations	Facade B - Vault No violations recorded.
AUDITORIUM	
Instance on 1st Floor (500 Seats)	Inspected
Instance on 1st Floor (500 Seats)	Inspected
Ceiling	
Instance on 1st Floor (500 Seats)	Inspected
Condition	2 - Between Good and Fair
Deficiency	PLASTER: CRACKS/SPALLING
Deficiency Location/Instance	Near Seat U/11
Deficiency Quantity	10
Quantity Uom	S.F.
Potential Action	REPLACE
Urgency of Action	PRIORITY 3
Purpose of Action	LEVEL 2
Deficiency Photo1

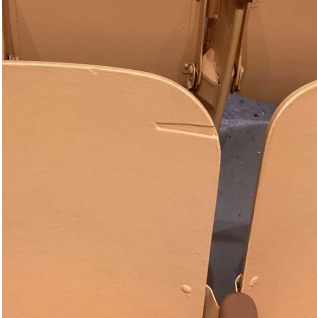
Question	Response
INTERIOR	
AUDITORIUM	
Fixed Seating	
Instance on 1st Floor (500 Seats)	Inspected
Condition	2 - Between Good and Fair
Deficiency	DAMAGED/BROKEN/INOPERABLE
Deficiency Location/Instance	Seats A/101,102,104,105,111, and others
Deficiency Quantity	10
Quantity Uom	EACH
Potential Action	REPLACE
Urgency of Action	PRIORITY 3
Purpose of Action	LEVEL 2
Deficiency Photo1

Violations	Seat A/102 No violations recorded.
Deficiency	DAMAGED/BROKEN/INOPERABLE
Deficiency Location/Instance	Seats C/102, E/101
Deficiency Quantity	2
Quantity Uom	EACH
Potential Action	REPLACE
Urgency of Action	PRIORITY 5
Purpose of Action	LEVEL 6
Deficiency Photo1

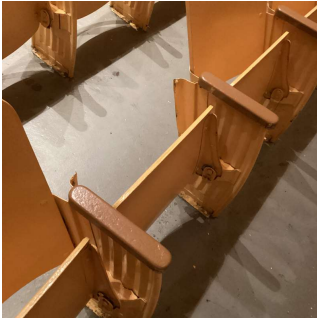
Violations	Seat C/102 No violations recorded.
Floor Finish	
Instance on 1st Floor (500 Seats)	Inspected
Condition	2 - Between Good and Fair
Deficiency	No deficiencies recorded
Sliding-folding Partition	
Instance on 1st Floor (500 Seats)	Does not Exist
Stage	
Instance on 1st Floor (500 Seats)	Inspected

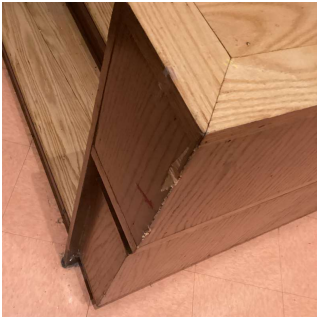
Question	Response
INTERIOR	
AUDITORIUM	
Stage	
Stage	
Instance on 1st Floor (500 Seats)	Inspected
Condition	2 - Between Good and Fair
Deficiency	DAMAGED FASCIA
Deficiency Location/Instance	Right Stage
Deficiency Quantity	10
Quantity Uom	S.F.
Potential Action	REPLACE
Urgency of Action	PRIORITY 3
Purpose of Action	LEVEL 2
Deficiency Photo1

Right Stage
Violations	No violations recorded.
Deficiency	DAMAGED STEPS
Deficiency Location/Instance	Right Stage
Deficiency Quantity	10
Quantity Uom	S.F.
Potential Action	REPLACE
Urgency of Action	PRIORITY 3
Purpose of Action	LEVEL 2
Deficiency Photo1

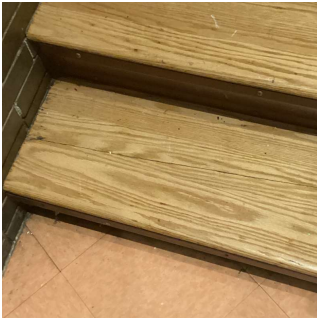
Right Stage
Violations	No violations recorded.
Stage Curtain Rigging	Inspected
Instance on 1st Floor (500 Seats)	Inspected
Condition	2 - Between Good and Fair
Deficiency	No deficiencies recorded
Stage Curtains	Inspected
Instance on 1st Floor (500 Seats)	Inspected
Condition	1 - Good
Deficiency	No deficiencies recorded

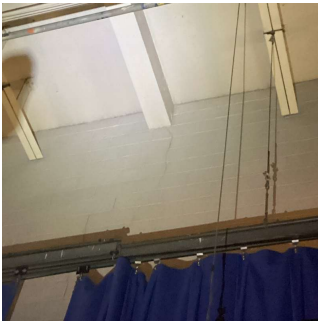
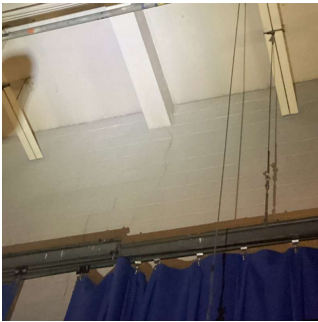
Rear Stage wall
No violations recorded.

Instance on 1st Floor (500 Seats)	Inspected
Condition	2 - Between Good and Fair
Deficiency	MASONRY: CRACKS/SPALLING
Deficiency Location/Instance	Rear Stage wall
Deficiency Quantity	20
Quantity Uom	S.F.
Potential Action	REPLACE
Urgency of Action	PRIORITY 3
Purpose of Action	LEVEL 2
Deficiency Photo1

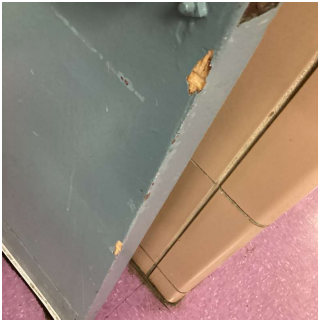
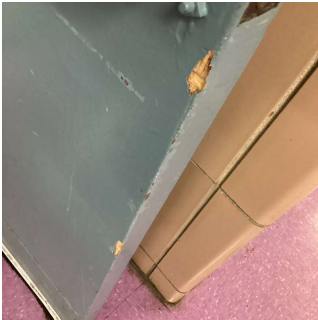
Instance on Basement	Inspected
Condition	5 - Poor
Deficiency	WOOD: DETERIORATED DOOR
Deficiency Location/Instance	Main Entrance, Side Entrance
Deficiency Quantity	6
Quantity Uom	EACH
Potential Action	MAINTENANCE
Urgency of Action	PRIORITY 3
Purpose of Action	LEVEL 2
Deficiency Photo1

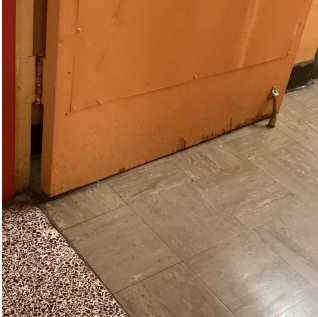
Question	Response
INTERIOR	
CLASSROOMS/CORRIDORS/ADMIN SPACES	
Door(s)	
Deficiency Location/Instance	Room 152, 218, 220, 242, Corridor near Room 315, and others
Deficiency Quantity	10
Quantity Uom	EACH
Potential Action	MAINTENANCE
Urgency of Action	PRIORITY 3
Purpose of Action	LEVEL 2
Deficiency Photo1

Violations	Room 152 No violations recorded.
Floor Finish	
Condition	Inspected 2 - Between Good and Fair
Deficiency	VINYL TILES: TRIPPING HAZARD - ELECTRICAL OUTLET
Deficiency Location/Instance	Room 231
Deficiency Quantity	10
Quantity Uom	S.F.
Potential Action	REMOVE
Urgency of Action	PRIORITY 5
Purpose of Action	LEVEL 6
Deficiency Photo1

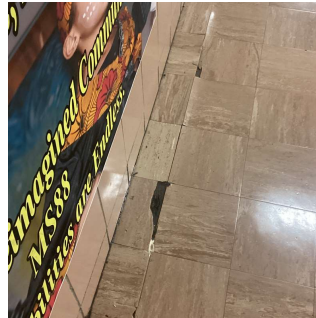
Corridor near Stair C/3

VINYL TILES: BROKEN/DETERIORATED/MISSING TILES

REPLACE

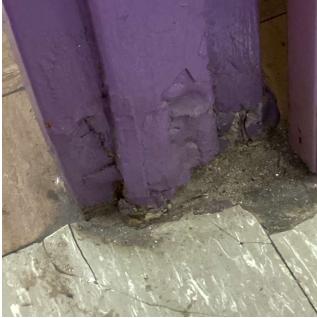
Violations	Stair B/2 No violations recorded.
Door(s)	
Condition	Inspected 3 - Fair
Deficiency	METAL: DETERIORATED DOOR AND FRAME
Deficiency Location/Instance	Stair B/3
Deficiency Quantity	2
Quantity Uom	EACH

Stair B/3
Violations	No violations recorded.
Partition	Does not Exist
Railings	Inspected
Condition	4 - Between Fair and Poor
Deficiency	METAL: BROKEN BRACKET
Deficiency Location/Instance	Stair C/Bulkhead
Deficiency Quantity	1
Quantity Uom	EACH
Potential Action	REPLACE
Urgency of Action	PRIORITY 3
Purpose of Action	LEVEL 2
Deficiency Photo1

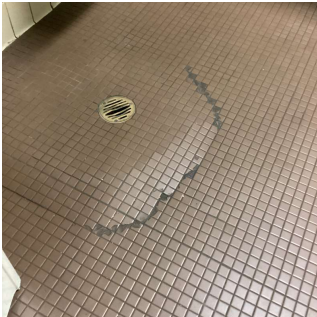
Room 310
Violations	No violations recorded.
Floor Finish	
Condition	Inspected
Deficiency	CERAMIC TILE: DETERIORATED SUBSTRATE
Deficiency Location/Instance	Room B27
Deficiency Quantity	10
Quantity Uom	S.F.
Potential Action	REPLACE
Urgency of Action	PRIORITY 3
Purpose of Action	LEVEL 2
Deficiency Photo1

Room B27
Violations	No violations recorded.
Deficiency	CERAMIC TILE: BROKEN/MISSING TILES
Deficiency Location/Instance	Room 310, inside Room 131
Deficiency Quantity	15
Quantity Uom	S.F.
Potential Action	REPLACE
Urgency of Action	PRIORITY 3
Purpose of Action	LEVEL 2
