NYC Department of Education
Building Condition Assessment Survey 2023 - 2024

Architectural Inspection

Asset: P.S. 90 - BROOKLYN, 2840 WEST 12 STREET, New York, 11224

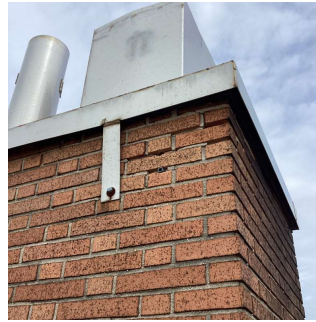
Roof 1 - CH

BRICK: DETERIORATED JOINTS

10
S.F.
REPOINT
PRIORITY 4
LEVEL 2

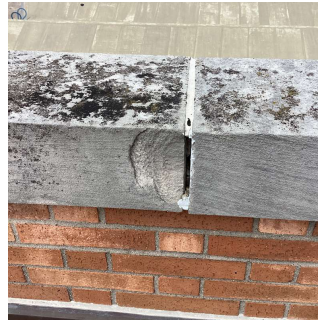
Roof 1 - Facade G

CAST STONE: CRACKED/BROKEN PIECES

10
 L.F.
 REPLACE-IN-KIND
 PRIORITY 4
 LEVEL 2

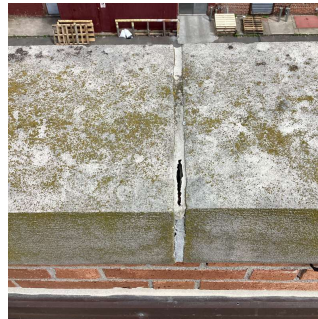
Roof 1 - Facade A

CAST STONE: DETERIORATED TRANSVERSE JOINTS

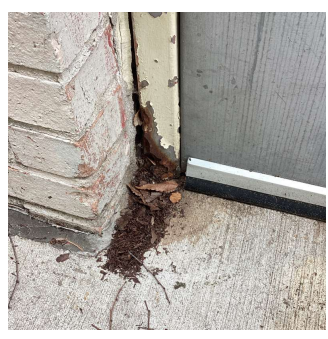
METAL: DETERIORATED DOOR AND FRAME - MAJOR DETERIORATION

Violations	Facade B - Exit 7 No violations recorded.
DOOR HARDWARE	Inspected
Condition	3 - Fair
Deficiency	No deficiencies recorded
LINTELS	Inspected
Condition	2 - Between Good and Fair
Deficiency	No deficiencies recorded
TRANSOM/SIDE LIGHT	Inspected
Condition	2 - Between Good and Fair
Deficiency	No deficiencies recorded
EXTERIOR WALLS	Inspected
Material Type(s)	Concrete, Masonry
Replacement Quantity	18,000
Replacement Uom	S.F.
Instance on All Facades	Inspected
Instance Condition	3 - Fair
Instance Quantity	18,000
Instance Quantity Uom	S.F.
Deficiency	BRICK: DETERIORATED MASONRY SILLS - MINOR

Deficiency Quantity	2
Quantity Uom	EACH
Potential Action	REPLACE
Urgency of Action	PRIORITY 4
Purpose of Action	LEVEL 2
Deficiency Photo1

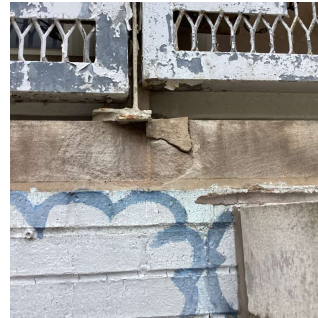
Facade G

BRICK: DETERIORATED MASONRY SILLS - MAJOR

REMOVE AND REPLACE

PRIORITY 4
LEVEL 2

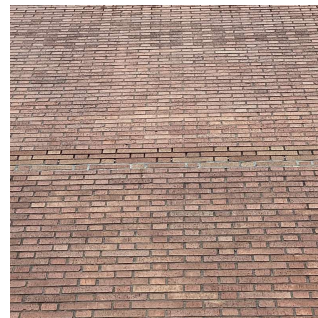
Facade H

BRICK: DETERIORATED JOINTS

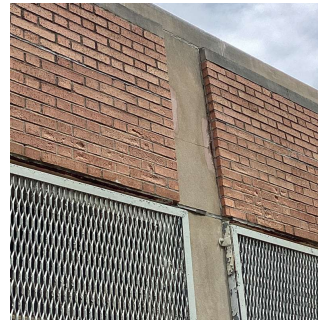
Facade B

BRICK: MINOR CRACKS AND SPALLING

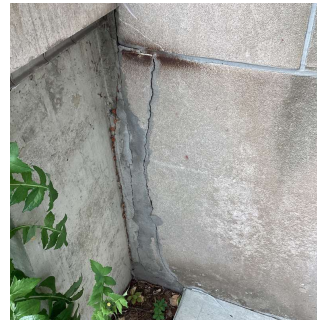
Facade A - Main Entrance

CAST IN PLACE / PRE-CAST CONCRETE: MAJOR
CRACKS/SPALLING

REPLACE

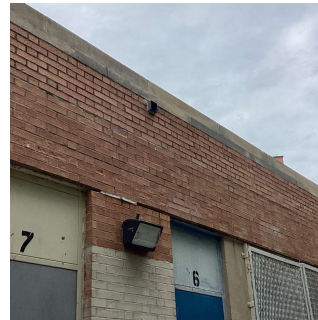
Roof 2 - Facade B

BRICK: DETERIORATED JOINTS

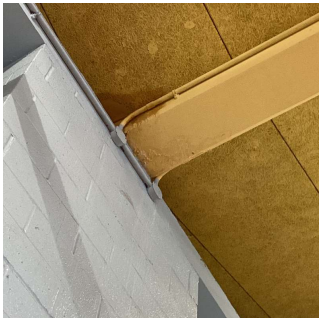
Roof 3 - Gymnasium

Question	Response
EXTERIOR	
ROOF	
Roofing	
ROOF CAGE	Does not Exist
ROOFING	Inspected
Instance on Modified Bitumen: Roof 3	Inspected
Instance Condition	4 - Between Fair and Poor
Instance Photo	 
	Roof 3
Instance Quantity	3,000
Instance Quantity Uom	S.F.
Does the roof have major mechanical equipment sitting on Dunnage Steel less than 18" above the Roofing?	No
Does this roof instance have a Sustainable Roof System?	Yes
Sustainable Roof Type	White Roof
Sustainable Roof Location (Roof Number)	Roof 3
Do solar panels exist on these roofs?	No
Is/Are the roof(s) suitable for Solar Panel installation?	No
Installation Year	2015
Source of Installation	Custodial Staff
Deficiency	MODIFIED BITUMEN: ROOFING: MAJOR ACTIVE ROOF LEAKS IN INSTRUCTIONAL SPACE
Roof Plan reference	K090

Deficiency Quantity	100
Quantity Uom	S.F.
Potential Action	REPLACE ROOFING WITHOUT MAJOR EQUIPMENT REMOVAL
Urgency of Action	PRIORITY 5
Purpose of Action	LEVEL 2

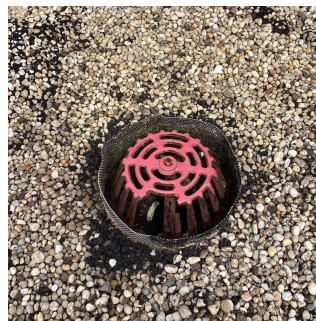
Roof 1

DETERIORATED

REPLACE

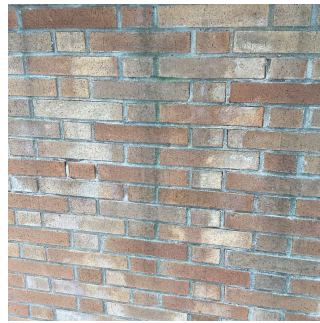
Facade B - HC Ramp

Deficiency	BRICK: DETERIORATED JOINTS
------------	----------------------------

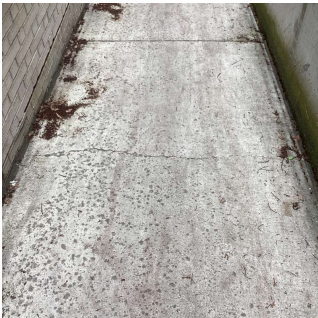
Question	Response
EXTERIOR	
STAIRS/RAMPS: EXTERIOR	Inspected
STAIRS/RAMPS	
Deficiency Quantity	10
Quantity Uom	S.F.
Potential Action	REPLACE
Urgency of Action	PRIORITY 4
Purpose of Action	LEVEL 2
Deficiency Photo1	 
Violations	Facade B - Exit 2 No violations recorded.
Deficiency	CONCRETE: CRACKS/SPALLING - MINOR
Roof Plan reference	K090

Violations	Facade B - HC Ramp No violations recorded.
WINDOWS	Inspected
Replacement Quantity	8,030
Replacement Uom	S.F.
EXTERIOR GUARDS	Inspected

Deficiency Quantity	10
Quantity Uom	S.F.
Potential Action	REPAIR
Urgency of Action	PRIORITY 3
Purpose of Action	LEVEL 2
Deficiency Photo1

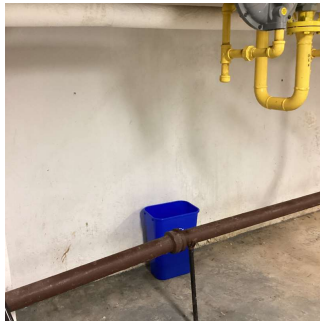
Violations	Universal Waste/Fluorescent Bulb Storage Area No violations recorded.
FOUNDATION WALLS	
Material Type(s)	Inspected Concrete
Condition	4 - Between Fair and Poor
Deficiency	CONCRETE: WATER INFILTRATION IN NON- INSTRUCTIONAL SPACE
Deficiency Location/Instance	Basement - Gas Meter Room
Deficiency Quantity	100
Quantity Uom	S.F.
Potential Action	INSTALL WATERPROOFING
Urgency of Action	PRIORITY 5
Purpose of Action	LEVEL 5
Deficiency Photo1

Violations	Gas Meter Room No violations recorded.
ROOF STRUCTURE	
Condition	Inspected 2 - Between Good and Fair
Deficiency	No deficiencies recorded
VAULTS-BUNKERS	
	Does not Exist
AUDITORIUM	
Instance on 1st Floor (400 Seats)	Inspected Inspected
Ceiling	
Instance on 1st Floor (400 Seats)	Inspected Inspected
Condition	2 - Between Good and Fair
Deficiency	No deficiencies recorded
Door(s)	
Instance on 1st Floor (400 Seats)	Inspected Inspected

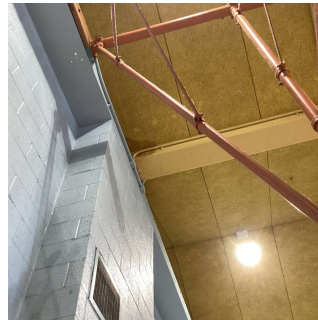
Deficiency	TECTUM: DAMAGED/MISSING - ACTIVE LEAK
Deficiency Location/Instance	Left Side

Deficiency Quantity	10
Quantity Uom	S.F.
Potential Action	REPLACE
Urgency of Action	PRIORITY 5
Purpose of Action	LEVEL 2
Deficiency Photo1

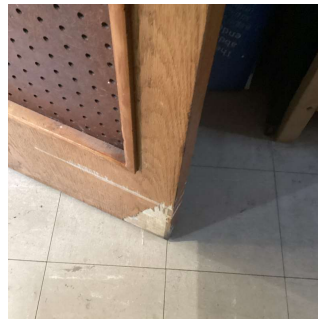
Office Room

Instance on 1st Floor	Inspected
Condition	4 - Between Fair and Poor
Deficiency	WOOD: DETERIORATED DOOR
Deficiency Location/Instance	Office Room, Storage Room
Deficiency Quantity	2
Quantity Uom	EACH
Potential Action	MAINTENANCE
Urgency of Action	PRIORITY 3
Purpose of Action	LEVEL 2
Deficiency Photo1

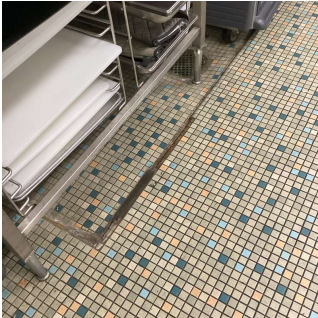
Instance on 1st Floor	Inspected
Condition	2 - Between Good and Fair
Deficiency	CERAMIC TILE: BROKEN/MISSING TILES
Deficiency Location/Instance	Near Ovens
Deficiency Quantity	10
Quantity Uom	S.F.
Potential Action	REPLACE
Urgency of Action	PRIORITY 3
Purpose of Action	LEVEL 2
Deficiency Photo1

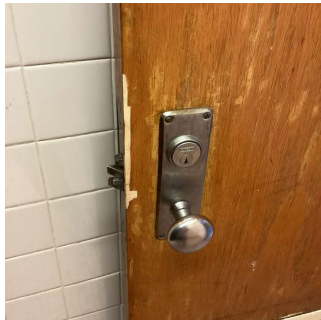
Violations	In Room 101 No violations recorded.
Door(s)	Inspected
Condition	5 - Poor
Deficiency	WOOD: DETERIORATED DOOR
Deficiency Location/Instance	Rooms 222, 218
Deficiency Quantity	2
Quantity Uom	EACH
Potential Action	MAINTENANCE
Urgency of Action	PRIORITY 3
Purpose of Action	LEVEL 2
Deficiency Photo1

Violations	Room 222 No violations recorded.
Deficiency	WOOD: DETERIORATED DOOR AND FRAME
Deficiency Location/Instance	Room 118
Deficiency Quantity	1
