**NYC Department of Education**  
**Building Condition Assessment Survey 2023 - 2024**

Architectural Inspection

**Asset: P.S. 92 - BROOKLYN, 601 PARKSIDE AVENUE, New York, 11226**

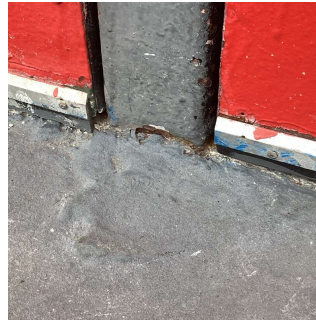
Facade A

Deficiency	METAL CLAD: DETERIORATED DOOR AND FRAME - MINOR DETERIORATION
------------	---

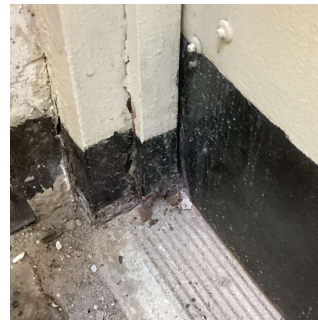
Facade C

**METAL: DETERIORATED DOOR AND FRAME - MAJOR DETERIORATION**

REPLACE

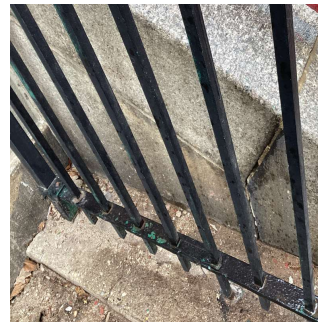
Facade A

<b>BUILDING CHEEK/FLANK WALLS</b>	Inspected
Condition	5 - Poor
Deficiency	STONE: DETERIORATED JOINTS
Roof Plan reference	<p>K092</p>

Deficiency Quantity	20
Quantity Uom	S.F.
Potential Action	REPOINT
Urgency of Action	PRIORITY 4
Purpose of Action	LEVEL 2

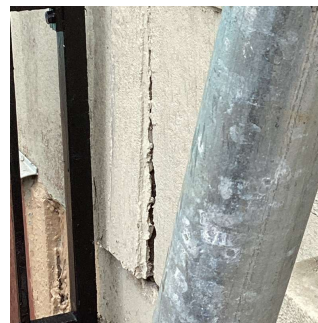
Facade A

**STONE: CRACKS/SPALLING - MAJOR**

REPLACE

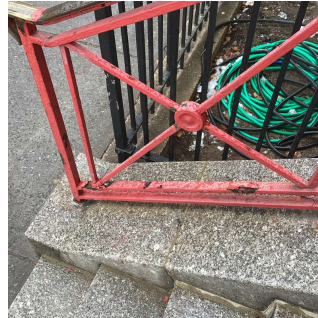
Facade A

**RUST - MAJOR**

L.F.  
REPLACE  
PRIORITY 4  
LEVEL 2

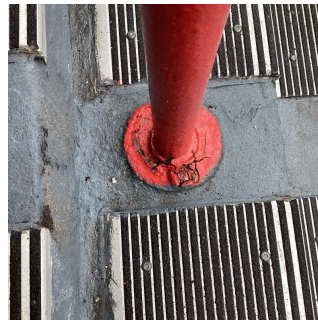
Facade A

**BROKEN BRACKET**

2  
EACH  
REPLACE  
PRIORITY 4  
LEVEL 2

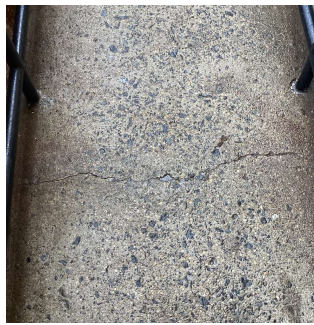
Facade C

CONCRETE: CRACKS/SPALLING - MAJOR

REPLACE

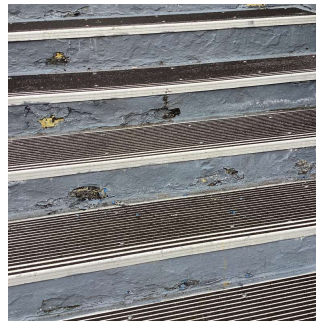
Facade A

CONCRETE: WORN-OUT TREAD/RISER/NOSING

REPLACE

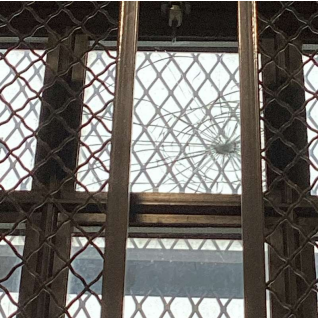
Deficiency Quantity	20
Quantity Uom	EACH
Potential Action	REPLACE BALANCES
Urgency of Action	PRIORITY 3
Purpose of Action	LEVEL 2
Deficiency Photo1	No photo recorded
Violations	No violations recorded.
Instance on Aluminum - Double Hung: Facade C - Gymnasium	Inspected
Instance Condition	2 - Between Good and Fair
Instance Quantity	1,400
Instance Quantity Uom	S.F.
Are these windows insulated	No
Installation Year	2009
Source of Installation	Custodial Staff
Deficiency	ALUMINUM - DOUBLE HUNG: BROKEN PANE

Deficiency Quantity	30
Quantity Uom	S.F.
Potential Action	MAINTENANCE
Urgency of Action	PRIORITY 3
Purpose of Action	LEVEL 2
Deficiency Photo1

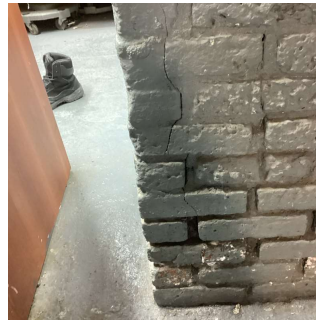
Basement - Boiler Room

**STEEL COLUMNS/BEAMS: DETERIORATED MASONRY FIREPROOFING**

REPLACE

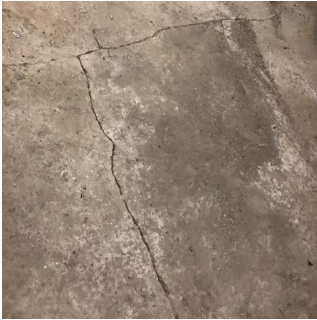
Violations	1950 Addition - Sub-Basement - Mechanical Equipment Room No violations recorded.

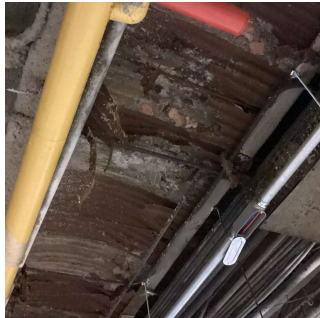
Yes	Potential Falling Debris	Deteriorated cinder concrete arch metal pan is a potential falling debris hazard.	INTERIOR   STRUCTURAL   FLOOR STRUCTURE	Basement - Boiler Room	Michael Rea	Custodian

Deficiency	CINDER CONCRETE ARCH: METAL PAN DETERIORATED, SPALLED
Deficiency Location/Instance	Basement - Boiler Room
Deficiency Quantity	30
Quantity Uom	S.F.
Potential Action	REPAIR
Urgency of Action	PRIORITY 5

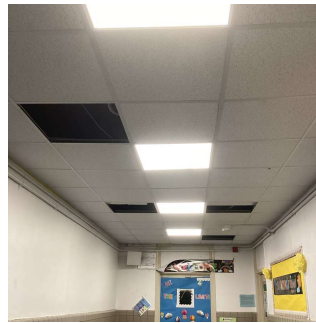
Violations	Corridor near Stair F/3 No violations recorded.
Deficiency	ACOUSTIC TILES: DAMAGED/MISSING
Deficiency Location/Instance	Corridor near Room B28
Deficiency Quantity	20
Quantity Uom	S.F.
Potential Action	REPLACE
Urgency of Action	PRIORITY 3
Purpose of Action	LEVEL 2
