NYC Department of Education
Building Condition Assessment Survey 2023 - 2024

Architectural Inspection

Asset: P.S. 93 - BROOKLYN, 31 NEW YORK AVENUE, New York, 11216

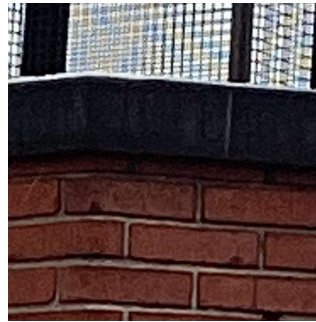
CH

BRICK: MINOR CRACKS AND SPALLING

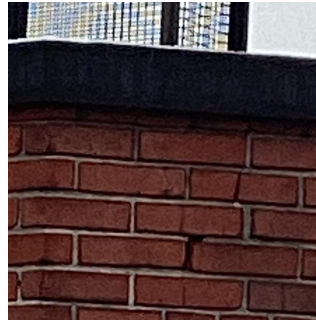
CH
No violations recorded.

BRICK: DETERIORATED JOINTS

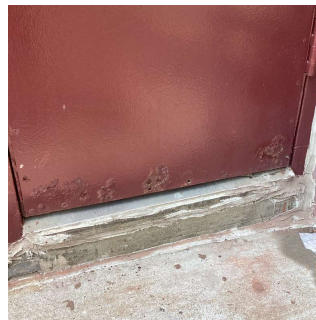
Facade C - Exit 9

METAL CLAD: DETERIORATED DOOR - MAJOR DETERIORATION

REPLACE

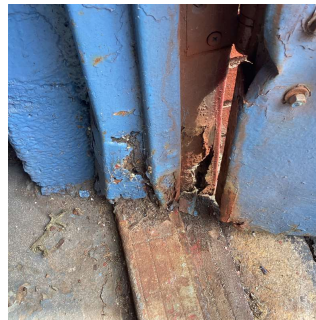
Facade C - Exit 7

METAL: DETERIORATED DOOR AND FRAME - MAJOR DETERIORATION

1
EACH
REPLACE
PRIORITY 4
LEVEL 2

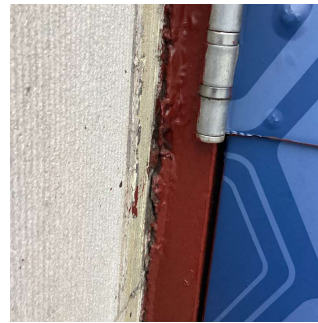
Facade A - Main Entrance

METAL: DETERIORATED DOOR AND FRAME - MINOR DETERIORATION

4
EACH
MAINTENANCE
PRIORITY 3
LEVEL 2

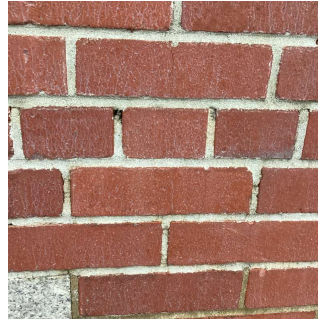
Facade A - Near Exit 3

BRICK: DETERIORATED JOINTS

Deficiency Quantity	20
Quantity Uom	S.F.
Potential Action	REPOINT
Urgency of Action	PRIORITY 3
Purpose of Action	LEVEL 2
Deficiency Photo1

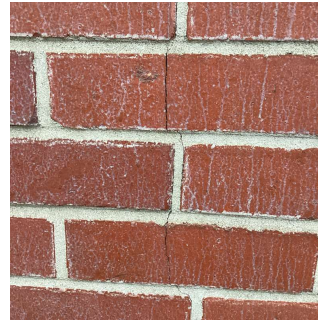
Facade A - Near Exit 3

Deficiency	BRICK: MINOR CRACKS AND SPALLING
Roof Plan reference	K093

Deficiency Quantity	20
Quantity Uom	S.F.
Potential Action	RESTITCH
Urgency of Action	PRIORITY 3
Purpose of Action	LEVEL 2

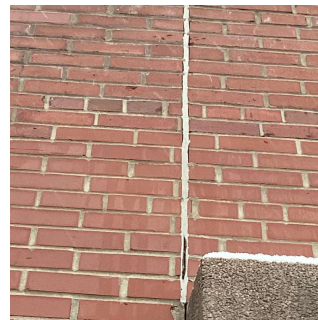
Facade A - Exit 3

BRICK: DETERIORATED CONTROL/EXPANSION JOINTS

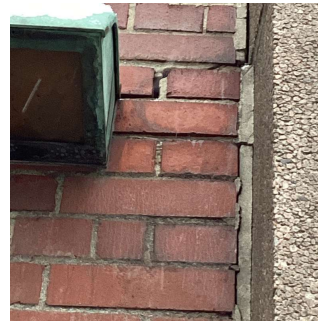
Facade A - Exit 3

BRICK: DETERIORATED JOINTS

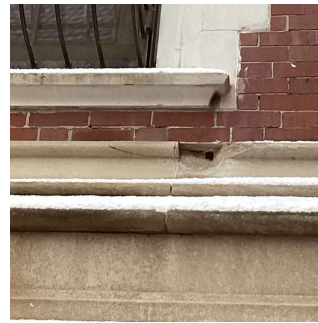
Facade A - Exit 2

STONE: CHIPPED/SPALLED/BROKEN PIECES - MAJOR

REPLACE

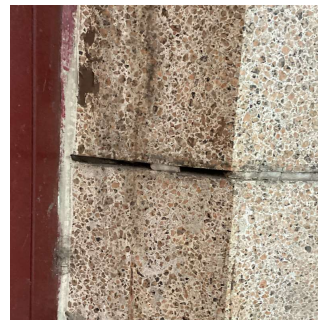
Facade A - Exit 3

STONE: DETERIORATED JOINTS

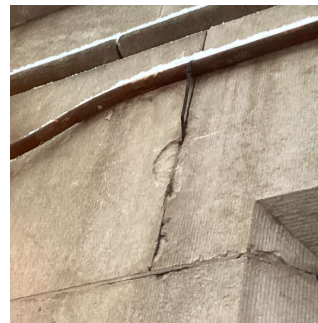
Facade A - Exit 2
No violations recorded.

STONE: CHIPPED/SPALLED/BROKEN PIECES - MINOR

15
S.F.
REPAIR
PRIORITY 3
LEVEL 2

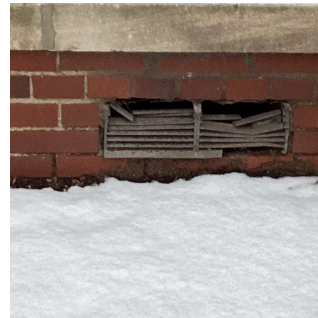
Facade A - Near Exit 2
No violations recorded.

BROKEN/ DENTED BLADES

20
S.F.
REPLACE
PRIORITY 4
LEVEL 2

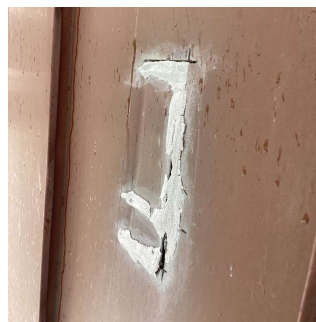
BH1

Condition	Inspected
Deficiency	3 - Fair
	BULKHEAD/PENTHOUSE WALLS/EXTERIOR: DAMAGED METAL SIDING

10
S.F.
REPLACE
PRIORITY 4
LEVEL 2

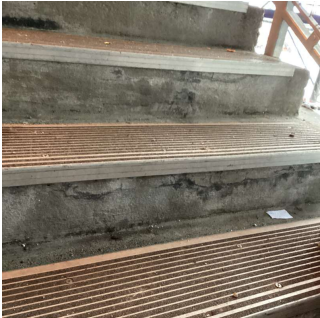
RAILINGS	Inspected
Condition	2 - Between Good and Fair
Deficiency	No deficiencies recorded
STAIRS/RAMPS	Inspected
Condition	3 - Fair
Deficiency	CONCRETE: CRACKS/SPALLING - MINOR
Roof Plan reference	K093

Violations	Facade C - Near Exit 5 No violations recorded.
WINDOWS	Inspected
Replacement Quantity	16,000
Replacement Uom	S.F.
EXTERIOR GUARDS	Inspected
Condition	2 - Between Good and Fair
Deficiency	No deficiencies recorded
LINTELS	Inspected
Condition	2 - Between Good and Fair
Deficiency	No deficiencies recorded
WINDOWS	Inspected
Material Type(s)	Aluminum, Steel
Instance on Aluminum - Double Hung: All Facades (Original Building)	Inspected
Instance Condition	3 - Fair
Instance Quantity	10,000
Instance Quantity Uom	S.F.
Are these windows insulated	No
Installation Year	2000
Source of Installation	Custodial Staff
Deficiency	No deficiencies recorded
Instance on Steel: Boiler Room	Inspected
Instance Condition	5 - Poor

Question	Response
EXTERIOR	
STAIRS/RAMPS: EXTERIOR	Inspected
STAIRS/RAMPS	
Deficiency Quantity	20
Quantity Uom	S.F.
Potential Action	REPAIR
Urgency of Action	PRIORITY 3
Purpose of Action	LEVEL 2
Deficiency Photo1

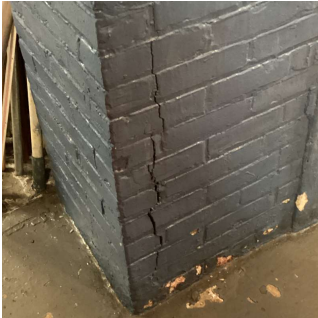
Question	Response
INTERIOR	
STRUCTURAL	
COLUMNS/BEAMS/BEARING WALLS	
Deficiency	MASONRY BEARING WALL: CRACKED/SPALLED
Deficiency Location/Instance	Basement - Boiler Room
Deficiency Quantity	10
Quantity Uom	S.F.
Potential Action	RESTITCH
Urgency of Action	PRIORITY 3
Purpose of Action	LEVEL 5
Deficiency Photo1

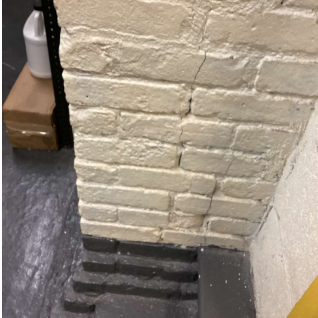
Violations	Basement - Boiler Room No violations recorded.
Deficiency	STEEL COLUMNS/BEAMS: DETERIORATED MASONRY FIREPROOFING
Deficiency Location/Instance	Basement - Room B9, 1st Floor - Auditorium South MER
Deficiency Quantity	30
Quantity Uom	S.F.
Potential Action	REPLACE
Urgency of Action	PRIORITY 3
Purpose of Action	LEVEL 5
Deficiency Photo1

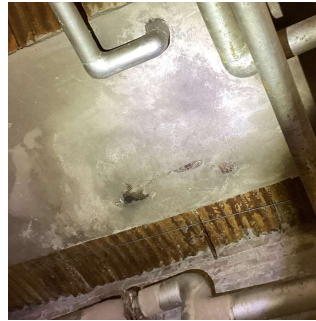
Violations	Basement - Room B9 No violations recorded.
FLOOR STRUCTURE	Inspected
Condition	3 - Fair
Deficiency	CONCRETE: CRACKS/SPALLED/REINFORCEMENT EXPOSED
Deficiency Location/Instance	Basement - Boiler Room
Deficiency Quantity	10
Quantity Uom	S.F.
Potential Action	REPAIR

Urgency of Action	PRIORITY 4
Purpose of Action	LEVEL 5

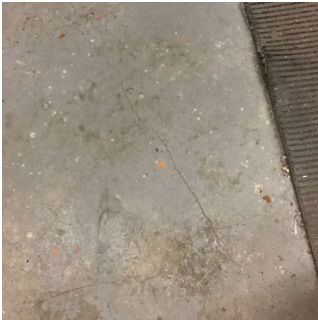
Question	Response
INTERIOR	
STRUCTURAL	
VAULTS-BUNKERS	
Slab Structure	Inspected
Condition	3 - Fair
Deficiency	CONCRETE SLAB ON GRADE: THRU CRACKS
Deficiency Location/Instance	Basement - B6B
Deficiency Quantity	10
Quantity Uom	S.F.
Potential Action	REPAIR
Urgency of Action	PRIORITY 3
Purpose of Action	LEVEL 5
Deficiency Photo1

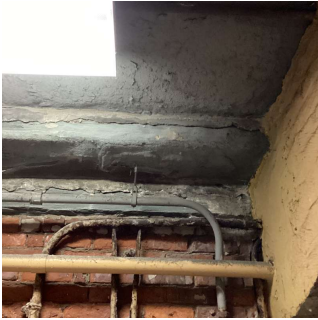
Violations	Basement - B6B No violations recorded.
Deficiency	CONCRETE: CRACKS/SPALLED/REINFORCEMENT EXPOSED
Deficiency Location/Instance	Basement - B6B
Deficiency Quantity	10
Quantity Uom	S.F.
Potential Action	REPAIR
Urgency of Action	PRIORITY 4
Purpose of Action	LEVEL 5
Deficiency Photo1

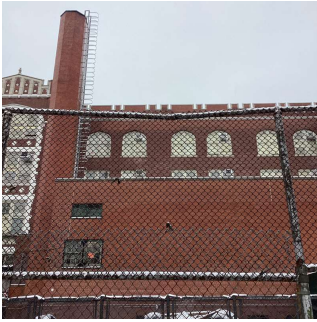
Violations	Near Exit 2 No violations recorded.
Culverts - Concrete Covering	
	Does not Exist
Drainage System for Soil	
	Does not Exist
DRINKING FOUNTAINS	
Condition	Inspected 5 - Poor
Deficiency	INOPERABLE
Deficiency Location/Instance	Schoolyard
Deficiency Quantity	1
Quantity Uom	EACH
Potential Action	MAINTENANCE
Urgency of Action	PRIORITY 3
Purpose of Action	LEVEL 2
Deficiency Photo1	No photo recorded
Violations	No violations recorded.
FENCES	
Condition	Inspected 3 - Fair
Deficiency	CHAIN LINK: DAMAGED POST/RAIL
Deficiency Location/Instance	Schoolyard
Deficiency Quantity	10
Quantity Uom	L.F.
Potential Action	REPLACE
Urgency of Action	PRIORITY 3
Purpose of Action	LEVEL 2
Deficiency Photo1

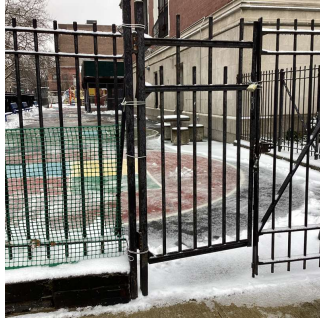
Violations	Schoolyard No violations recorded.
Deficiency	WROUGHT IRON: DAMAGED/DETERIORATED
Deficiency Location/Instance	Along New York Avenue, Herkimer Street

Question	Response
SITE	
FENCES	
Deficiency Quantity	320
Quantity Uom	S.F.
Potential Action	REPLACE
Urgency of Action	PRIORITY 3
Purpose of Action	LEVEL 2
Deficiency Photo1

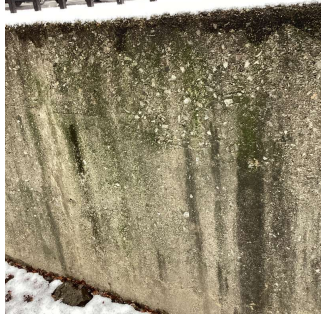
Question	Response
SITE	
RETAINING WALLS	
Condition	3 - Fair
Deficiency	CAST IN PLACE CONCRETE: CRACKS/SPALLING - MAJOR
Deficiency Location/Instance	Atlantic Avenue Playground
Deficiency Quantity	50
Quantity Uom	S.F.
Potential Action	REPLACE
Urgency of Action	PRIORITY 3
Purpose of Action	LEVEL 2
Deficiency Photo1

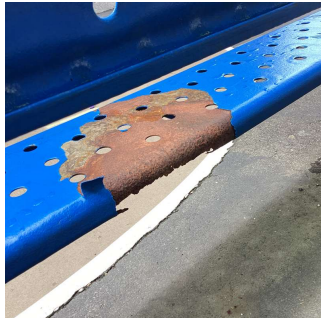
Priority Condition Exist Last Year?	Priority Category	Condition Description	Component Affected	Location Description	Person(s) Notified	Person(s) Title	PhotoImage
Yes	Protruding Elements	Two rusted metal benches with jagged edges is a potential safety hazard.	SITE SEATING Benches Metal/Wood/Plastic	Schoolyard near Herkimer Street	Omar Rosario	Cleaner
