**NYC Department of Education**  
**Building Condition Assessment Survey 2023 - 2024**

Architectural Inspection

**Asset: P.S. 95 - BROOKLYN, 345 VAN SICKLEN STREET, New York, 11223**

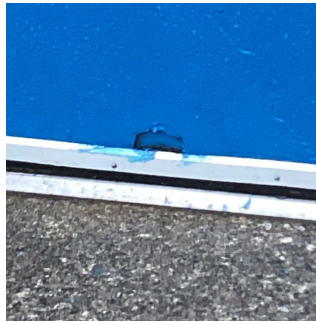
Facade B

METAL CLAD: DETERIORATED DOOR - MAJOR DETERIORATION

2  
EACH  
REPLACE  
PRIORITY 4  
LEVEL 2

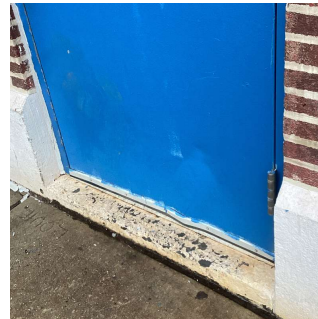
**METAL: DETERIORATED DOOR - MAJOR DETERIORATION**

REPLACE

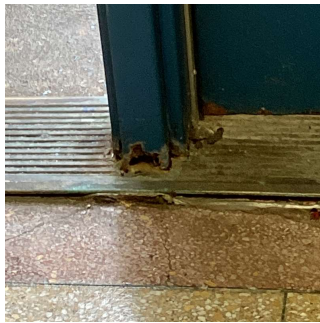
**METAL: DETERIORATED DOOR AND FRAME - MAJOR DETERIORATION**

REPLACE

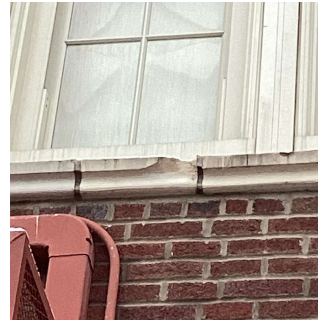
Facade E

**BRICK: DETERIORATED MASONRY SILLS - MAJOR**

REMOVE AND REPLACE

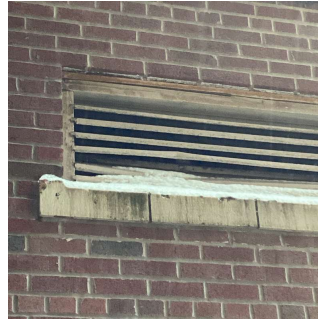
Facade C1

BROKEN/ DENTED BLADES

Deficiency Quantity	30
Quantity Uom	S.F.
Potential Action	REPLACE
Urgency of Action	PRIORITY 4
Purpose of Action	LEVEL 2
Deficiency Photo1

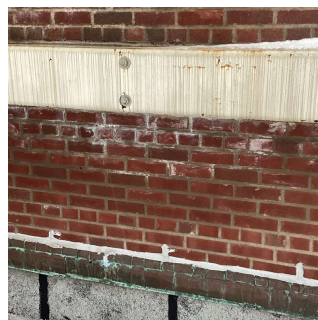
Roof 1

Material Type(s)	Inspected Masonry
Replacement Quantity	7,000
Replacement Uom	C.F.
Instance on All Roofs	Inspected
Instance Condition	3 - Fair
Instance Quantity	7,000
Instance Quantity Uom	C.F.
Deficiency	BRICK: EFFLORESCENCE
Roof Plan reference	K095

Deficiency Quantity	140
Quantity Uom	S.F.
Potential Action	MAINTENANCE
Urgency of Action	PRIORITY 1
Purpose of Action	LEVEL 1
Deficiency Photo1

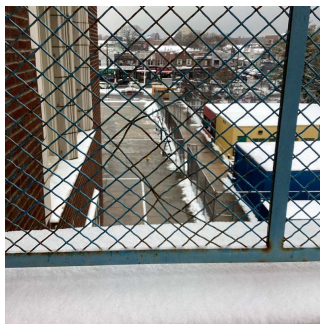
Question	Response
<b>EXTERIOR</b>	
<b>ROOF</b>	
<b>Roofing</b>	
<b>ROOF CAGE</b>	
Deficiency	MESH: DETERIORATED
Roof Plan reference	K095
Deficiency Quantity	10
Quantity Uom	S.F.
Potential Action	REPLACE
Urgency of Action	PRIORITY 4
Purpose of Action	LEVEL 2
Deficiency Photo1

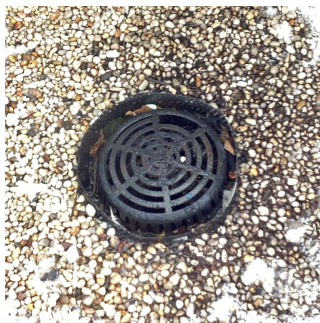
Roof 1
Instance Quantity	12,000
Instance Quantity Uom	S.F.
Does the roof have major mechanical equipment sitting on Dunnage Steel less than 18" above the Roofing?	No
Does this roof instance have a Sustainable Roof System?	No
Do solar panels exist on these roofs?	No
Is/Are the roof(s) suitable for Solar Panel installation?	Yes
Installation Year	2017
Source of Installation	Custodial Staff
Deficiency	No deficiencies recorded
<b>ROOFING DRAINS</b>	
	Inspected
Condition	4 - Between Fair and Poor
Deficiency	DETERIORATED
Roof Plan reference	K095

Deficiency Quantity	2
Quantity Uom	EACH
Potential Action	REPLACE
Urgency of Action	PRIORITY 4
Purpose of Action	LEVEL 2
Deficiency Photo1

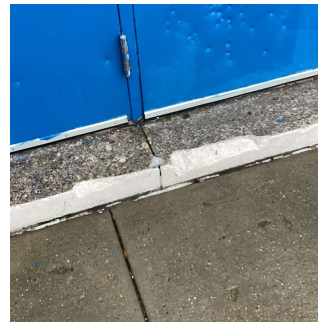
Facade C - Exit 4

STONE: CRACKS/SPALLING - MAJOR

REPLACE

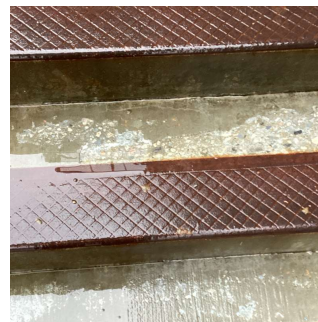
Facade E

**CONCRETE: CRACKS/SPALLING - MINOR**

REPAIR

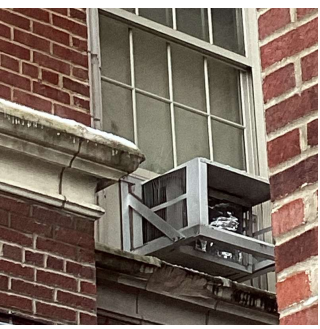
Question	Response
<b>EXTERIOR</b>	
<b>WINDOWS</b>	
<b>WINDOWS</b>	
Installation Year	2012
Source of Installation	Custodial Staff
Deficiency	ALUMINUM - DOUBLE HUNG: BROKEN PANE
Roof Plan reference	K095

Deficiency Quantity	30
Quantity Uom	S.F.
Potential Action	MAINTENANCE
Urgency of Action	PRIORITY 3
Purpose of Action	LEVEL 2
Deficiency Photo1

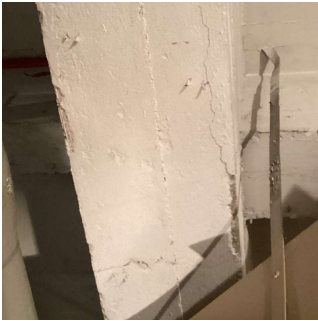
Violations	Basement Crawl Space under Exit 3 No violations recorded.
Deficiency	<b>STEEL COLUMNS/BEAMS: DETERIORATED CONCRETE FIREPROOFING</b>
Deficiency Location/Instance	Basement, 1st Floor
Deficiency Quantity	140
Quantity Uom	S.F.
Potential Action	REPLACE
Urgency of Action	PRIORITY 3
Purpose of Action	LEVEL 5
Deficiency Photo1

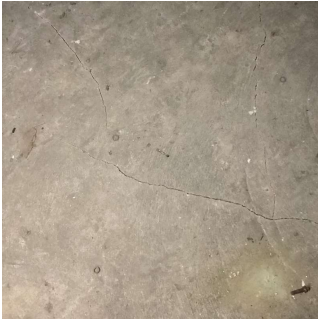
Violations	Gymnasium Fan Room (1st Floor Electrical Panel Room, Crawl Space similar) No violations recorded.
<b>FLOOR STRUCTURE</b>	Inspected
Condition	3 - Fair
Deficiency	CONCRETE SLAB ON GRADE: THRU CRACKS
Deficiency Location/Instance	Basement
Deficiency Quantity	120
Quantity Uom	S.F.
Potential Action	REPAIR
Urgency of Action	PRIORITY 3
Purpose of Action	LEVEL 5
Deficiency Photo1

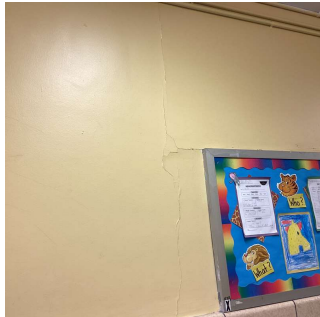
Room 125C
Violations	No violations recorded.
Deficiency	PLASTER: CRACKS/SPALLING
Deficiency Location/Instance	Corridor near room 237, Main Lobby
Deficiency Quantity	40
Quantity Uom	S.F.
Potential Action	REPLACE
Urgency of Action	PRIORITY 3
Purpose of Action	LEVEL 2
Deficiency Photo1

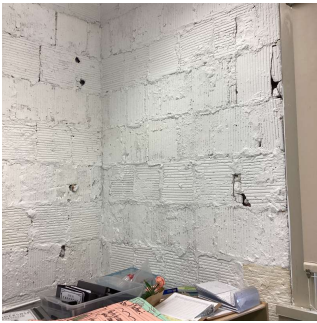
Corridor near room 237
Violations	No violations recorded.
Deficiency	PLASTER: CRACKS/SPALLING - ACTIVE LEAK
Deficiency Location/Instance	Rooms 425,403,338, 336 325, 303, 203, 125-C

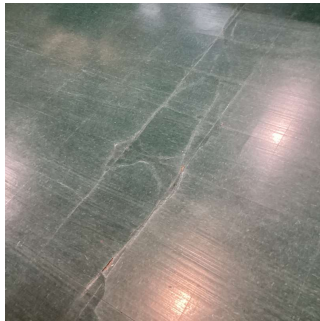
Violations	Near room 101 No violations recorded.
Instance on 1st Floor - North	Inspected
Condition	5 - Poor
Deficiency	VINYL TILES: DETERIORATED SUBSTRATE
Deficiency Location/Instance	Center, Along Windows, Near Entrance, Exit, near room 125-B and others
Deficiency Quantity	450
Quantity Uom	S.F.
Potential Action	REPLACE
Urgency of Action	PRIORITY 3
Purpose of Action	LEVEL 2
Deficiency Photo1

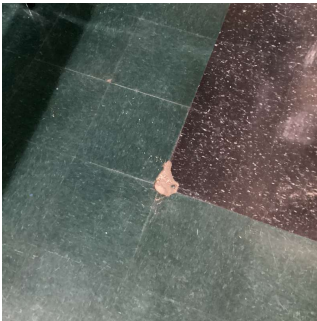
Violations	Center No violations recorded.
Deficiency	VINYL TILES: BROKEN/DETERIORATED/MISSING TILES
Deficiency Location/Instance	Near Entrance
Deficiency Quantity	15
Quantity Uom	S.F.
Potential Action	REPLACE
Urgency of Action	PRIORITY 3
Purpose of Action	LEVEL 2

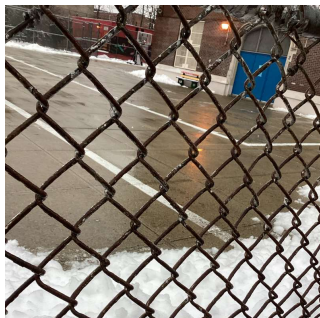
Violations	Van Sicklen Street No violations recorded.
Deficiency	CHAIN LINK: RUST - MAJOR
Deficiency Location/Instance	Van Sicklen Street, Avenue U
Deficiency Quantity	1,000
Quantity Uom	S.F.
Potential Action	REPLACE
Urgency of Action	PRIORITY 3
Purpose of Action	LEVEL 2
Deficiency Photo1
