**NYC Department of Education**  
**Building Condition Assessment Survey 2023 - 2024**

Architectural Inspection

**K096**

**Asset:**        **I.S. 96 - BROOKLYN, 99 AVENUE P, New York, 11204**

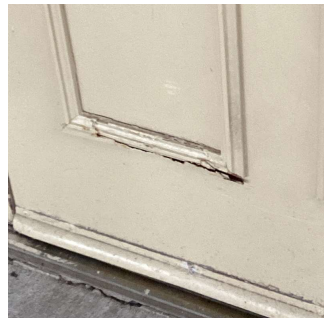
Question	Response
<b>EXTERIOR</b>	
<b>COPING</b>	
Deficiency	No deficiencies recorded
<b>CORNICE</b>	Under Construction
<b>DOORS</b>	Inspected
<b>DOORS AND FRAMES</b>	Inspected
Condition	4 - Between Fair and Poor
Deficiency	METAL: DETERIORATED DOOR - MINOR DETERIORATION
Roof Plan reference

Deficiency Quantity	2
Quantity Uom	EACH
Potential Action	MAINTENANCE
Urgency of Action	PRIORITY 3
Purpose of Action	LEVEL 2
Deficiency Photo1

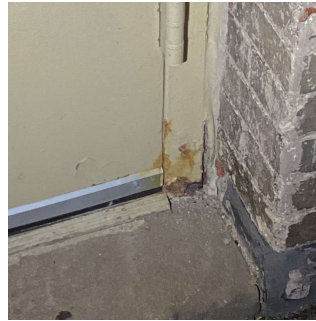
Facade F

**METAL CLAD: DETERIORATED DOOR - MAJOR DETERIORATION**

REPLACE

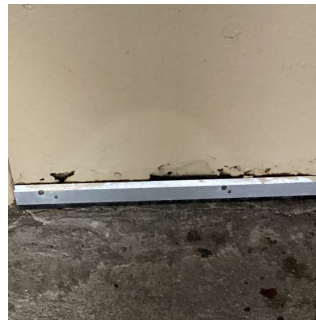
Facade H

**METAL CLAD: DETERIORATED DOOR AND FRAME - MAJOR DETERIORATION**

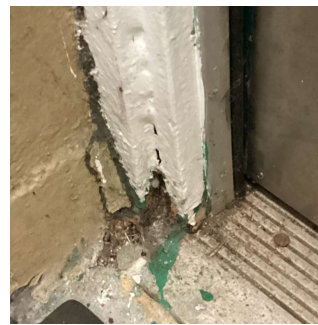
Facade A

METAL: BROKEN GLASS

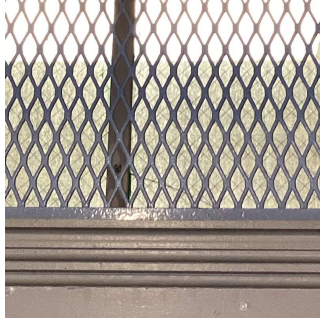
Question	Response
<b>EXTERIOR</b>	
<b>DOORS</b>	
<b>TRANSOM/SIDE LIGHT</b>	
Urgency of Action	PRIORITY 3
Purpose of Action	LEVEL 2
Deficiency Photo1

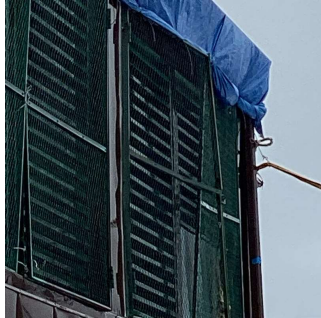
Question	Response
<b>EXTERIOR</b>	
<b>LOUVER</b>	
Potential Action	REPLACE
Urgency of Action	PRIORITY 4
Purpose of Action	LEVEL 2
Deficiency Photo1

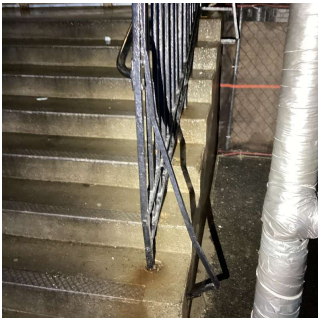
Violations	Facade D No violations recorded.
Deficiency	RUST - MAJOR

Deficiency Quantity	10
Quantity Uom	L.F.
Potential Action	REPLACE
Urgency of Action	PRIORITY 4
Purpose of Action	LEVEL 2
Deficiency Photo1

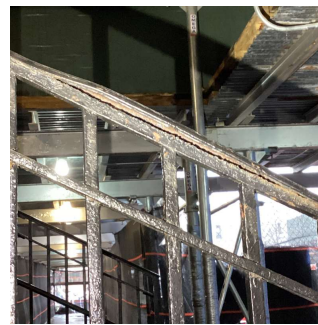
Facade D

CONCRETE: WORN-OUT TREAD/RISER/NOSING

25  
S.F.  
REPLACE  
PRIORITY 4  
LEVEL 2

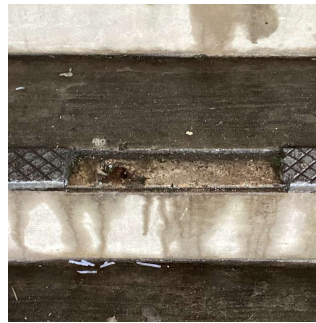
Facade C

**CONCRETE: CRACKS/SPALLING - MINOR**

REPAIR

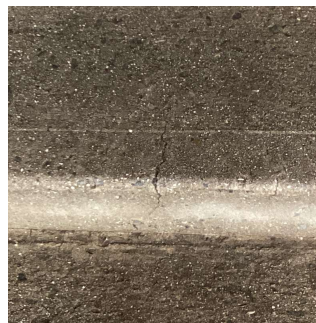
Facade H

**CONCRETE: CRACKS/SPALLING - MAJOR**

Question	Response
<b>EXTERIOR</b>	
<b>STAIRS/RAMPS: EXTERIOR</b>	
<b>STAIRS/RAMPS</b>	
Roof Plan reference	
Deficiency Quantity	15
Quantity Uom	S.F.
Potential Action	REPLACE
Urgency of Action	PRIORITY 4
Purpose of Action	LEVEL 2
Deficiency Photo1	
Violations	Facade A No violations recorded.
<b>WINDOWS</b>	Inspected
Replacement Quantity	20,700
Replacement Uom	S.F.
<b>EXTERIOR GUARDS</b>	Inspected
Condition	1 - Good
Deficiency	No deficiencies recorded
<b>LINTELS</b>	Inaccessible
<b>WINDOWS</b>	Inspected
Material Type(s)	Aluminum
Instance on Aluminum - Double Hung: All Facades	Under Construction
Instance Quantity	20,700
Instance Quantity Uom	S.F.
<b>INTERIOR</b>	Inspected
<b>POOLS</b>	Does not Exist
<b>STRUCTURAL</b>	Inspected
<b>COLUMNS/BEAMS/BEARING WALLS</b>	Inspected
Condition	3 - Fair
Deficiency	STEEL COLUMNS/BEAMS: DETERIORATED CONCRETE FIREPROOFING
Deficiency Location/Instance	Basement
Deficiency Quantity	85

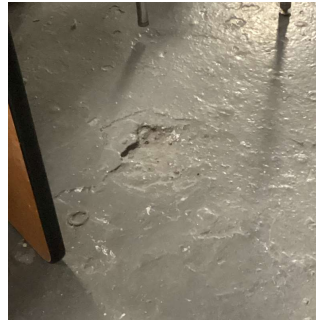
Basement Fan Area (Crawl Space similar)

CONCRETE: CRACKS/SPALLED/REINFORCEMENT EXPOSED

REPAIR

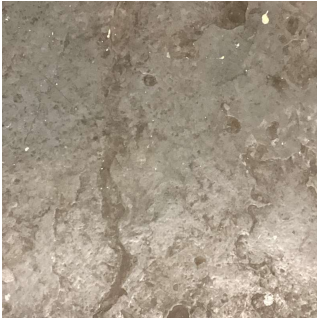
Question	Response
<b>INTERIOR</b>	
<b>STRUCTURAL</b>	
<b>FLOOR STRUCTURE</b>	
Deficiency	CONCRETE SLAB ON GRADE: THRU CRACKS
Deficiency Location/Instance	Basement
Deficiency Quantity	240
Quantity Uom	S.F.
Potential Action	REPAIR
Urgency of Action	PRIORITY 3
Purpose of Action	LEVEL 5
Deficiency Photo1

Basement West Fan Room (Basement Storage Area, Boiler Room, Custodian Shop, Basement Fan Area, Crawl Space similar)
Violations	No violations recorded.
<b>FOUNDATION WALLS</b>	
	Inspected
Material Type(s)	Concrete
Condition	3 - Fair
Deficiency	CONCRETE: CRACKED/SPALLED/REINFORCEMENT EXPOSED
Deficiency Location/Instance	Basement
Deficiency Quantity	70
Quantity Uom	S.F.
Potential Action	REPAIR
Urgency of Action	PRIORITY 3
Purpose of Action	LEVEL 5
Deficiency Photo1

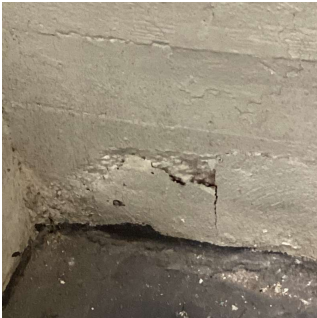
Boiler Room (Basement Fan Area similar)
Violations	No violations recorded.
Deficiency	CONCRETE: CRACKED/SPALLED/REINFORCEMENT EXPOSED
Deficiency Location/Instance	Basement

Deficiency Quantity	55
Quantity Uom	S.F.
Potential Action	REPAIR
Urgency of Action	PRIORITY 4

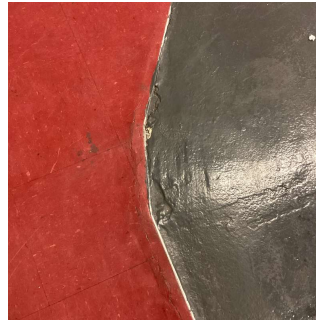
Right Side

CONCRETE: CRACKS

REPLACE

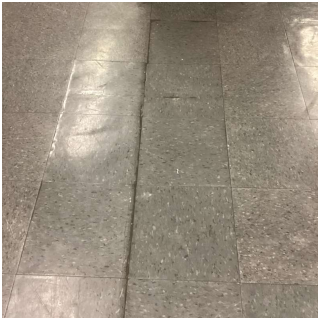
Center

Deficiency	VINYL TILES: DETERIORATED SUBSTRATE
Deficiency Location/Instance	Center, near Stairs EF, GH, by Room B14, close to Drinking Fountain and others
Deficiency Quantity	120
Quantity Uom	S.F.
Potential Action	REPLACE
Urgency of Action	PRIORITY 3
Purpose of Action	LEVEL 2
Deficiency Photo1

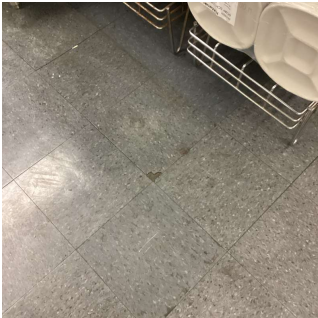
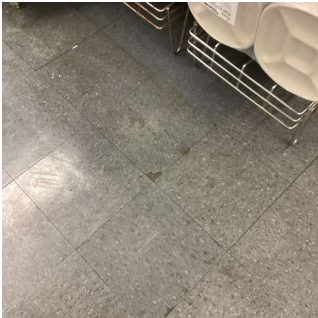
Deficiency	VINYL TILES: BROKEN/DETERIORATED/MISSING TILES
Deficiency Location/Instance	Near Room B14, by Stair EF, next to Kitchen Women Locker Room, close to Fridges
Deficiency Quantity	40
Quantity Uom	S.F.
Potential Action	REPLACE
Urgency of Action	PRIORITY 3
Purpose of Action	LEVEL 2
Deficiency Photo1

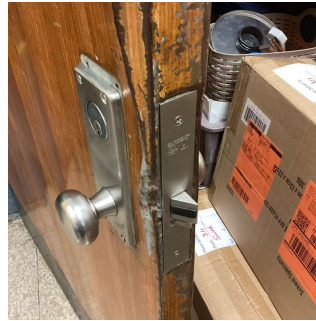
Violations	Near Kitchen No violations recorded.
<b>Window Curtains/Shades/Blinds</b>	
Instance on Basement	Does not Exist
<b>CLASSROOMS/CORRIDORS/ADMIN SPACES</b>	
Inspected	Inspected
<b>Ceiling</b>	
Condition	2 - Between Good and Fair
Deficiency	No deficiencies recorded
<b>Door(s)</b>	
Condition	5 - Poor
Deficiency	METAL: DETERIORATED DOOR

Deficiency Location/Instance	Room 202
Deficiency Quantity	1
Quantity Uom	EACH
Potential Action	MAINTENANCE
Urgency of Action	PRIORITY 3
Purpose of Action	LEVEL 2

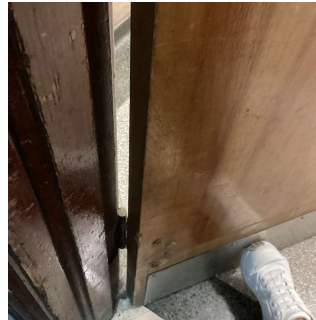
Main Entrance

WOOD: DETERIORATED DOOR

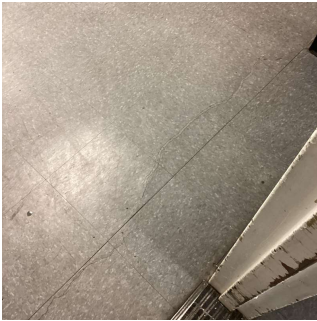
Violations	Room 435A No violations recorded.
Deficiency	VINYL TILES: DETERIORATED SUBSTRATE
Deficiency Location/Instance	Room 126, Corridor near Rooms B03, 112, 121, 123 and others
Deficiency Quantity	180
Quantity Uom	S.F.
Potential Action	REPLACE
Urgency of Action	PRIORITY 3
Purpose of Action	LEVEL 2
Deficiency Photo1

Violations	Corridor near Room B03 No violations recorded.
Deficiency	VINYL TILES: BROKEN/DETERIORATED/MISSING TILES
Deficiency Location/Instance	Rooms 320, 227, 213, 131, Corridor near Room 202 and others
Deficiency Quantity	1,050
Quantity Uom	S.F.

Potential Action	REPLACE
Urgency of Action	PRIORITY 3
Purpose of Action	LEVEL 2

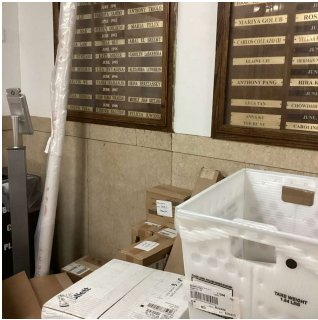
Violations	Corridor near Room 418 No violations recorded.
Deficiency	STONE MOLDINGS: CRACKS/SPALLING
Deficiency Location/Instance	Corridor near Main Entrance Lobby, Exit 2 - Vestibule
Deficiency Quantity	50
Quantity Uom	L.F.
Potential Action	REPLACE
Urgency of Action	PRIORITY 3
Purpose of Action	LEVEL 2
Deficiency Photo1

Violations	Corridor near Main Entrance Lobby No violations recorded.
Deficiency	STONE: CRACKS/SPALLING
Deficiency Location/Instance	Corridor near Main Entrance Lobby, Exit 3 - Vestibule

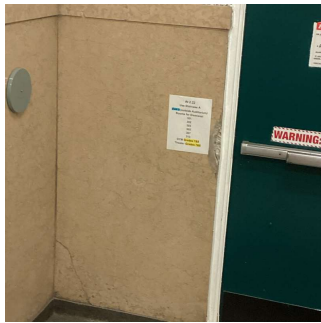
Violations	Exit 3 - Vestibule No violations recorded.
Deficiency	PLASTER: CRACKS/SPALLING
Deficiency Location/Instance	Room B14, Corridor near Room 212
Deficiency Quantity	30
Quantity Uom	S.F.
Potential Action	REPLACE
Urgency of Action	PRIORITY 3
Purpose of Action	LEVEL 2
Deficiency Photo1	 
Violations	Room B14 No violations recorded.
<b>Specialties</b>	Does not Exist
<b>GYMNASIUM</b>	Inspected
Instance on 3rd Floor	Inspected
Instance on 4th Floor	Inspected
<b>Ceiling</b>	Inspected
Instance on 4th Floor	Inspected
Condition	2 - Between Good and Fair
Deficiency	PLASTER: CRACKS/SPALLING
Deficiency Location/Instance	Near Right and Left Side Windows
Deficiency Quantity	80
Quantity Uom	S.F.
Potential Action	REPLACE
Urgency of Action	PRIORITY 3
Purpose of Action	LEVEL 2
