NYC Department of Education
Building Condition Assessment Survey 2023 - 2024

Architectural Inspection

K097

Asset: P.S. 97 - BROOKLYN, 1855 STILLWELL AVENUE, New York, 11223

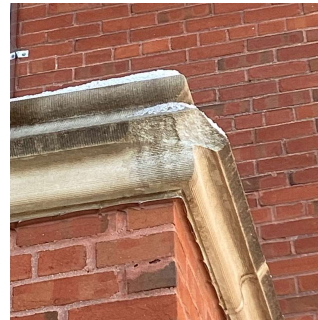
Facade J

Question	Response
Architectural	
EXTERIOR	Inspected
AREAWAY	Inspected
Instance on AW1	Inspected
Instance Condition	2 - Between Good and Fair
Instance Quantity	1
Instance Quantity Uom	EACH
Deficiency	No deficiencies recorded
AWNINGS AND CANOPIES	Inspected
Condition	1 - Good
Deficiency	No deficiencies recorded
CHIMNEY	Inspected
Material Type(s)	Masonry, Metal
Condition	2 - Between Good and Fair
Deficiency	No deficiencies recorded
COPING	Inspected
Condition	3 - Fair
Deficiency	CAST STONE: CRACKED/BROKEN PIECES

10
L.F.
REPLACE-IN-KIND
PRIORITY 4
LEVEL 2

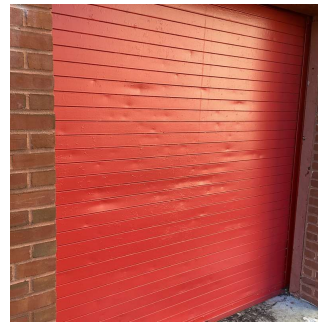
Facade G

ROLL-UP DOOR: DETERIORATED DOOR - MINOR DETERIORATION

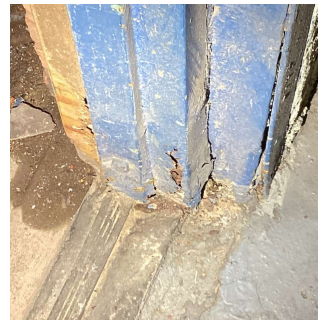
Boiler Room

METAL: DETERIORATED DOOR AND FRAME - MAJOR DETERIORATION

REPLACE

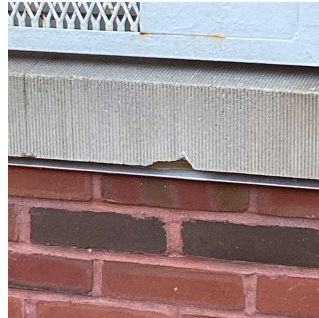
Question	Response
EXTERIOR	
EXTERIOR WALLS	Inspected
Material Type(s)	Masonry
Replacement Quantity	51,300
Replacement Uom	S.F.
Instance on All Facades except 2021 Addition	Inspected
Instance Condition	3 - Fair
Instance Quantity	33,000
Instance Quantity Uom	S.F.
Deficiency	BRICK: DETERIORATED MASONRY SILLS - MINOR
Roof Plan reference

Deficiency Quantity	20
Quantity Uom	L.F.
Potential Action	REPAIR
Urgency of Action	PRIORITY 3
Purpose of Action	LEVEL 2
Deficiency Photo1

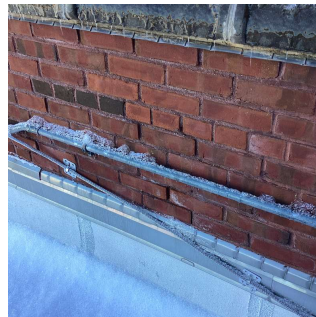
Roof 3
No violations recorded.

BRICK: DETERIORATED JOINTS

420
S.F.
REPOINT
PRIORITY 3
LEVEL 2

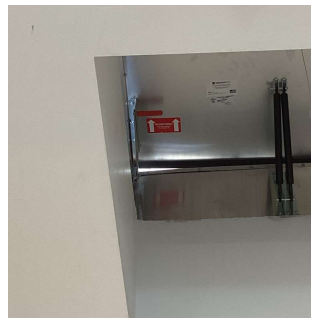
Question	Response
EXTERIOR	
PLAZA DECK	Inspected
Instance on Concrete: Roof 11	Inspected
Instance Condition	1 - Good
Instance Quantity	1,200
Instance Quantity Uom	S.F.
Installation Year	2021
Source of Installation	Custodial Staff
Deficiency	No deficiencies recorded
ROOF	Inspected
Roofing	Inspected
Replacement Quantity	43,000
Replacement Uom	S.F.
ROOF HATCH/SMOKE HATCH	Inspected
Condition	5 - Poor
Deficiency	DETERIORATED
Roof Plan reference

Deficiency Quantity	1
Quantity Uom	EACH
Potential Action	REPLACE
Urgency of Action	PRIORITY 4
Purpose of Action	LEVEL 2
Deficiency Photo1

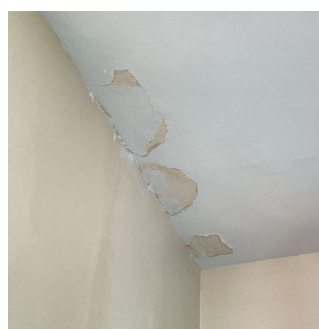
Question	Response
EXTERIOR	
ROOF	
Roofing	
ROOFING	
Does the roof have major mechanical equipment sitting on Dunnage Steel less than 18" above the Roofing?	No
Does this roof instance have a Sustainable Roof System?	Yes
Sustainable Roof Type	White Roof
Sustainable Roof Location (Roof Number)	Roofs 1-7
Do solar panels exist on these roofs?	No
Is/Are the roof(s) suitable for Solar Panel installation?	Yes
Installation Year	2014
Source of Installation	Custodial Staff
Deficiency	MODIFIED BITUMEN: ROOFING: MAJOR ACTIVE ROOF LEAKS IN INSTRUCTIONAL SPACE
Roof Plan reference

Deficiency Quantity	100
Quantity Uom	S.F.
Potential Action	REPLACE ROOFING WITHOUT MAJOR EQUIPMENT REMOVAL
Urgency of Action	PRIORITY 5
Purpose of Action	LEVEL 2
Deficiency Photo1

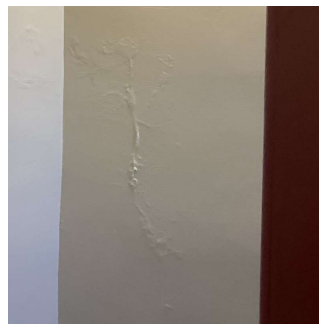
Question	Response
EXTERIOR	
ROOF	
Roofing	
ROOFING	
Instance Quantity Uom	S.F.
Does the roof have major mechanical equipment sitting on Dunnage Steel less than 18" above the Roofing?	No
Does this roof instance have a Sustainable Roof System?	No
Do solar panels exist on these roofs?	No
Is/Are the roof(s) suitable for Solar Panel installation?	Yes
Installation Year	2021
Source of Installation	Custodial Staff
Deficiency	No deficiencies recorded
ROOFING DRAINS	Inspected
Condition	2 - Between Good and Fair
Deficiency	No deficiencies recorded
Specialties	Inspected
BULKHEAD/PENTHOUSE	Inspected
Condition	3 - Fair
Deficiency	BULKHEAD/PENTHOUSE WALLS/EXTERIOR: WATER INFILTRATION
Roof Plan reference

Deficiency Quantity	50
Quantity Uom	S.F.
Potential Action	REPAIR
Urgency of Action	PRIORITY 5
Purpose of Action	LEVEL 2
Deficiency Photo1

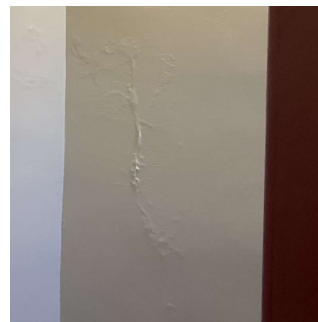
BH1
No violations recorded.

Violations	BH1
Deficiency	No violations recorded.
Deficiency	BULKHEAD/PENTHOUSE WALLS/INTERIOR: PLASTER CRACKS/SPALLING

20
S.F.
REPLACE
PRIORITY 3
LEVEL 2

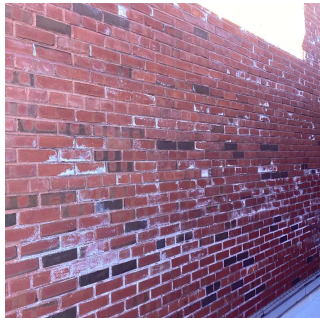
Violations	PH3 No violations recorded.
Deficiency	BULKHEAD/PENTHOUSE WALLS/EXTERIOR: EFFLORESCENCE
Roof Plan reference

Deficiency Quantity	100
Quantity Uom	S.F.
Potential Action	MAINTENANCE
Urgency of Action	PRIORITY 1
Purpose of Action	LEVEL 1
Deficiency Photo1

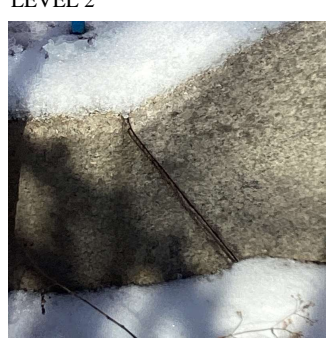
Question	Response
EXTERIOR	
ROOF	Inspected
Specialties	Inspected
SKYLIGHT/ROOF VENT	Inspected
Condition	1 - Good
Deficiency	No deficiencies recorded
ROOF/GRAVITY TANK	Does not Exist
STAIRS/RAMPS: EXTERIOR	Inspected
BUILDING CHEEK/FLANK WALLS	Inspected
Condition	3 - Fair
Deficiency	STONE: DETERIORATED JOINTS
Roof Plan reference

Deficiency Quantity	15
Quantity Uom	S.F.
Potential Action	REPOINT
Urgency of Action	PRIORITY 3
Purpose of Action	LEVEL 2
Deficiency Photo1

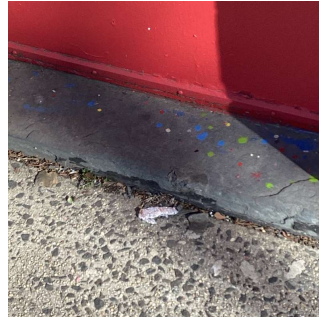
Violations	Facade A No violations recorded.
RAILINGS	Inspected
Condition	2 - Between Good and Fair
Deficiency	No deficiencies recorded
STAIRS/RAMPS	Inspected
Condition	5 - Poor
Deficiency	STONE: WORN-OUT TREAD/RISER/NOSING

Deficiency Quantity	25
Quantity Uom	S.F.
Potential Action	REPLACE
Urgency of Action	PRIORITY 4
Purpose of Action	LEVEL 2
Deficiency Photo1

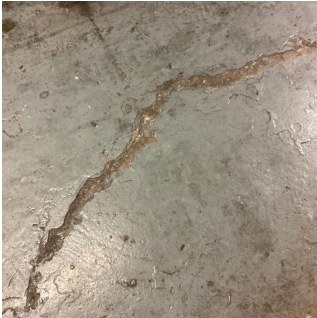
Violations	Boiler Room No violations recorded.
Deficiency	CONCRETE SLAB ON GRADE: THRU CRACKS
Deficiency Location/Instance	1st Floor
Deficiency Quantity	60
Quantity Uom	S.F.
Potential Action	REPLACE
Urgency of Action	PRIORITY 4
Purpose of Action	LEVEL 5
Deficiency Photo1

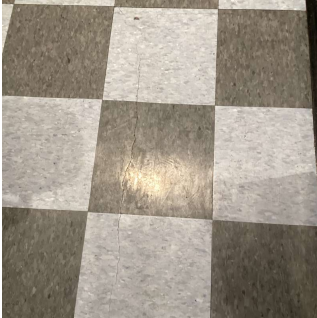
Question	Response
INTERIOR	
AUDITORIUM	
Floor Finish	
Condition	2 - Between Good and Fair
Deficiency	VINYL TILES: DETERIORATED SUBSTRATE
Deficiency Location/Instance	Aisle near H/2, Near Entrance, Near seats C/1, B/7
Deficiency Quantity	40
Quantity Uom	S.F.
Potential Action	REPLACE
Urgency of Action	PRIORITY 3
Purpose of Action	LEVEL 2
Deficiency Photo1

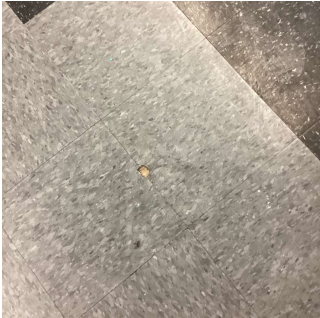
Violations	Near Servery No violations recorded.
Deficiency	VINYL TILES: BROKEN/DETERIORATED/MISSING TILES
Deficiency Location/Instance	Center
Deficiency Quantity	15
Quantity Uom	S.F.
Potential Action	REPLACE
Urgency of Action	PRIORITY 3
Purpose of Action	LEVEL 2
Deficiency Photo1

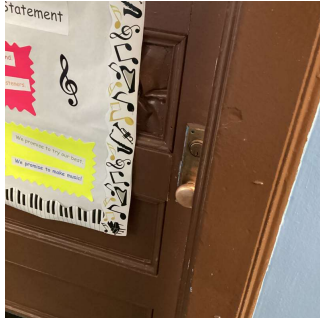
Question	Response
INTERIOR	
CLASSROOMS/CORRIDORS/ADMIN SPACES	
Door(s)	
Deficiency	METAL CLAD WOOD: DETERIORATED DOOR
Deficiency Location/Instance	Room 402
Deficiency Quantity	1
Quantity Uom	EACH
Potential Action	MAINTENANCE
Urgency of Action	PRIORITY 3
Purpose of Action	LEVEL 2
Deficiency Photo1

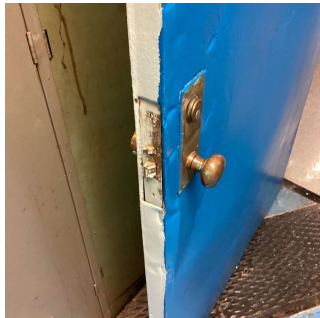
Room 402
Violations	No violations recorded.
Deficiency	METAL: DETERIORATED DOOR
Deficiency Location/Instance	Room 106
Deficiency Quantity	1
Quantity Uom	EACH
Potential Action	MAINTENANCE
Urgency of Action	PRIORITY 3
Purpose of Action	LEVEL 2
Deficiency Photo1

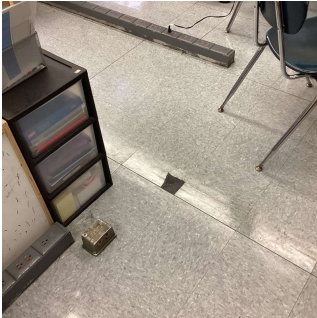
Question	Response
INTERIOR	
CLASSROOMS/CORRIDORS/ADMIN SPACES	
Floor Finish	
Deficiency	VINYL TILES: TRIPPING HAZARD - ELECTRICAL OUTLET
Deficiency Location/Instance	Room 308
Deficiency Quantity	20
Quantity Uom	S.F.
Potential Action	REMOVE
Urgency of Action	PRIORITY 5
Purpose of Action	LEVEL 6
Deficiency Photo1

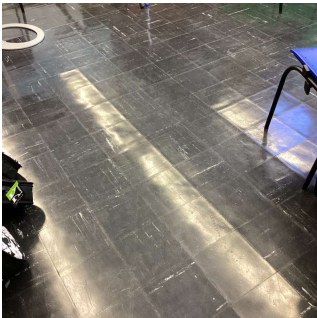
Room 308
Violations	No violations recorded.
Deficiency	VINYL TILES: DETERIORATED SUBSTRATE
Deficiency Location/Instance	Rooms 401, 208
Deficiency Quantity	200
Quantity Uom	S.F.
Potential Action	REPLACE
Urgency of Action	PRIORITY 3
Purpose of Action	LEVEL 2
Deficiency Photo1

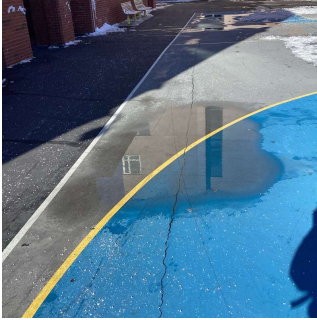
Question	Response
SITE	
PAVING	
Student Use	
Asphalt	Inspected
Condition	3 - Fair
Deficiency	CRACKS - MAJOR
Deficiency Location/Instance	Schoolyard
Deficiency Quantity	350
Quantity Uom	S.F.
Potential Action	REPLACE
Urgency of Action	PRIORITY 3
Purpose of Action	LEVEL 2
Deficiency Photo1

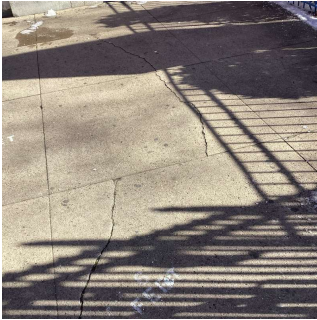
Question	Response
SITE	
PAVING	
Site Sidewalks & Walkways	
Concrete	
Deficiency	CRACKS - MAJOR
Deficiency Location/Instance	Exits 3, 2
Deficiency Quantity	150
Quantity Uom	S.F.
Potential Action	REPLACE
Urgency of Action	PRIORITY 3
Purpose of Action	LEVEL 2
Deficiency Photo1
