NYC Department of Education
Building Condition Assessment Survey 2023 - 2024

Architectural Inspection

Asset: P.S. 99 - BROOKLYN, 1120 EAST 10 STREET, New York, 11230

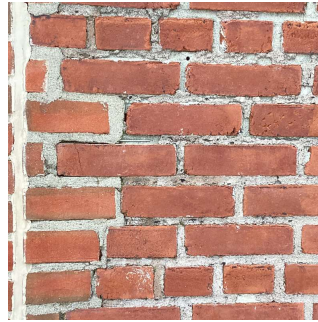
Chimney

CHIMNEY

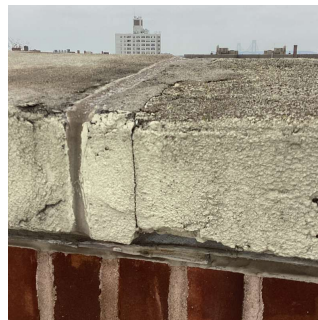
Roof 1

CAST STONE: CRACKED/BROKEN PIECES

REPLACE-IN-KIND

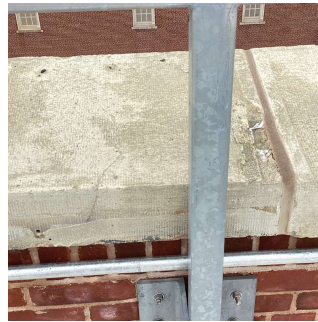
Roof 1
No violations recorded.

TERRA COTTA: CRACKED/BROKEN PIECES

COPING

80
L.F.
REPLACE-IN-KIND
PRIORITY 4
LEVEL 2

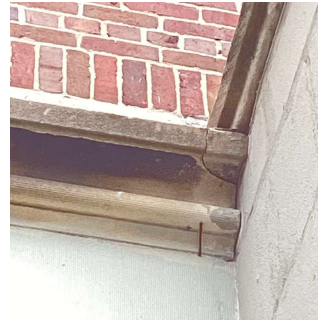
Facade B

STONE: MINOR CRACKS, SPALLING

CORNICE

10
S.F.
REPAIR
PRIORITY 3
LEVEL 2

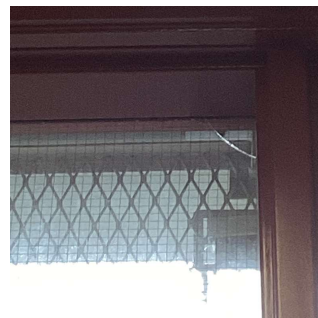
METAL: BROKEN GLASS

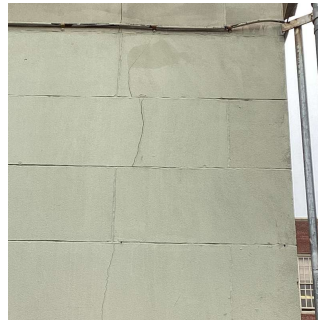
Facade G

STONE: CRACKS AT BUILDING CORNERS

REPLACE

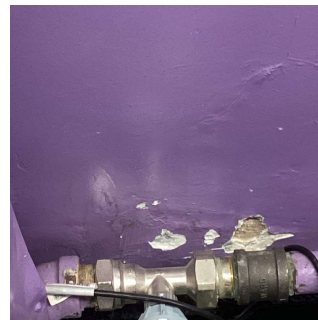
Facade A - Room 109

BRICK: WATER INFILTRATION IN INSTRUCTIONAL SPACE

REPAIR

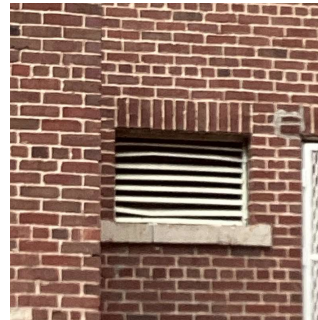
Facade F

BROKEN/ DENTED BLADES

REPLACE

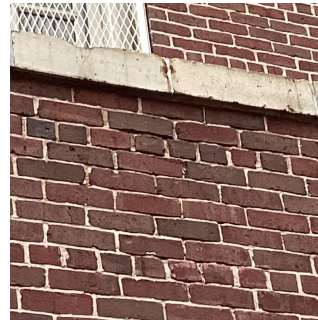
Roof 6

BRICK: DETERIORATED JOINTS

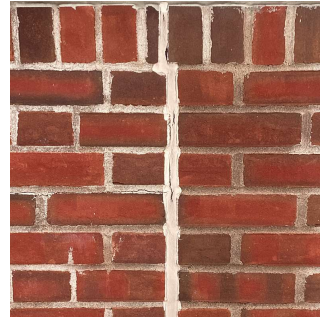
Roof 1

BRICK: DETERIORATED CONTROL/EXPANSION JOINT

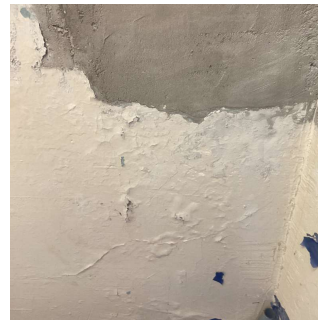
BH1
No violations recorded.

**BULKHEAD/PENTHOUSE WALLS/INTERIOR: PLASTER
CRACKS/SPALLING**

25
S.F.
REPLACE
PRIORITY 4
LEVEL 2

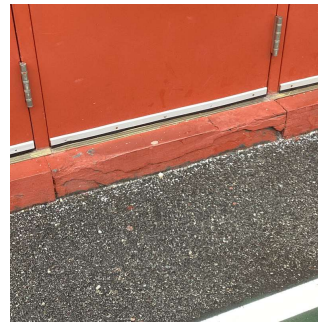
Facade B - Exit 4

STONE: CRACKS/SPALLING - MAJOR

REPLACE

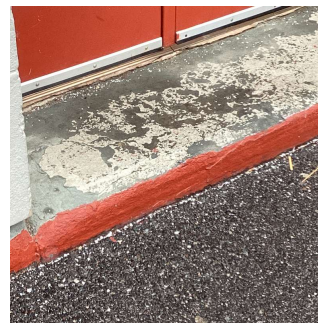
Facade B

STONE: WORN-OUT TREAD/RISER/NOSING

REPLACE

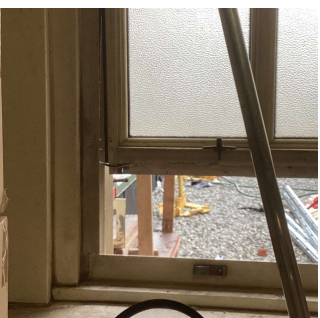
Question	Response
EXTERIOR	
WINDOWS	
WINDOWS	Inspected
Material Type(s)	Aluminum
Instance on Aluminum - Double Hung: All Facades	Inspected
Instance Condition	3 - Fair
Instance Quantity	15,000
Instance Quantity Uom	S.F.
Are these windows insulated	No
Installation Year	1997
Source of Installation	Custodial Staff
Deficiency	ALUMINUM - DOUBLE HUNG: INOPERABLE BALANCE
Roof Plan reference	<p>K099</p>

Deficiency Quantity	600
Quantity Uom	EACH
Potential Action	REPLACE BALANCES
Urgency of Action	PRIORITY 3
Purpose of Action	LEVEL 2
Deficiency Photo1

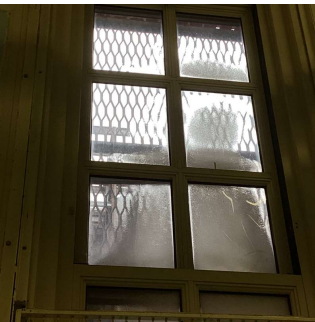
Violations	Facade E No violations recorded.
Deficiency	ALUMINUM - DOUBLE HUNG: DETERIORATED

Deficiency Quantity	30
Quantity Uom	S.F.
Potential Action	REPLACE WINDOW
Urgency of Action	PRIORITY 4
Purpose of Action	LEVEL 2
Deficiency Photo1

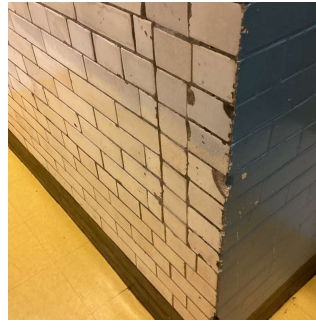
Violations	Front No violations recorded.
Floor Finish	
Instance on Basement- East	Inspected
Condition	1 - Good
Deficiency	No deficiencies recorded
Instance on Basement- West	Inspected
Condition	1 - Good
Deficiency	No deficiencies recorded
Sliding-folding Partition	
Instance on Basement- East	Does not Exist
Instance on Basement- West	Does not Exist
Stage	
Instance on Basement- West	Does not Exist
Instance on Basement- East	Does not Exist
Walls	
Instance on Basement- East	Inspected
Condition	2 - Between Good and Fair
Deficiency	BRICK: CRACKS/SPALLING
Deficiency Location/Instance	Near Girls Restroom
Deficiency Quantity	15
Quantity Uom	S.F.

Potential Action	REPLACE
Urgency of Action	PRIORITY 3
Purpose of Action	LEVEL 2

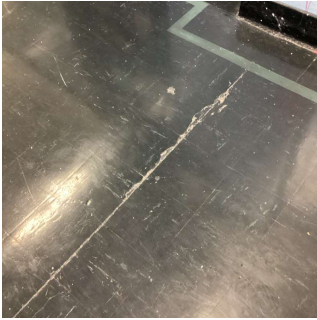
Violations	Room 217 No violations recorded.
Deficiency	VINYL TILES: BROKEN/DETERIORATED/MISSING TILES
Deficiency Location/Instance	Room 305,308, 315 Corridor near room 306, 307, and others
Deficiency Quantity	8,000
Quantity Uom	S.F.
Potential Action	REPLACE
Urgency of Action	PRIORITY 3
Purpose of Action	LEVEL 2
Deficiency Photo1

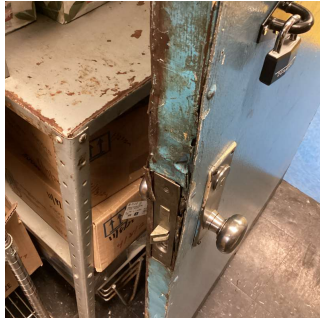
Question	Response
INTERIOR	
KITCHEN	
Door(s)	
Deficiency	METAL CLAD WOOD: DETERIORATED DOOR AND FRAME
Deficiency Location/Instance	Storage Room
Deficiency Quantity	1
Quantity Uom	EACH
Potential Action	MAINTENANCE
Urgency of Action	PRIORITY 3
Purpose of Action	LEVEL 2
Deficiency Photo1

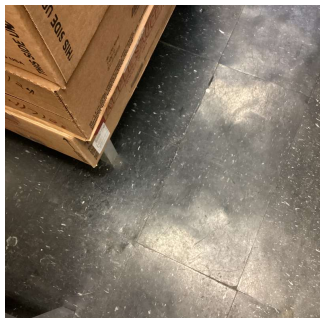
Storage Room
Violations	No violations recorded.
Floor Finish	
Instance on Basement	Inspected
Condition	3 - Fair
Deficiency	VINYL TILES: BROKEN/DETERIORATED/MISSING TILES
Deficiency Location/Instance	Storage room
Deficiency Quantity	35
Quantity Uom	S.F.
Potential Action	REPLACE
Urgency of Action	PRIORITY 3
Purpose of Action	LEVEL 2
Deficiency Photo1
