NYC Department of Education
Building Condition Assessment Survey 2023 - 2024

Architectural Inspection

Asset: P.S. 102 - BROOKLYN, 211 72 STREET, New York, 11209

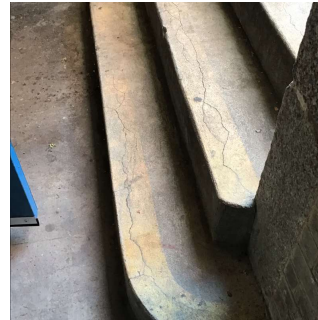
AW9

AREAWAY WALLS: CRACKS AND SPALLING

REPAIR

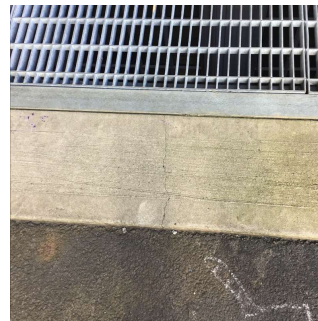
AW8

AREAWAY DRAINS: DETERIORATED

REPLACE

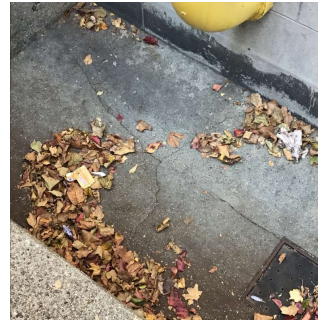
AW6

AREAWAY SLAB: CRACKS AND SPALLING

REPAIR

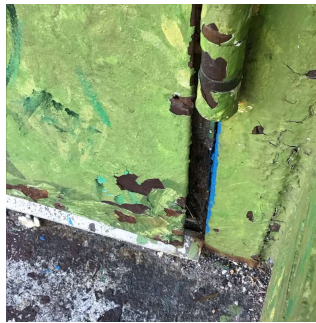
Facade L - Exit 4

METAL CLAD: DETERIORATED DOOR - MAJOR DETERIORATION

2
EACH
REPLACE
PRIORITY 4
LEVEL 2

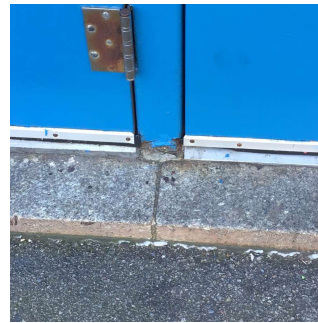
Facade L - Exit 2

METAL: DETERIORATED DOOR AND FRAME - MINOR DETERIORATION

7
EACH
MAINTENANCE
PRIORITY 3
LEVEL 2

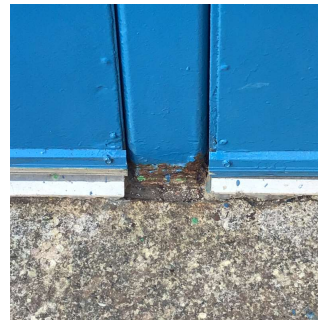
Facade D - Exit 8

METAL CLAD: DETERIORATED DOOR AND FRAME - MAJOR DETERIORATION

REPLACE

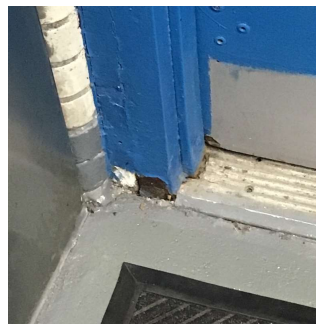
Facade K - Exit 7

METAL CLAD: DETERIORATED DOOR AND FRAME - MINOR DETERIORATION

2
EACH
MAINTENANCE
PRIORITY 3
LEVEL 2

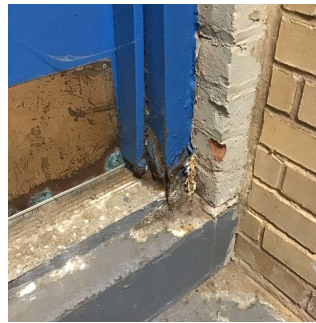
Facade E - Exit 9

METAL: DETERIORATED DOOR AND FRAME - MAJOR DETERIORATION

3
EACH
REPLACE
PRIORITY 4
LEVEL 2

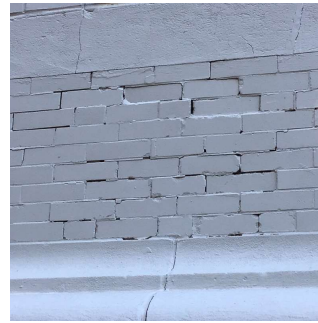
Facade J

BRICK: DETERIORATED JOINTS

S.F.
REPOINT
PRIORITY 4
LEVEL 2

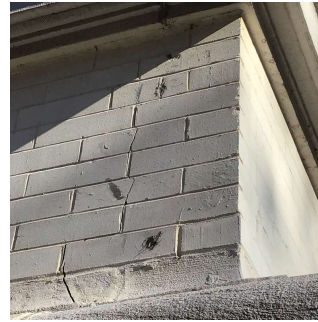
Corner of Facades E and F

BRICK: CRACKS/DISPLACED/SPALLED BRICK AT BUILDING CORNERS

30
S.F.
REMOVE AND REBUILD
PRIORITY 4
LEVEL 2

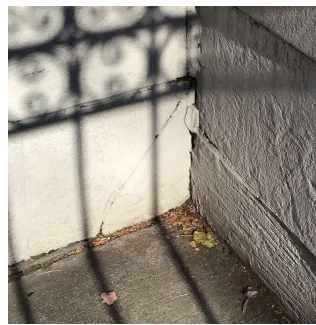
Facade F

<p>Facade F</p> <p>No violations recorded.</p>
Deficiency	CAST IN PLACE CONCRETE: CRACKS/SPALLING - MAJOR

20
S.F.
REPLACE
PRIORITY 4
LEVEL 2

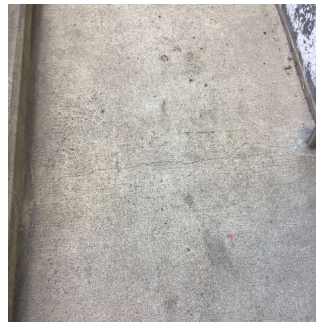
Facade K - HC Ramp
No violations recorded.

CONCRETE: CRACKS/SPALLING - MINOR

80
S.F.
REPAIR
PRIORITY 3
LEVEL 2

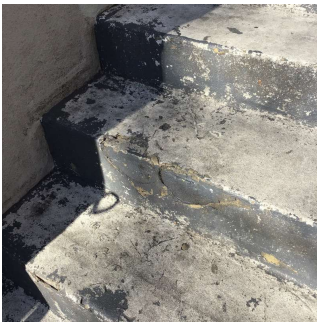
Violations	Facade F No violations recorded.
Deficiency	STONE: CRACKS/SPALLING - MAJOR
Roof Plan reference	K102

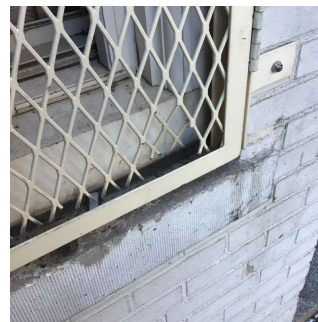
Facade L
No violations recorded.

Violations	Facade A - Main Entrance No violations recorded.
WINDOWS	Inspected
Replacement Quantity	18,000
Replacement Uom	S.F.
EXTERIOR GUARDS	Inspected
Condition	3 - Fair
Deficiency	DETERIORATED/TORN-OUT/MISSING

30
S.F.
REPLACE
PRIORITY 4
LEVEL 2

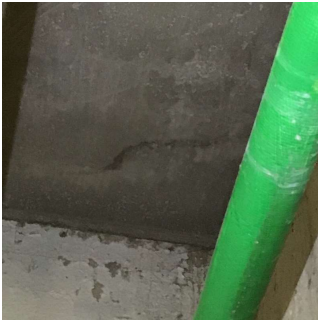
Violations	Boiler Room Vault No violations recorded.
Deficiency	STEEL COLUMNS/BEAMS: DETERIORATED CONCRETE FIREPROOFING

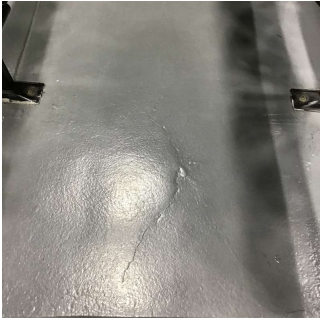
Question	Response
INTERIOR	
AUDITORIUM	
Floor Finish	
Deficiency	CONCRETE: CRACKS
Deficiency Location/Instance	Near F,R Rows
Deficiency Quantity	30
Quantity Uom	S.F.
Potential Action	REPLACE
Urgency of Action	PRIORITY 3
Purpose of Action	LEVEL 2
Deficiency Photo1

Violations	Near F Row No violations recorded.
Sliding-folding Partition	
Instance on 1st Floor (480 Seats)	Does not Exist
Stage	
Instance on 1st Floor (480 Seats)	Inspected
Stage	Inspected
Instance on 1st Floor (480 Seats)	Inspected
Condition	2 - Between Good and Fair
Deficiency	DAMAGED STEPS
Deficiency Location/Instance	Right and Left Side
Deficiency Quantity	20
Quantity Uom	S.F.
Potential Action	REPLACE
Urgency of Action	PRIORITY 3
Purpose of Action	LEVEL 2
Deficiency Photo1

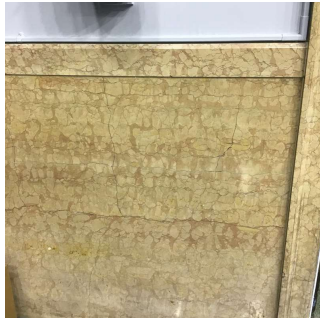
Violations	Near Entrance No violations recorded.
Deficiency	STONE: CRACKS/SPALLING
Deficiency Location/Instance	Near Entrance, Right and Left Side
Deficiency Quantity	100
Quantity Uom	S.F.
Potential Action	REPLACE
Urgency of Action	PRIORITY 3
Purpose of Action	LEVEL 2
Deficiency Photo1

Violations	Near Entrance No violations recorded.
Window Curtains/Shades/Blinds	
Instance on 1st Floor (480 Seats)	Inspected
Condition	1 - Good

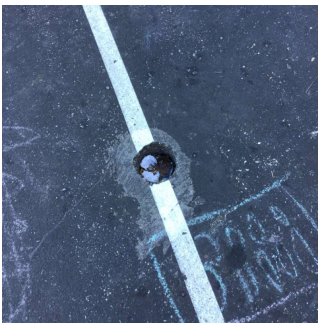
Priority Condition Exist Last Year?	Priority Category	Condition Description	Component Affected	Location Description	Person(s) Notified	Person(s) Title	PhotoImage
No	Tripping Hazard	A hole in Asphalt Paving is a potential tripping hazard.	SITE PAVING Student Use Asphalt	Schoolyard - Near Exit 2	Angelo Rotolo	Custodian

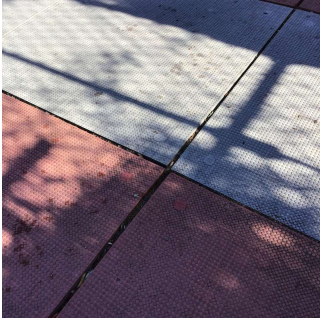
Question	Response
SITE	
PLAYGROUNDS	
Safety Surfacing	
Condition	3 - Fair
Deficiency	DETERIORATED/MISSING
Deficiency Location/Instance	Left Side
Deficiency Quantity	200
Quantity Uom	S.F.
Potential Action	MAINTENANCE
Urgency of Action	PRIORITY 3
Purpose of Action	LEVEL 2
Deficiency Photo1

Violations	Left Side No violations recorded.
Unpaved Area	
Instance on Schoolyard - East	Does not Exist
PLAYING SURFACE	
	Inspected
Playing Field	
	Does not Exist
Running Track	
	Does not Exist
RETAINING WALLS	
	Inspected
Are there any Retaining Walls 6' OR higher facing public street/sidewalk?	No
Condition	3 - Fair
Deficiency	CAST IN PLACE CONCRETE: DETERIORATED COPING STONE
Deficiency Location/Instance	Ridge Boulevard
Deficiency Quantity	10
Quantity Uom	S.F.
Potential Action	REPLACE
Urgency of Action	PRIORITY 3
Purpose of Action	LEVEL 2
Deficiency Photo1
