NYC Department of Education
Building Condition Assessment Survey 2023 - 2024

Architectural Inspection

Asset: P.S. 104 - BROOKLYN, 9115 5TH AVENUE, New York, 11209

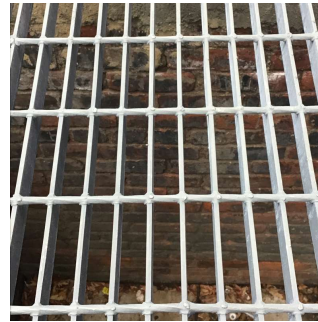
AW5

Question	Response
Architectural	
EXTERIOR	Inspected
AREAWAY	Inspected
Instance on AW1 - AW6	Inspected
Instance Condition	3 - Fair
Instance Quantity	6
Instance Quantity Uom	EACH
Deficiency	AREAWAY WALLS: DETERIORATED JOINTS

REPAIR

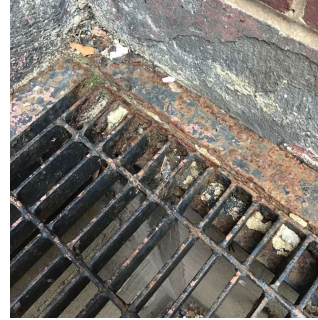
AW4

AREAWAY GRATINGS: MAJOR RUSTING / OR BROKEN

REPLACE

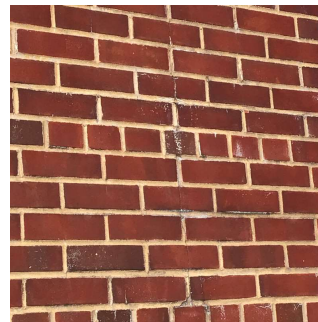
BRICK: MINOR CRACKS AND SPALLING

20
S.F.
RESTITCH
PRIORITY 3
LEVEL 2

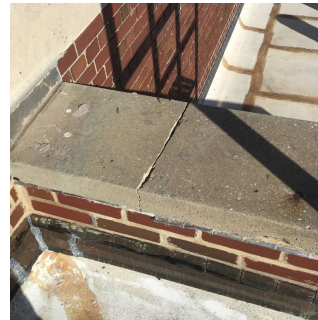
BH1
No violations recorded.

CAST STONE: CRACKED/BROKEN PIECES

20
L.F.
REPLACE-IN-KIND
PRIORITY 4
LEVEL 2

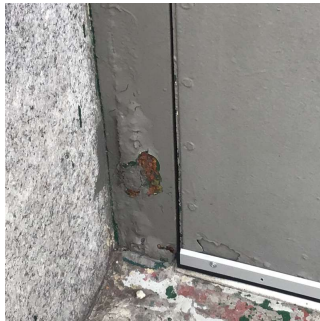
METAL CLAD: DETERIORATED DOOR AND FRAME - MINOR DETERIORATION

6
EACH
MAINTENANCE
PRIORITY 3
LEVEL 2

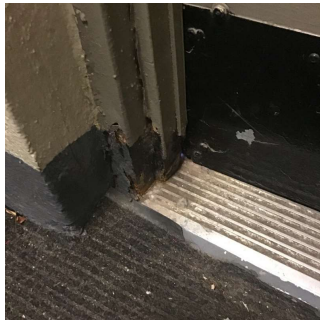
Violations	Facade G - Exit 6 No violations recorded.
Deficiency	METAL CLAD: DETERIORATED DOOR AND FRAME - MAJOR DETERIORATION
Roof Plan reference	K104

Deficiency Quantity	4
Quantity Uom	EACH
Potential Action	REPLACE
Urgency of Action	PRIORITY 4
Purpose of Action	LEVEL 2
Deficiency Photo1

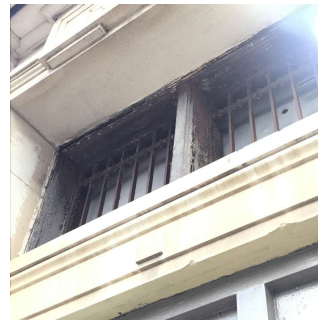
Facade G - Exit 5

WOOD: EXCESSIVELY WEATHERED

60
S.F.
REPAIR
PRIORITY 3
LEVEL 2

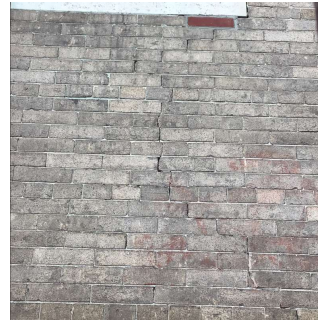
Question	Response
EXTERIOR	
DOORS	
TRANSOM/SIDE LIGHT	
Deficiency Photo1	 
Violations	Facade H - Exit 3 No violations recorded.
EXTERIOR WALLS	Inspected
Material Type(s)	Masonry
Replacement Quantity	37,000
Replacement Uom	S.F.
Instance on All Facades	Inspected
Instance Condition	3 - Fair
Instance Quantity	37,000
Instance Quantity Uom	S.F.
Deficiency	BRICK: MAJOR / THRU CRACKS
Roof Plan reference	K104  
Elevation	 
Deficiency Quantity	20
Quantity Uom	S.F.
Potential Action	REMOVE AND REBUILD
Urgency of Action	PRIORITY 4
Purpose of Action	LEVEL 2

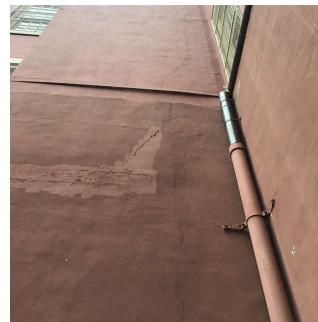
Facade E

STUCCO CEMENT SURFACE: CRACKS, SPALLING

REPLACE

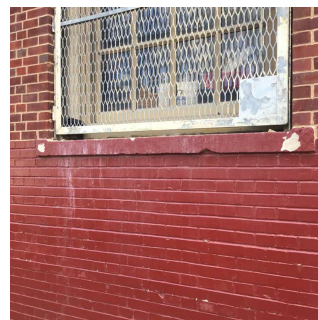
Facade B

BRICK: DETERIORATED MASONRY SILLS - MINOR

100
L.F.
REPAIR
PRIORITY 3
LEVEL 2

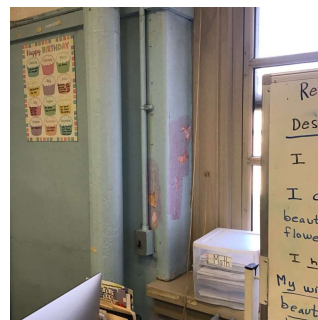
BRICK: WATER INFILTRATION IN INSTRUCTIONAL SPACE

Facade D - Room 211 shown, Facade G - Room 126 similar

REPAIR

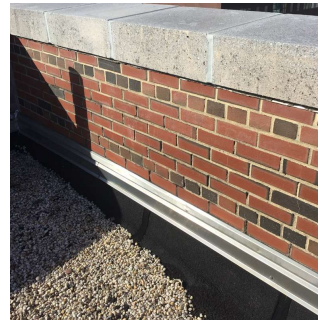
Roof 1 - Facade A
 No violations recorded.

Violations	Roof 1 - Facade D 35665478N
Deficiency	BRICK: DETERIORATED JOINTS

100
 S.F.
 REPOINT
 PRIORITY 3
 LEVEL 2

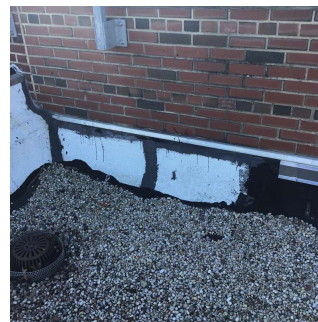
Roof 1 - Facade H
No violations recorded.

Roof 1
Instance Quantity	9,500
Instance Quantity Uom	S.F.
Does the roof have major mechanical equipment sitting on Dunnage Steel less than 18" above the Roofing?	No
Does this roof instance have a Sustainable Roof System?	No
Do solar panels exist on these roofs?	No
Is/Are the roof(s) suitable for Solar Panel installation?	No
Installation Year	2007
Source of Installation	Custodial Staff
Deficiency	BUILT-UP: FLASHING: CAP FLASHING MISSING

10
L.F.
INSTALL NEW
PRIORITY 4
LEVEL 2

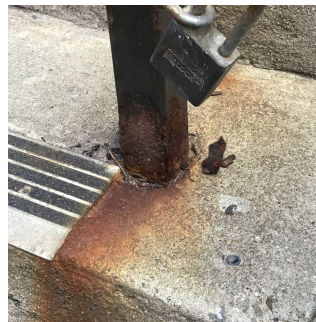
Facade C

RUST - MAJOR

10
 L.F.
 REPLACE
 PRIORITY 4
 LEVEL 2

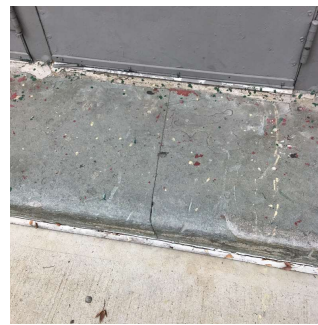
Facade G - Exit 5
No violations recorded.

STONE: CRACKS/SPALLING - MINOR

30
S.F.
REPAIR
PRIORITY 3
LEVEL 2

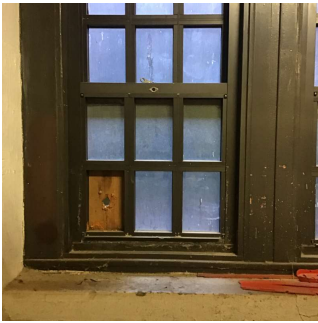
ALUMINUM - DOUBLE HUNG: BROKEN PANE

Violations	Facade C - Sub-Basement/Work Shop No violations recorded.
INTERIOR	
POOLS	Does not Exist
STRUCTURAL	Inspected
COLUMNS/BEAMS/BEARING WALLS	Inspected
Condition	3 - Fair
Deficiency	STEEL COLUMNS/BEAMS: DETERIORATED CONCRETE FIREPROOFING
Deficiency Location/Instance	Sub-Basement - Boiler Room, Mechanical Equipment Room West
Deficiency Quantity	20
Quantity Uom	S.F.
Potential Action	REPLACE
Urgency of Action	PRIORITY 3
Purpose of Action	LEVEL 5
Deficiency Photo1

30
S.F.
MAINTENANCE
PRIORITY 3
LEVEL 2

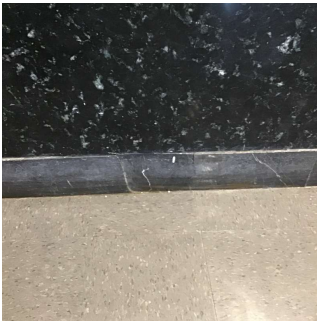
Violations	Left Side No violations recorded.
Window Curtains/Shades/Blinds	
Instance on Basement (705 Seats)	Inspected
Condition	5 - Poor
Deficiency	WORN/DAMAGED CURTAINS
Deficiency Location/Instance	Right and Left Side
Deficiency Quantity	400
Quantity Uom	S.F.
Potential Action	MAINTENANCE
Urgency of Action	PRIORITY 3
Purpose of Action	LEVEL 2
Deficiency Photo1

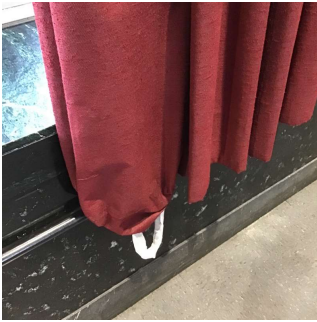
Violations	Right Side No violations recorded.
Deficiency	INOPERABLE CURTAINS
Deficiency Location/Instance	Right and Left Side
Deficiency Quantity	3
Quantity Uom	EACH
Potential Action	MAINTENANCE
Urgency of Action	PRIORITY 3
Purpose of Action	LEVEL 2
Deficiency Photo1	No photo recorded
Violations	No violations recorded.
CAFETERIA	
Instance on Basement	Inspected
Ceiling	
Instance on Basement	Inspected
Condition	2 - Between Good and Fair

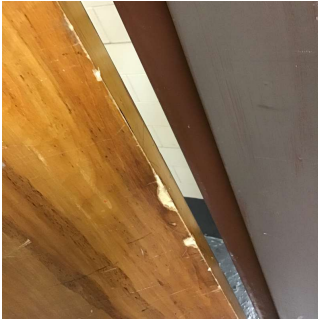
Violations	Exit 2 - Vestibule No violations recorded.
Deficiency	WOOD: DETERIORATED DOOR AND FRAME
Deficiency Location/Instance	Exit 3 - Vestibule, Stair I/1
Deficiency Quantity	2
Quantity Uom	EACH
Potential Action	MAINTENANCE
Urgency of Action	PRIORITY 3
Purpose of Action	LEVEL 2
Deficiency Photo1

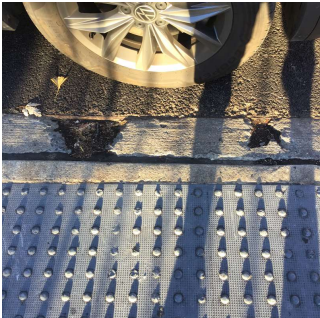
Violations	5th Avenue No violations recorded.
Deficiency	DAMAGED CURBS
Deficiency Location/Instance	5th Avenue, 92nd Street, Gelston Avenue
Deficiency Quantity	180
Quantity Uom	L.F.
Potential Action	REPLACE
Urgency of Action	PRIORITY 3
Purpose of Action	LEVEL 2
Deficiency Photo1
