**NYC Department of Education**  
**Building Condition Assessment Survey 2023 - 2024**

Architectural Inspection

**K106**

**Asset:** P.S. 106 - BROOKLYN, 1328 PUTNAM AVENUE, New York, 11221

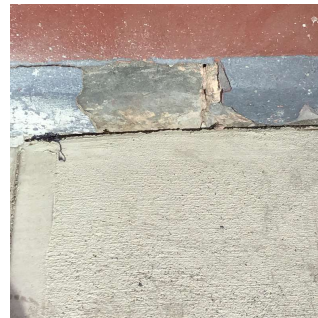
Facade M

Deficiency CAST IN PLACE / PRE-CAST CONCRETE: MAJOR CRACKS/SPALLING

500  
S.F.  
REPLACE  
PRIORITY 4  
LEVEL 2

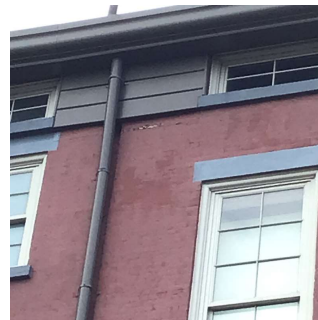
Facade K - North View

BRICK: MINOR CRACKS AND SPALLING

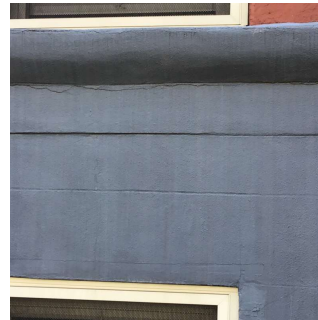
Facade A - West view

CAST IN PLACE / PRE-CAST CONCRETE: MINOR CRACKS/SPALLING

REPAIR

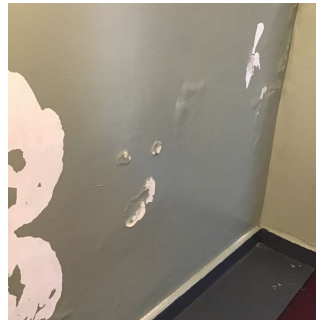
Facade H - near Stair Door 6, Facade G Auditorium near Radiator, and Stage, Facade B - Room 401, F

BRICK: WATER INFILTRATION IN INSTRUCTIONAL SPACE

REPAIR

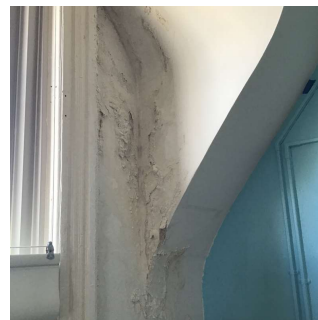
Roof 2
Violations	No violations recorded.
Deficiency	ASPHALT SHINGLE: ROOFING: MAJOR ACTIVE ROOF LEAKS IN INSTRUCTIONAL SPACE

Room 401 Leak from Roof 3 Dormer

200  
S.F.  
REPLACE ROOFING  
PRIORITY 5  
LEVEL 2

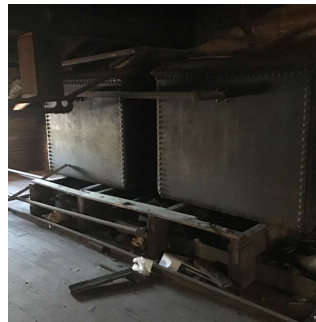
TANK: NOT IN USE - MINOR DETERIORATION

Attic Tanks  
 No violations recorded.

2  
 EACH  
 NO ACTION  
 PRIORITY 1  
 LEVEL 1

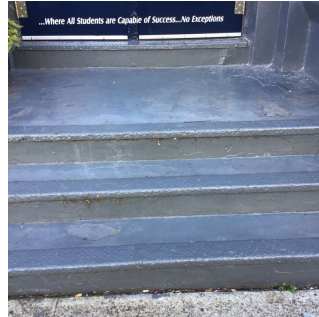
CONCRETE: CRACKS/SPALLING - MINOR

Violations	Facade A - Main Entry No violations recorded.
<b>WINDOWS</b>	Inspected
Replacement Quantity	10,000
Replacement Uom	S.F.
<b>EXTERIOR GUARDS</b>	Inspected
Condition	2 - Between Good and Fair
Deficiency	No deficiencies recorded
<b>LINTELS</b>	Inspected
Condition	2 - Between Good and Fair
Deficiency	No deficiencies recorded
<b>WINDOWS</b>	Inspected
Material Type(s)	Aluminum
Instance on Aluminum - Double Hung: All Facades	Inspected
Instance Condition	2 - Between Good and Fair
Instance Quantity	9,500
Instance Quantity Uom	S.F.
Are these windows insulated	No
Installation Year	2015
Source of Installation	Custodial Staff
Deficiency	No deficiencies recorded
Instance on Aluminum - Other: Facades D , E, J, K	Inspected

Deficiency Quantity	80
Quantity Uom	S.F.
Potential Action	REPAIR
Urgency of Action	PRIORITY 3
Purpose of Action	LEVEL 2
Deficiency Photo1

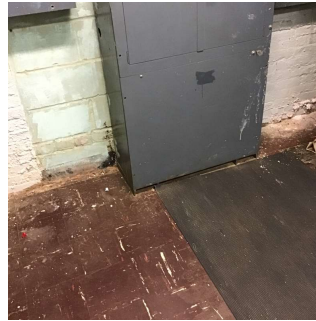
Deficiency	BRICK: WATER INFILTRATION IN ELECTRICAL PANEL ROOM
Deficiency Location/Instance	Basement Electrical Panel Room
Deficiency Quantity	100
Quantity Uom	S.F.
Potential Action	INSTALL WATERPROOFING
Urgency of Action	PRIORITY 5
Purpose of Action	LEVEL 6

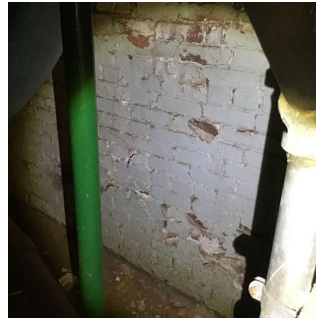
Mechanical Equipment Room - North

BRICK: DETERIORATED JOINTS

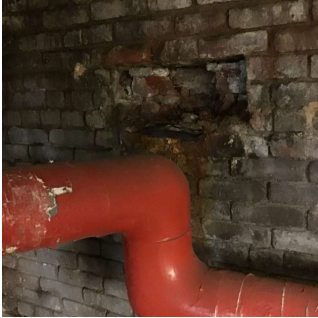
Deficiency	CRACKS, SPALLING
Deficiency Location/Instance	vault at Mechanical Equipment Room - North
Deficiency Quantity	150
Quantity Uom	S.F.
Potential Action	REPAIR

Violations	Vault North Wall No violations recorded.
<b>Slab Structure</b>	
Condition	Inspected 3 - Fair
Deficiency	CONCRETE SLAB ON GRADE: THRU CRACKS
Deficiency Location/Instance	Mechanical Equipment Room - North
Deficiency Quantity	80
Quantity Uom	S.F.
Potential Action	REPAIR
Urgency of Action	PRIORITY 3
Purpose of Action	LEVEL 5
Deficiency Photo1

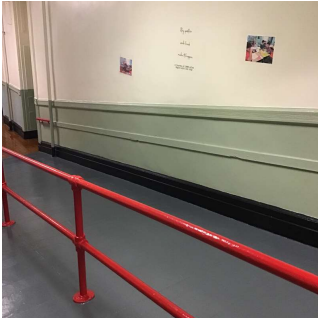
Violations	Stair E/3 No violations recorded.
<b>Railings</b>	Inspected
Condition	5 - Poor
Deficiency	METAL: MISSING
Deficiency Location/Instance	Corridor near Room 307, Corridor near Stair C/2, Stairs D/1, E/1
Deficiency Quantity	59
Quantity Uom	L.F.
Potential Action	REPLACE
Urgency of Action	PRIORITY 5
Purpose of Action	LEVEL 6
Deficiency Photo1

Violations	Corridor near Room 307 No violations recorded.
Deficiency	METAL: BROKEN BRACKET
Deficiency Location/Instance	Stair B/Basement

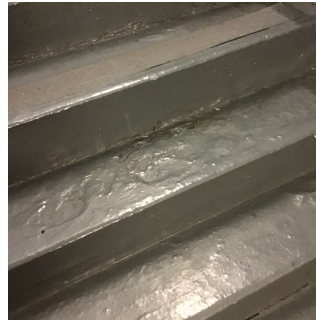
Cafeteria Exit 10

Violations	Stair F/1 No violations recorded.
Deficiency	CONCRETE: CRACKS/SPALLING - MAJOR
Deficiency Location/Instance	Cafeteria Exit 9, Cafeteria Exit 10, Stair D/Basement Vestibule
Deficiency Quantity	50
Quantity Uom	S.F.
Potential Action	REPLACE
Urgency of Action	PRIORITY 3
Purpose of Action	LEVEL 2

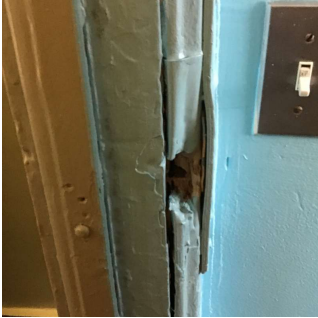
In Stair C/2
Violations	No violations recorded.
<b>Door(s)</b>	Inspected
Condition	5 - Poor
Deficiency	WOOD: DETERIORATED DOOR AND FRAME
Deficiency Location/Instance	In Stair C/2
Deficiency Quantity	1
Quantity Uom	EACH
Potential Action	MAINTENANCE
Urgency of Action	PRIORITY 3
Purpose of Action	LEVEL 2
Deficiency Photo1

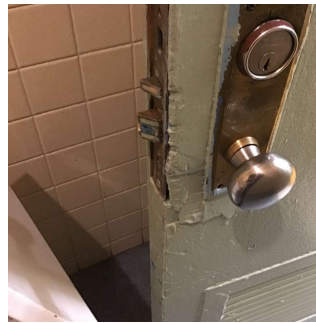
In Stair C/2
Violations	No violations recorded.
Deficiency	WOOD: DETERIORATED DOOR
Deficiency Location/Instance	Room 219
Deficiency Quantity	1
Quantity Uom	EACH
Potential Action	MAINTENANCE
Urgency of Action	PRIORITY 3
Purpose of Action	LEVEL 2
