**NYC Department of Education**  
**Building Condition Assessment Survey 2023 - 2024**

Architectural Inspection

**K108**

**Asset:** P.S. 108 - BROOKLYN, 200 LINWOOD STREET, New York, 11208

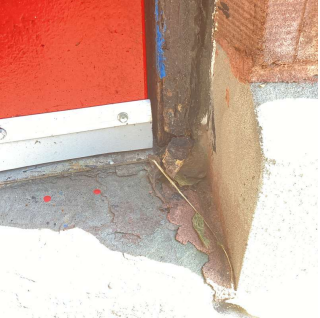
Violations	Facade B No violations recorded.
Deficiency	METAL CLAD: DETERIORATED DOOR - MAJOR DETERIORATION

Question	Response
<b>EXTERIOR</b>	
<b>CHIMNEY</b>	
Condition	2 - Between Good and Fair
Deficiency	No deficiencies recorded
<b>COPING</b>	Inspected
Condition	2 - Between Good and Fair
Deficiency	No deficiencies recorded
<b>CORNICE</b>	Inspected
Condition	2 - Between Good and Fair
Deficiency	No deficiencies recorded
<b>DOORS</b>	Inspected
<b>DOORS AND FRAMES</b>	Inspected
Condition	5 - Poor
Deficiency	METAL: DETERIORATED DOOR AND FRAME - MAJOR DETERIORATION
Roof Plan reference	<p>K108</p>

Deficiency Quantity	3
Quantity Uom	EACH
Potential Action	REPLACE
Urgency of Action	PRIORITY 4
Purpose of Action	LEVEL 2
Deficiency Photo1

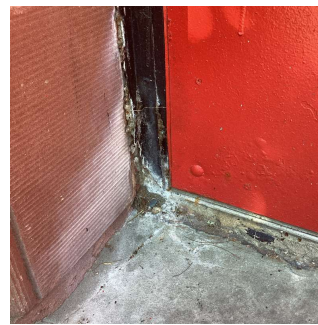
Facade A

K108

1  
EACH  
REPLACE  
PRIORITY 4  
LEVEL 2

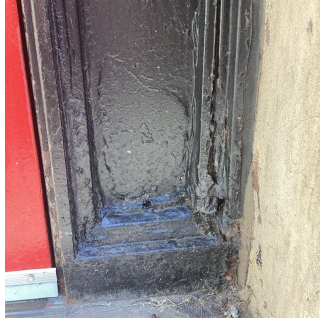
METAL: DENTED, MAJOR RUSTING

10  
S.F.  
REPLACE

Question	Response
<b>EXTERIOR</b>	
<b>DOORS</b>	
<b>TRANSOM/SIDE LIGHT</b>	
Urgency of Action	PRIORITY 4
Purpose of Action	LEVEL 2
Deficiency Photo1

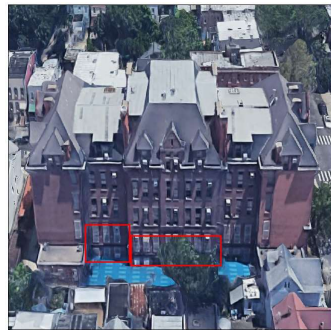
Facade B
Violations	No violations recorded.
<b>EXTERIOR WALLS</b>	
Material Type(s)	Inspected Masonry
Replacement Quantity	35,000
Replacement Uom	S.F.
Instance on All Facades	Inspected
Instance Condition	3 - Fair
Instance Quantity	35,000
Instance Quantity Uom	S.F.
Deficiency	BRICK: EFFLORESCENCE
Roof Plan reference	K108

Deficiency Quantity	200
Quantity Uom	S.F.
Potential Action	MAINTENANCE
Urgency of Action	PRIORITY 1
Purpose of Action	LEVEL 1
Deficiency Photo1	No photo recorded

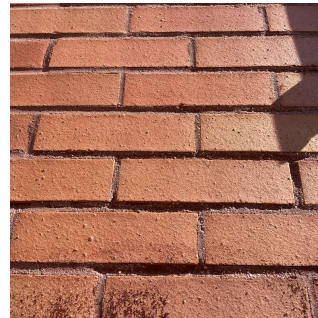
Facade B

**BRICK: DETERIORATED JOINTS**

20

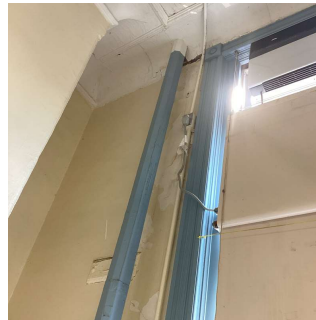
Facade A - Room 304 (Facade A - Room 208, Facade C - Room 109 similar)

**BRICK: WATER INFILTRATION IN INSTRUCTIONAL SPACE**

300

REPAIR

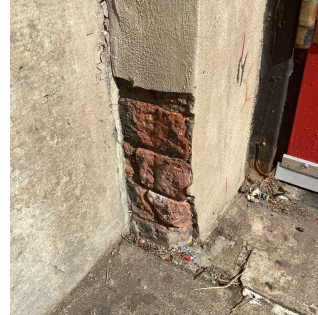
Facade B

**BRICK: MINOR CRACKS AND SPALLING**

RESTITCH  
 PRIORITY 3  
 LEVEL 2

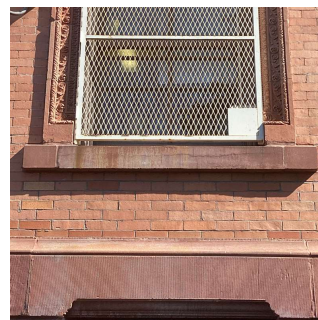
**BRICK: DETERIORATED MASONRY SILLS - MINOR**

20  
 L.F.  
 REPAIR  
 PRIORITY 3  
 LEVEL 2

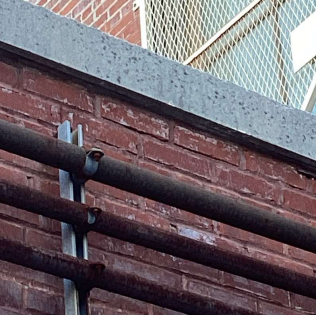
Question	Response
<b>EXTERIOR</b>	
<b>EXTERIOR WALLS</b>	Inspected
	Facade A
Violations	No violations recorded.
<b>EXTERIOR SOFFITS</b>	Inspected
Condition	2 - Between Good and Fair
Deficiency	No deficiencies recorded
<b>LOADING DOCK</b>	Does not Exist
<b>LOUVER</b>	Inspected
Condition	2 - Between Good and Fair
Deficiency	No deficiencies recorded
<b>PARAPETS</b>	Inspected
Material Type(s)	Masonry
Replacement Quantity	1,000
Replacement Uom	C.F.
Instance on All Facades	Inspected
Instance Condition	2 - Between Good and Fair
Instance Quantity	1,000
Instance Quantity Uom	C.F.
Deficiency	<b>BRICK: DETERIORATED JOINTS</b>
Roof Plan reference	<p>K108</p>

Deficiency Quantity	10
Quantity Uom	S.F.
Potential Action	REPOINT
Urgency of Action	PRIORITY 3
Purpose of Action	LEVEL 2
Deficiency Photo1

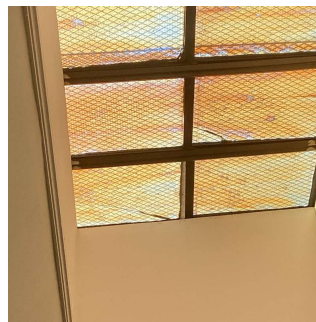
SK2  
 No violations recorded.

<b>SKYLIGHT/ROOF VENT</b>	Inspected
Material Type(s)	Glass
Condition	3 - Fair
Deficiency	BROKEN GLASS

20  
 S.F.  
 MAINTENANCE  
 PRIORITY 3  
 LEVEL 2

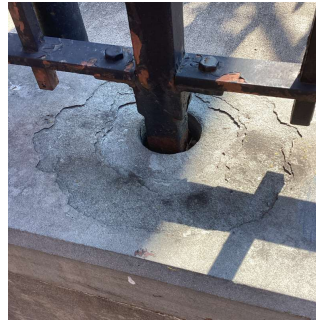
Facade B

STONE: DETERIORATED COPING STONE

30  
 S.F.  
 REPLACE  
 PRIORITY 4  
 LEVEL 2

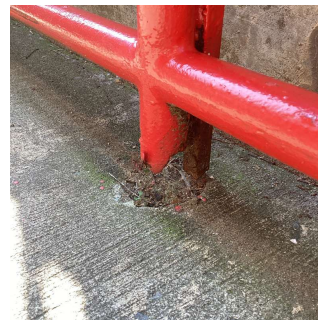
Facade B

**RUST - MAJOR**

30

L.F.

REPLACE

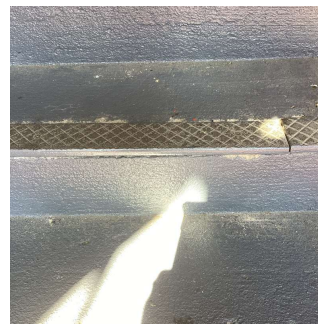
Facade A - Main Entrance  
 No violations recorded.

**CONCRETE: WORN-OUT TREAD/RISER/NOSING**

10  
 S.F.  
 REPLACE  
 PRIORITY 5  
 LEVEL 6

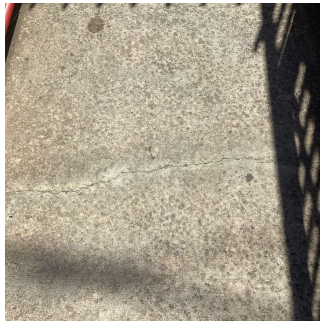
**CONCRETE: CRACKS/SPALLING - MINOR**

20  
 S.F.  
 REPAIR  
 PRIORITY 3  
 LEVEL 2

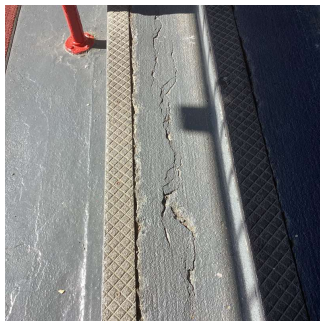
Violations	Facade B No violations recorded.
Deficiency	<b>CONCRETE: CRACKS/SPALLING - MAJOR</b>
Roof Plan reference	K108

Deficiency Quantity	20
Quantity Uom	S.F.
Potential Action	REPLACE
Urgency of Action	PRIORITY 4
Purpose of Action	LEVEL 2
Deficiency Photo1

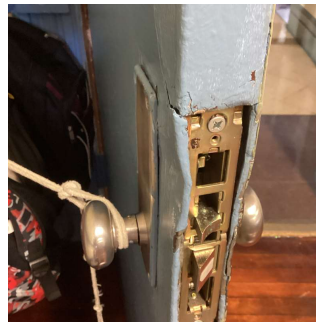
Room 401

Violations	Room 408 No violations recorded.
Deficiency	METAL: DETERIORATED DOOR
Deficiency Location/Instance	Rooms 208, 401, 402, 403, 404, 409
Deficiency Quantity	6
Quantity Uom	EACH
Potential Action	MAINTENANCE
Urgency of Action	PRIORITY 3
Purpose of Action	LEVEL 2

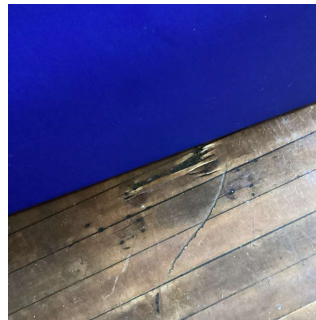
Room 201

WOOD: DAMAGED/DETERIORATED

REPLACE

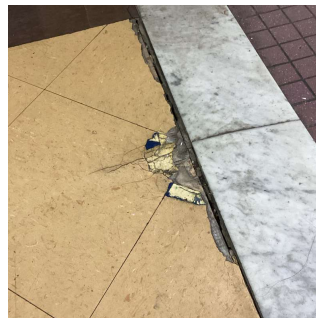
VINYL TILES: DETERIORATED SUBSTRATE

REPLACE

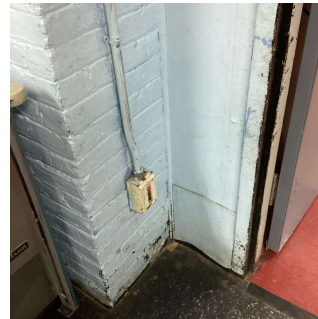
Near Entrance

PLASTER: CRACKS/SPALLING

REPLACE
