NYC Department of Education
Building Condition Assessment Survey 2023 - 2024

Architectural Inspection

Asset: P.S. 110 - BROOKLYN, 124 MONITOR STREET, New York, 11222

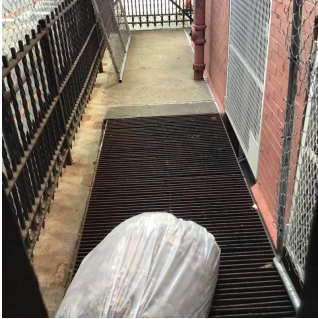
<p>AW2</p>

Question	Response
EXTERIOR	
AREAWAY	
Instance on AW1-AW2	Inspected
Instance Condition	3 - Fair
Instance Quantity	2
Instance Quantity Uom	EACH
Deficiency	AREAWAY GRATINGS: MAJOR RUSTING / OR BROKEN
Roof Plan reference	<p>K110</p>

Deficiency Quantity	20
Quantity Uom	S.F.
Potential Action	REPLACE
Urgency of Action	PRIORITY 4
Purpose of Action	LEVEL 2
Deficiency Photo1

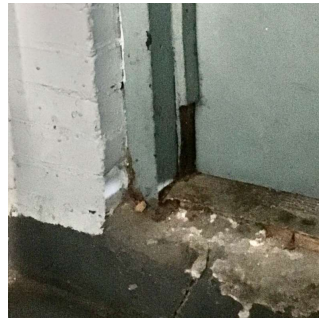
Question	Response
EXTERIOR	
COPING	Inspected
Deficiency	No deficiencies recorded
CORNICE	Inspected
Condition	2 - Between Good and Fair
Deficiency	No deficiencies recorded
DOORS	Inspected
DOORS AND FRAMES	Inspected
Condition	3 - Fair
Deficiency	METAL: DETERIORATED DOOR - MINOR DETERIORATION
Roof Plan reference

Violations	Facade H - Exit 7 No violations recorded.
DOOR HARDWARE	Inspected
Condition	3 - Fair
Deficiency	No deficiencies recorded
LINTELS	Inspected
Condition	2 - Between Good and Fair
Deficiency	No deficiencies recorded
TRANSOM/SIDE LIGHT	Does not Exist
EXTERIOR WALLS	Inspected
Material Type(s)	Masonry
Replacement Quantity	24,500
Replacement Uom	S.F.
Instance on All Facades	Inspected
Instance Condition	4 - Between Fair and Poor
Instance Quantity	24,500

Deficiency Quantity	10
Quantity Uom	EACH
Potential Action	MAINTENANCE
Urgency of Action	PRIORITY 3
Purpose of Action	LEVEL 2
Deficiency Photo1

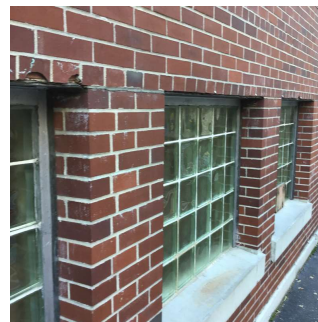
Facade G

BRICK: MINOR CRACKS AND SPALLING

20
S.F.
RESTITCH
PRIORITY 3
LEVEL 2

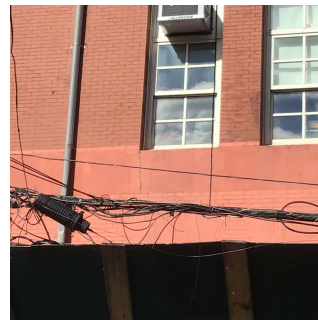
Facade H

STONE: CRACKS AT BUILDING CORNERS

REPLACE

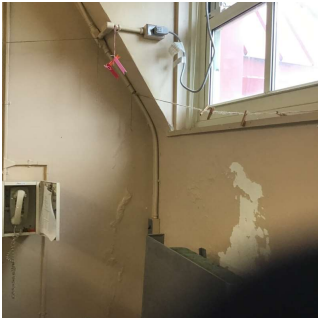
BRICK: WATER INFILTRATION IN INSTRUCTIONAL SPACE

Facade A - Room 401 (Original Building shown) Facade G - Rooms 306, 307 similar
Violations	No violations recorded.
EXTERIOR SOFFITS	
Condition	Inspected
Deficiency	2 - Between Good and Fair
	No deficiencies recorded
LOADING DOCK	
	Does not Exist
LOUVER	
Condition	Inspected
Deficiency	2 - Between Good and Fair
	No deficiencies recorded
PARAPETS	
Material Type(s)	Inspected
Replacement Quantity	Masonry
Replacement Uom	900
Instance on All Facades	C.F.
Instance Condition	Inspected
Instance Quantity	2 - Between Good and Fair
Instance Quantity Uom	900
Deficiency	C.F.
	No deficiencies recorded
PLAZA DECK	
	Does not Exist
ROOF	
Roofing	Inspected
Replacement Quantity	18,500
Replacement Uom	S.F.
ROOF HATCH/SMOKE HATCH	
Condition	Inspected
Deficiency	2 - Between Good and Fair
	No deficiencies recorded
LEADERS, GUTTERS, DOWNSPOUTS, SCUPPERS

Question	Response
EXTERIOR	
EXTERIOR WALLS	
Urgency of Action	PRIORITY 5
Purpose of Action	LEVEL 2
Deficiency Photo1

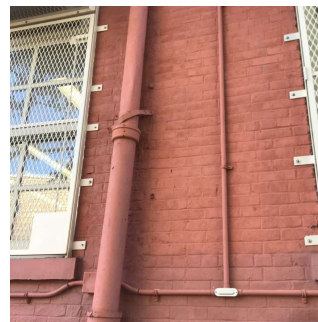
Facade G
No violations recorded.

Condition	Inspected
Deficiency	3 - Fair
	LOOSE

2
EACH
MAINTENANCE
PRIORITY 3
LEVEL 2

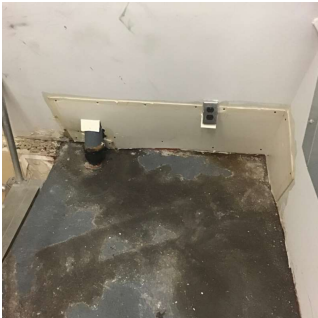
<p>Roof 6 Elevator Machine Room</p>
Violations	No violations recorded.
Deficiency	METAL: ROOFING: MAJOR ACTIVE ROOF LEAKS IN INSTRUCTIONAL SPACE
Roof Plan reference	<p>K110</p>

Question	Response
EXTERIOR	
ROOF	
Roofing	
ROOFING	
Quantity Uom	S.F.
Potential Action	REPLACE
Urgency of Action	PRIORITY 5
Purpose of Action	LEVEL 2
Deficiency Photo1

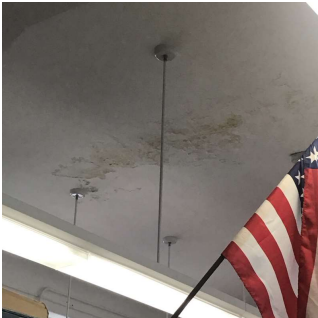
<p>Roof 6 - Room 403 shown, Roof 6 Room 401 (addition) similar</p>
Violations	No violations recorded.
Instance on Metal: Roof 1, 3A, 5, 11, 12	Inspected
Instance Condition	4 - Between Fair and Poor
Instance Quantity	10,800

<p align="center">Monitor Street</p> <p align="right">Driggs Avenue</p>
Deficiency Quantity	200
Quantity Uom	S.F.
Potential Action	REPLACE
Urgency of Action	PRIORITY 5
Purpose of Action	LEVEL 2
Deficiency Photo1

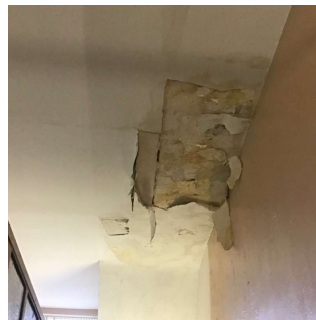
Deficiency	METAL: ROOFING: MAJOR ACTIVE ROOF LEAKS IN INSTRUCTIONAL SPACE
------------	--

Roof 1 - Stair A4 shown, Roof 5 - 407 similar
No violations recorded.

Deficiency Quantity	200
Quantity Uom	S.F.
Potential Action	REPLACE
Urgency of Action	PRIORITY 5
Purpose of Action	LEVEL 2
Deficiency Photo1

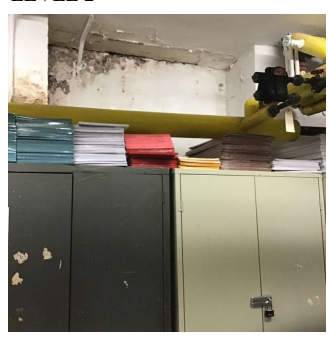
Question	Response
EXTERIOR	
ROOF	
Roofing	
ROOFING	
Does the roof have major mechanical equipment sitting on Dunnage Steel less than 18" above the Roofing?	No
Does this roof instance have a Sustainable Roof System?	No
Do solar panels exist on these roofs?	No
Is/Are the roof(s) suitable for Solar Panel installation?	No
Installation Year	2014
Source of Installation	Custodial Staff
Deficiency	BUILT-UP: ROOFING: MAJOR ACTIVE ROOF LEAKS IN NON-INSTRUCTIONAL SPACE
Roof Plan reference	<p>K110</p>

Violations	Roof 9 Basement Multipurpose No violations recorded.
Instance on Modified Bitumen: Roof 2, 3, 4, 7, 8, 10	Inspected
Instance Condition	3 - Fair
Instance Quantity	6,400
Instance Quantity Uom	S.F.
Does the roof have major mechanical equipment sitting on Dunnage Steel less than 18" above the Roofing?	No

Deficiency Quantity	100
Quantity Uom	S.F.
Potential Action	REPLACE ROOFING WITHOUT MAJOR EQUIPMENT REMOVAL
Urgency of Action	PRIORITY 5
Purpose of Action	LEVEL 2
Deficiency Photo1

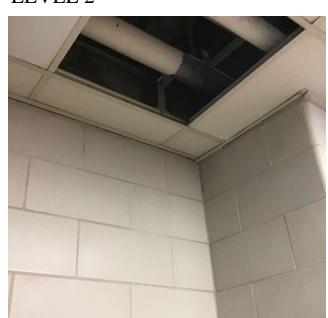
Question	Response
EXTERIOR	
ROOF	
Roofing	
ROOFING	
Deficiency	MODIFIED BITUMEN: ROOFING: MAJOR ACTIVE ROOF LEAKS IN INSTRUCTIONAL SPACE
Roof Plan reference	K110

Violations	Basement Landing girls toilet room No violations recorded.
ROOFING DRAINS	Inspected
Condition	2 - Between Good and Fair
Deficiency	No deficiencies recorded
Specialties	Inspected
BULKHEAD/PENTHOUSE	Does not Exist
CUPOLA/ SPIRES/ TOWERS	Does not Exist
DORMER	Inspected
Condition	2 - Between Good and Fair
Deficiency	No deficiencies recorded
DUNNAGE STEEL	Does not Exist
SKYLIGHT/ROOF VENT	Does not Exist
ROOF/GRAVITY TANK	Does not Exist
STAIRS/RAMPS: EXTERIOR	Inspected
BUILDING CHEEK/FLANK WALLS	Inspected
Condition	2 - Between Good and Fair
Deficiency	CAST IN PLACE CONCRETE: CRACKS/SPALLING - MINOR

Deficiency Quantity	100
Quantity Uom	S.F.
Potential Action	REPLACE ROOFING WITHOUT MAJOR EQUIPMENT REMOVAL
Urgency of Action	PRIORITY 5
Purpose of Action	LEVEL 2
Deficiency Photo1

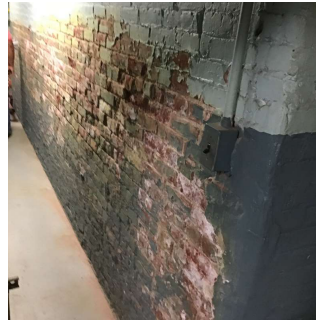
Violations	Facade A No violations recorded.
WINDOWS	Inspected
Replacement Quantity	9,100
Replacement Uom	S.F.
EXTERIOR GUARDS	Inspected
Condition	2 - Between Good and Fair
Deficiency	No deficiencies recorded
LINTELS	Inspected
Condition	2 - Between Good and Fair
Deficiency	No deficiencies recorded
WINDOWS	Inspected
Material Type(s)	Aluminum
Instance on Aluminum - Double Hung: All Facades	Inspected
Instance Condition	2 - Between Good and Fair
Instance Quantity	9,100
Instance Quantity Uom	S.F.
Are these windows insulated	Yes
Installation Year	2014
Source of Installation	Custodial Staff
Deficiency	No deficiencies recorded
INTERIOR	Inspected
POOLS	Does not Exist
STRUCTURAL	Inspected
COLUMNS/BEAMS/BEARING WALLS	Inspected
Condition	3 - Fair
Deficiency	CONCRETE BEARING WALL: CRACKED/SPALLED/REINFORCEMENT EXPOSED
Deficiency Location/Instance	Boiler Room

Deficiency Quantity	200
Quantity Uom	S.F.
Potential Action	REPAIR
Urgency of Action	PRIORITY 3
Purpose of Action	LEVEL 5

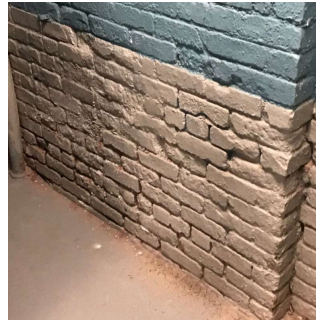
Basement Oil Tank Room

Basement Tool Room
Violations	No violations recorded.
FOUNDATION WALLS	
Material Type(s)	Inspected Masonry
Condition	5 - Poor
Deficiency	BRICK: DETERIORATED JOINTS
Deficiency Location/Instance	Basement - Oil Tank Room, Boiler Room, Gas Meter Room, Electrical Panel Room, Exit 4 near boys toilet Room
Deficiency Quantity	400
Quantity Uom	S.F.
Potential Action	REPOINT
Urgency of Action	PRIORITY 4
Purpose of Action	LEVEL 5

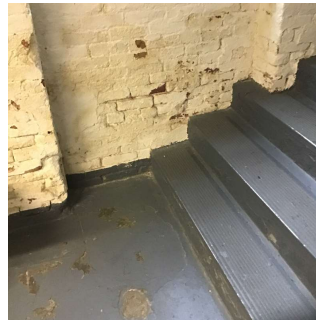
Basement - Exit 7 and 8 Vestibule

BRICK: WATER INFILTRATION IN INSTRUCTIONAL SPACE

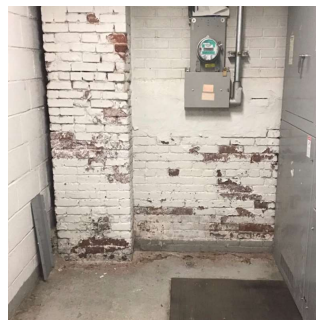
Basement Electrical Panel Room

BRICK: WATER INFILTRATION IN ELECTRICAL PANEL ROOM

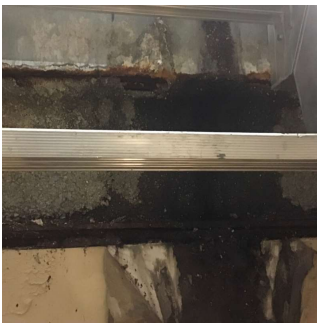
Question	Response
INTERIOR	
STRUCTURAL	
FOUNDATION WALLS	
Violations	No violations recorded.
Deficiency	BRICK: WATER INFILTRATION IN NON- INSTRUCTIONAL SPACE
Deficiency Location/Instance	Basement - Oil Tank Room, Boiler Room
Deficiency Quantity	200
Quantity Uom	S.F.
Potential Action	INSTALL WATERPROOFING
Urgency of Action	PRIORITY 5
Purpose of Action	LEVEL 5
Deficiency Photo1	 
	Basement - Oil Tank Room
Violations	No violations recorded.
Deficiency	BRICK: CRACKED/SPALLED
Deficiency Location/Instance	Basement - Multipurpose Room South, Oil Tank Room, Boiler Room
Deficiency Quantity	100
Quantity Uom	S.F.
Potential Action	RESTITCH
Urgency of Action	PRIORITY 3
Purpose of Action	LEVEL 5
Deficiency Photo1	 
	Multipurpose Room south
Violations	No violations recorded.
ROOF STRUCTURE	
	Inspected
Condition	3 - Fair
Deficiency	STEEL COLUMNS/BEAMS: MAJOR RUSTING
Deficiency Location/Instance	4th Floor Elevator Machine Room
Deficiency Quantity	10

Violations	4th Floor, Elevator Machine Room No violations recorded.
VAULTS-BUNKERS	Does not Exist
AUDITORIUM	Inspected
Instance on 4th Floor (300 Seats)	Inspected
Ceiling	
Instance on 4th Floor (300 Seats)	Inspected
Condition	2 - Between Good and Fair
Deficiency	No deficiencies recorded
Door(s)	
Instance on 4th Floor (300 Seats)	Inspected
Condition	2 - Between Good and Fair
Deficiency	No deficiencies recorded
Fixed H/C Lift	
Instance on 4th Floor (300 Seats)	Does not Exist
Fixed Seating	
Instance on 4th Floor (300 Seats)	Inspected
Condition	3 - Fair
Deficiency	DAMAGED/BROKEN/INOPERABLE
Deficiency Location/Instance	Seats A/1, 5, 7, D/1, 3 and others
Deficiency Quantity	12
Quantity Uom	EACH
Potential Action	REPLACE
Urgency of Action	PRIORITY 3
Purpose of Action	LEVEL 2
Deficiency Photo1

Quantity Uom	S.F.
Potential Action	REPLACE
Urgency of Action	PRIORITY 4
Purpose of Action	LEVEL 5

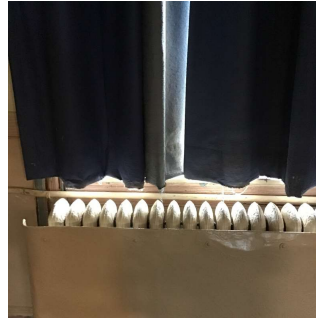
Near Stage
No violations recorded.

Question	Response
INTERIOR	
AUDITORIUM	
Stage	
Stage	
Quantity Uom	S.F.
Potential Action	REPLACE
Urgency of Action	PRIORITY 3
Purpose of Action	LEVEL 2
Deficiency Photo1	 
	Rear of Stage
Violations	No violations recorded.
Deficiency	DAMAGED STEPS
Deficiency Location/Instance	Left and Right Side
Deficiency Quantity	20
Quantity Uom	S.F.
Potential Action	REPLACE
Urgency of Action	PRIORITY 3
Purpose of Action	LEVEL 2
Deficiency Photo1	 
	Left Side
Violations	No violations recorded.
Stage Curtain Rigging	Does not Exist
Instance on 4th Floor (300 Seats)	Does not Exist
Stage Curtains	Does not Exist
Instance on 4th Floor (300 Seats)	Does not Exist
Walls	
Instance on 4th Floor (300 Seats)	Inspected
Condition	2 - Between Good and Fair
Deficiency	No deficiencies recorded
Window Curtains/Shades/Blinds	
Instance on 4th Floor (300 Seats)	Inspected
Condition	3 - Fair
Deficiency	WORN/DAMAGED CURTAINS
Deficiency Location/Instance	Near Stage, Rear

Deficiency Quantity	200
Quantity Uom	S.F.
Potential Action	MAINTENANCE
Urgency of Action	PRIORITY 3
Purpose of Action	LEVEL 2
Deficiency Photo1

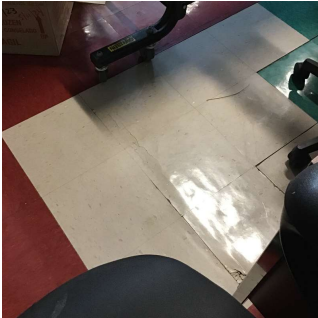
Question	Response
INTERIOR	
CAFETERIA	
Floor Finish	
	Center
Violations	No violations recorded.
Deficiency	VINYL TILES: DETERIORATED SUBSTRATE
Deficiency Location/Instance	Near Stair F/1, Near Entrance
Deficiency Quantity	50
Quantity Uom	S.F.
Potential Action	REPLACE
Urgency of Action	PRIORITY 3
Purpose of Action	LEVEL 2
Deficiency Photo1

Near Stair F/1
Violations	No violations recorded.
Sliding-folding Partition	
Instance on 1st Floor (2000SF)	Does not Exist
Stage	
Instance on 1st Floor (2000SF)	Does not Exist
Walls	
Instance on 1st Floor (2000SF)	Inspected
Condition	2 - Between Good and Fair
Deficiency	No deficiencies recorded
Window Curtains/Shades/Blinds	
Instance on 1st Floor (2000SF)	Does not Exist
CLASSROOMS/CORRIDORS/ADMIN SPACES	
Ceiling	
	Inspected
Condition	2 - Between Good and Fair
Deficiency	METAL PAN: DAMAGED/MISSING
Deficiency Location/Instance	Rooms 201, 111, Nurse Room, Main Office
Deficiency Quantity	40

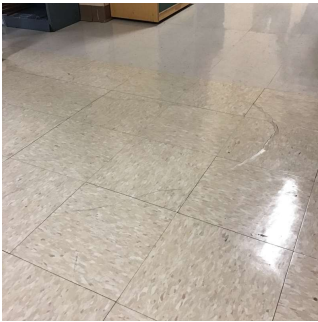
Question	Response
INTERIOR	
CLASSROOMS/CORRIDORS/ADMIN SPACES	
Floor Finish	
Violations	Room 405 No violations recorded.
Deficiency	VINYL TILES: DETERIORATED SUBSTRATE
Deficiency Location/Instance	Corridor near Rooms 405, 402, 401, Rooms 209, Nurse office and others
Deficiency Quantity	150
Quantity Uom	S.F.
Potential Action	REPLACE
Urgency of Action	PRIORITY 3
Purpose of Action	LEVEL 2
Deficiency Photo1

Violations	Corridor near Room 402 No violations recorded.
Walls	
Condition	Inspected 2 - Between Good and Fair
Deficiency	CERAMIC TILE: BROKEN/ MISSING
Deficiency Location/Instance	Room 406B
Deficiency Quantity	20
Quantity Uom	S.F.
Potential Action	REPLACE
Urgency of Action	PRIORITY 3
Purpose of Action	LEVEL 2
Deficiency Photo1

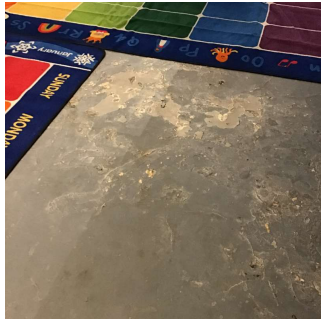
Center

Deficiency	CONCRETE: CRACKS
Deficiency Location/Instance	Center, Near Windows, Near Stair EF/Basement
Deficiency Quantity	450
Quantity Uom	S.F.
Potential Action	REPLACE
Urgency of Action	PRIORITY 3
Purpose of Action	LEVEL 2
Deficiency Photo1

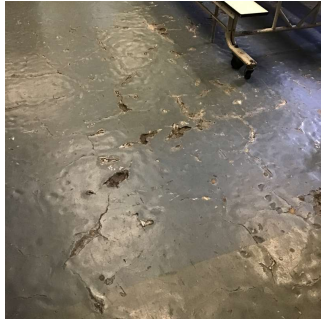
Right Side Near Windows

Deficiency	ROLLED ASPHALT: CRACKS
Deficiency Location/Instance	Right Side Near Windows, Left Side, Center
Deficiency Quantity	600
Quantity Uom	S.F.
Potential Action	REPLACE
Urgency of Action	PRIORITY 3
Purpose of Action	LEVEL 2
Deficiency Photo1

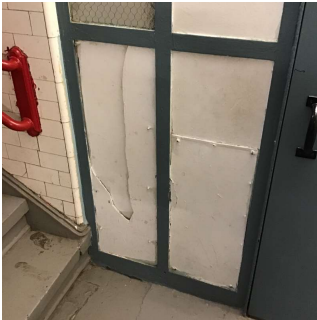
Violations	Stair AB/Basement No violations recorded.
Partition	Inspected
Condition	2 - Between Good and Fair
Deficiency	GLASS PANEL: DAMAGED/DETERIORATED
Deficiency Location/Instance	Stair GH/Basement
Deficiency Quantity	10
Quantity Uom	S.F.
Potential Action	REPLACE
Urgency of Action	PRIORITY 3
Purpose of Action	LEVEL 2
Deficiency Photo1

Violations	Stair GH/Basement No violations recorded.
Railings	Inspected
Condition	4 - Between Fair and Poor
Deficiency	METAL: MISSING
Deficiency Location/Instance	Stairs CD/Basement, EF/Basement
Deficiency Quantity	20
Quantity Uom	L.F.
Potential Action	REPLACE
Urgency of Action	PRIORITY 5
Purpose of Action	LEVEL 6

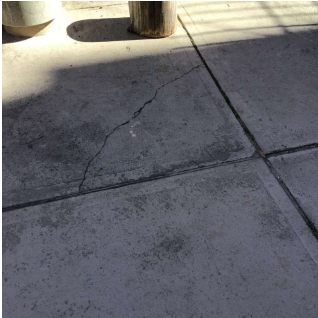
Violations	Near Exit 5 No violations recorded.
Concrete	Inspected
Condition	3 - Fair
Deficiency	CRACKS - MAJOR
Deficiency Location/Instance	North Side Plaza
Deficiency Quantity	150
Quantity Uom	S.F.
Potential Action	REPLACE
Urgency of Action	PRIORITY 3
Purpose of Action	LEVEL 2
Deficiency Photo1

Violations	North Side Plaza No violations recorded.
Pavers	Does not Exist
Site Sidewalks & Walkways	Inspected
Asphalt	Does not Exist
Concrete	Inspected
Condition	2 - Between Good and Fair
Deficiency	No deficiencies recorded

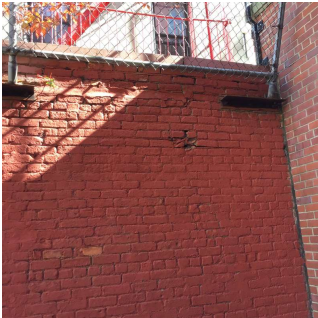
Violations	North Schoolyard No violations recorded.
Deficiency	BRICK: BULGING/DISPLACED
Deficiency Location/Instance	North Side Plaza, schoolyard
Deficiency Quantity	40
Quantity Uom	S.F.
Potential Action	REPLACE
Urgency of Action	PRIORITY 3
Purpose of Action	LEVEL 2
Deficiency Photo1

Violations	North Side Plaza No violations recorded.
STAIRS/RAMPS: EXTERIOR	Does not Exist
ARTWORK	Inspected
Instance	Interior - Principal's Office - 31126
Instance Photo
