NYC Department of Education
Building Condition Assessment Survey 2023 - 2024

Architectural Inspection

Asset: P.S. 112 - BROOKLYN, 7115 15 AVENUE, New York, 11228

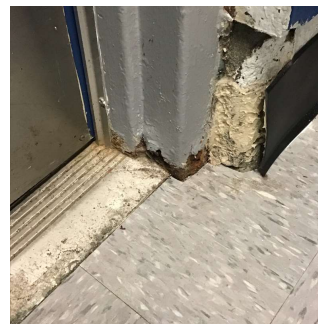
Facade D - Exit 5

Question	Response
EXTERIOR	
CHIMNEY	
Deficiency Photo1	 
Violations	Roof 1 - CH No violations recorded.
COPING	Under Construction
CORNICE	Under Construction
DOORS	Inspected
DOORS AND FRAMES	Inspected
Condition	3 - Fair
Deficiency	METAL: DETERIORATED DOOR AND FRAME - MINOR DETERIORATION
Roof Plan reference	 
Deficiency Quantity	4
Quantity Uom	EACH
Potential Action	MAINTENANCE
Urgency of Action	PRIORITY 3
Purpose of Action	LEVEL 2
Deficiency Photo1	 
Violations	Facade B - Exit 3 No violations recorded.
Deficiency	METAL: DETERIORATED DOOR AND FRAME - MAJOR DETERIORATION

1
EACH
REPLACE
PRIORITY 4
LEVEL 2

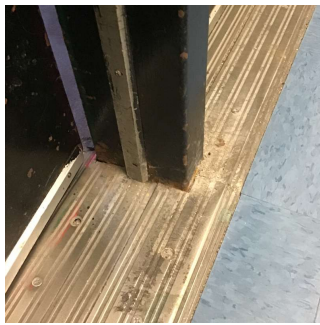
METAL CLAD: DETERIORATED DOOR AND FRAME - MINOR DETERIORATION

Violations	Facade A - Main Entrance No violations recorded.
DOOR HARDWARE	Inspected
Condition	3 - Fair
Deficiency	No deficiencies recorded
LINTELS	Inspected
Condition	2 - Between Good and Fair
Deficiency	No deficiencies recorded
TRANSOM/SIDE LIGHT	Inspected
Condition	2 - Between Good and Fair
Deficiency	No deficiencies recorded
EXTERIOR WALLS	Inspected
Material Type(s)	Masonry
Replacement Quantity	20,000
Replacement Uom	S.F.
Instance on All Facades	Under Construction
Instance Quantity	20,000
Instance Quantity Uom	S.F.
EXTERIOR SOFFITS	Inspected
Condition	2 - Between Good and Fair
Deficiency	No deficiencies recorded
LOADING DOCK	Does not Exist
LOUVER	Inspected
Condition	2 - Between Good and Fair
Deficiency	No deficiencies recorded
PARAPETS	Inspected
Material Type(s)	Masonry
Replacement Quantity	4,500
Replacement Uom	C.F.
Instance on All Facades	Under Construction

2
EACH
MAINTENANCE
PRIORITY 3
LEVEL 2

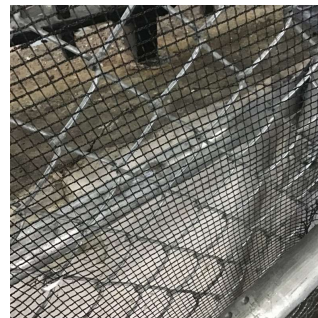
CAST IN PLACE CONCRETE: CRACKS/SPALLING - MAJOR

20

REPLACE

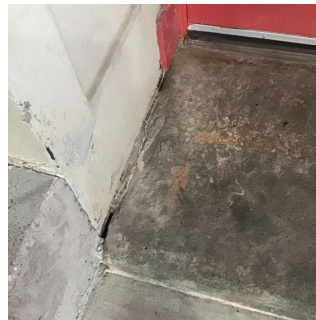
Facade F - Exit 2

Inspected
5 - Poor
STONE: CRACKS/SPALLING - MAJOR

30
S.F.
REPLACE
PRIORITY 4
LEVEL 2

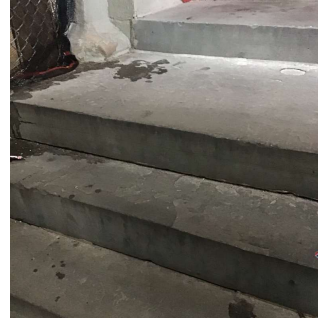
Facade A - Main Entrance

STONE: DETERIORATED JOINTS

REPOINT
 PRIORITY 4
 LEVEL 2

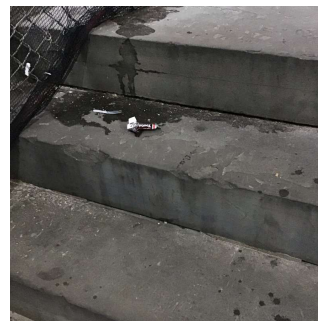
Facade A - Main Entrance

STONE: CRACKS/SPALLING - MINOR

30
 S.F.
 REPAIR
 PRIORITY 3
 LEVEL 2

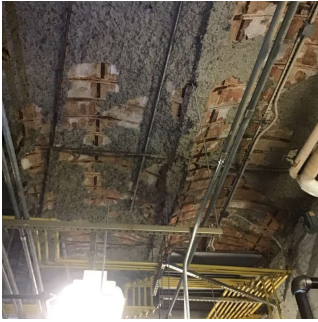
Question	Response
INTERIOR	
STRUCTURAL	
COLUMNS/BEAMS/BEARING WALLS	
Deficiency	STEEL COLUMNS/BEAMS: DETERIORATED/MISSING PLASTER FIREPROOFING
Deficiency Location/Instance	Basement - MDF Room, Boiler Room
Deficiency Quantity	30
Quantity Uom	S.F.
Potential Action	REPLACE
Urgency of Action	PRIORITY 3
Purpose of Action	LEVEL 5
Deficiency Photo1	 
	Basement - MDF Room
Violations	No violations recorded.
FLOOR STRUCTURE	
	Inspected
Condition	3 - Fair
Deficiency	CLAY TILE: PLASTER MISSING
Deficiency Location/Instance	Basement - Boiler Room, Gas Meter Room, Oil Tank Room
Deficiency Quantity	500
Quantity Uom	S.F.
Potential Action	REPLACE
Urgency of Action	PRIORITY 3
Purpose of Action	LEVEL 5
Deficiency Photo1

Boiler Room
Violations	No violations recorded.
Deficiency	CONCRETE SLAB ON GRADE: THRU CRACKS
Deficiency Location/Instance	Basement - MDF Room
Deficiency Quantity	30
Quantity Uom	S.F.
Potential Action	REPAIR
Urgency of Action	PRIORITY 3

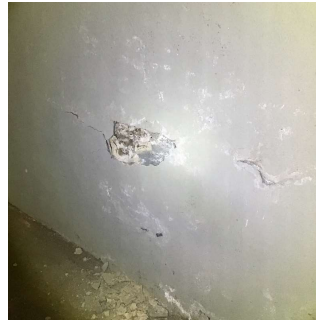
Question	Response
INTERIOR	
STRUCTURAL	
FLOOR STRUCTURE	
Deficiency Photo1	 
Violations	Basement - MDF Room No violations recorded.
FOUNDATION WALLS	
Material Type(s)	Inspected Concrete, Masonry
Condition	4 - Between Fair and Poor
Deficiency	BRICK: DETERIORATED JOINTS
Deficiency Location/Instance	Basement - Oil Tank Room
Deficiency Quantity	50
Quantity Uom	S.F.
Potential Action	REPOINT
Urgency of Action	PRIORITY 4
Purpose of Action	LEVEL 5
Deficiency Photo1	 
Violations	Oil Tank Room No violations recorded.
Deficiency	CONCRETE: WATER INFILTRATION IN NON- INSTRUCTIONAL SPACE
Deficiency Location/Instance	Basement - Oil Tank Room
Deficiency Quantity	100
Quantity Uom	S.F.
Potential Action	INSTALL WATERPROOFING
Urgency of Action	PRIORITY 5
Purpose of Action	LEVEL 5

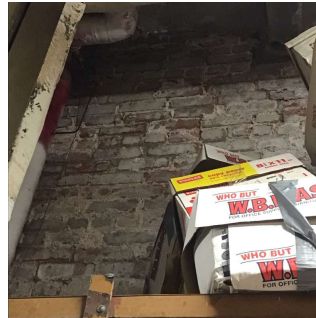
Basement - MDF Room

BRICK: DETERIORATED JOINTS

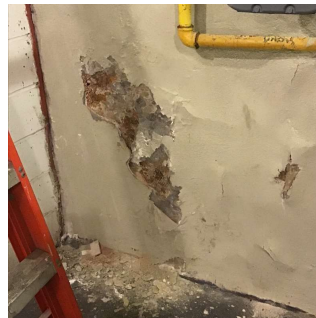
Gas Meter Room

BRICK: WATER INFILTRATION IN NON- INSTRUCTIONAL SPACE

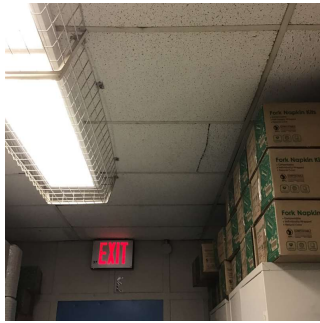
Violations	Ash Hoist Vault No violations recorded.
Slab Structure	Inspected
Condition	2 - Between Good and Fair
Deficiency	No deficiencies recorded
Vault/Ash Hoist Doors and Framing	Inspected
Condition	2 - Between Good and Fair
Deficiency	No deficiencies recorded
AUDITORIUM	Does not Exist
CAFETERIA	Inspected
Instance on Basement	Inspected
Ceiling	
Instance on Basement	Inspected
Condition	2 - Between Good and Fair
Deficiency	ACOUSTIC TILES: DAMAGED/MISSING

Deficiency Location/Instance	Near Stair E/Basement, By Servery
Deficiency Quantity	20
Quantity Uom	S.F.
Potential Action	REPLACE
Urgency of Action	PRIORITY 3
Purpose of Action	LEVEL 2

Violations	Near Stair E/Basement No violations recorded.
Door(s)	
Instance on Basement	Not Required
Fixed Equipment	
Instance on Basement	Inspected
Condition	2 - Between Good and Fair
Deficiency	No deficiencies recorded
Floor Finish	
Instance on Basement	Inspected
Condition	2 - Between Good and Fair
Deficiency	VINYL TILES: BROKEN/DETERIORATED/MISSING TILES
Deficiency Location/Instance	Near Boys Toilet Room - Basement, By Stair E/Basement
Deficiency Quantity	20
Quantity Uom	S.F.
Potential Action	REPLACE
Urgency of Action	PRIORITY 3
Purpose of Action	LEVEL 2
Deficiency Photo1

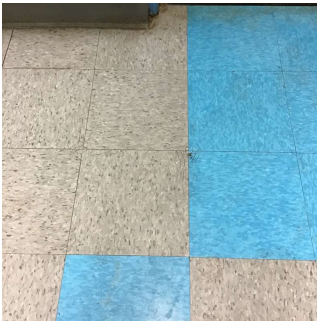
Violations	Near Boys Toilet Room - Basement No violations recorded.
Deficiency	VINYL TILES: DETERIORATED SUBSTRATE
Deficiency Location/Instance	Near Windows, By Custodian Office
Deficiency Quantity	20
Quantity Uom	S.F.
Potential Action	REPLACE
Urgency of Action	PRIORITY 3
Purpose of Action	LEVEL 2

Question	Response
INTERIOR	
CAFETERIA	
Floor Finish	
Deficiency Photo1

Violations	Near Windows No violations recorded.
Sliding-folding Partition	
Instance on Basement	Does not Exist
Stage	
Instance on Basement	Does not Exist
Walls	
Instance on Basement	Inspected
Condition	2 - Between Good and Fair
Deficiency	BRICK: CRACKS/SPALLING
Deficiency Location/Instance	Near Boiler Room
Deficiency Quantity	10
Quantity Uom	S.F.
Potential Action	REPLACE
Urgency of Action	PRIORITY 3
Purpose of Action	LEVEL 2
Deficiency Photo1

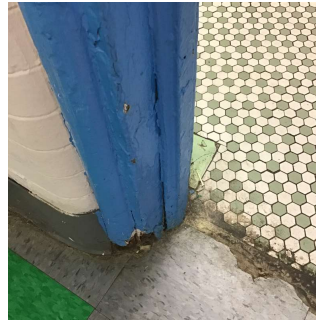
Near Cafeteria

WOOD: DETERIORATED DOOR AND FRAME

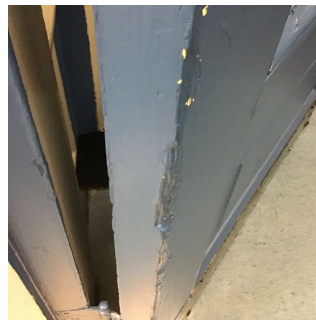
WOOD: DETERIORATED DOOR

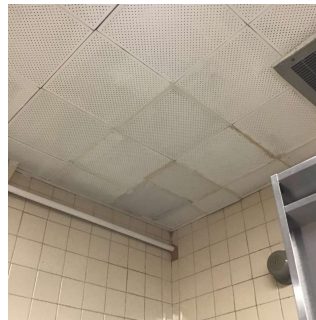
METAL PAN: DAMAGED/MISSING
Near Fridges
20
S.F.
REPLACE
PRIORITY 3
LEVEL 2

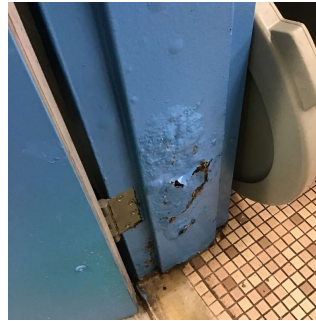
Entrance

METAL: DETERIORATED DOOR AND FRAME
Entrance, Office Room
2
EACH
MAINTENANCE
PRIORITY 3
LEVEL 2

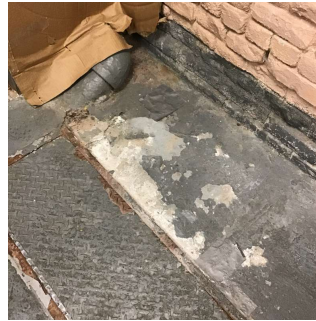
Office Room

CONCRETE: CRACKS

REPLACE

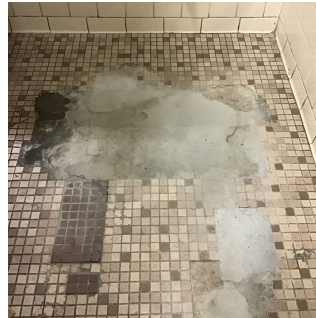
Servery

CERAMIC TILE: BROKEN/MISSING TILES

REPLACE

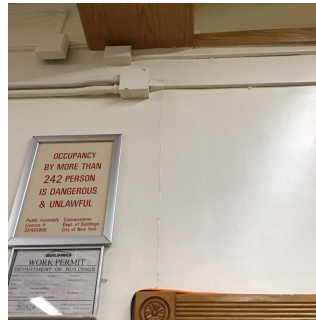
Deficiency	No deficiencies recorded
Walls	
Instance on 3rd Floor	Inspected
Condition	2 - Between Good and Fair
Deficiency	GYPSON BOARD: DETERIORATED
Deficiency Location/Instance	Near Entrance

Deficiency Quantity	10
Quantity Uom	S.F.
Potential Action	REPLACE
Urgency of Action	PRIORITY 3
Purpose of Action	LEVEL 2
Deficiency Photo1

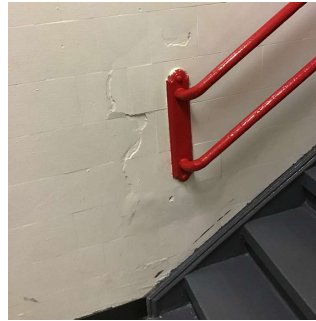
Stair E/3

Stair B/3
Violations	No violations recorded.
Walls	
Condition	Inspected
	2 - Between Good and Fair
Deficiency	CERAMIC TILE: BROKEN/ MISSING
Deficiency Location/Instance	Stairs C/1, E/3,2
Deficiency Quantity	40
Quantity Uom	S.F.
Potential Action	REPLACE
Urgency of Action	PRIORITY 3
Purpose of Action	LEVEL 2

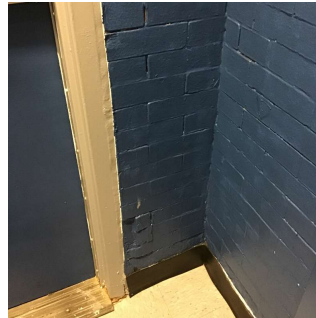
Exit B - Vestibule

BRICK: CRACKS/SPALLING

REPLACE

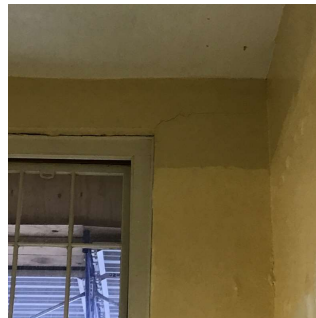
Stair C/3

PLASTER: CRACKS/SPALLING

REPLACE

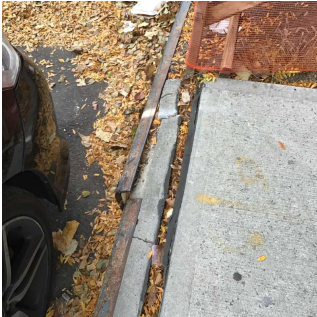
Priority Condition Exist Last Year?	Priority Category	Condition Description	Component Affected	Location Description	Person(s) Notified	Person(s) Title	PhotoImage
Yes	Protruding Elements	Heaving metal curb is a potential safety hazard.	SITE PAVING DOT Sidewalk Concrete	15th Avenue	Joseph Figetta	Fireman

Violations	72nd Street No violations recorded.
Pavers	Does not Exist
DOT Sidewalk	Inspected
Asphalt	Does not Exist
Concrete	Inspected
Condition	4 - Between Fair and Poor
Deficiency	DAMAGED CURBS
Deficiency Location/Instance	15th Avenue
Deficiency Quantity	10
Quantity Uom	L.F.
Potential Action	REPLACE

15th Avenue 51273
Violations	
Deficiency	HEAVING
Deficiency Location/Instance	15th Avenue, 72nd Street
Deficiency Quantity	225
Quantity Uom	S.F.
Potential Action	REPLACE
Urgency of Action	PRIORITY 4
Purpose of Action	LEVEL 4
Deficiency Photo1

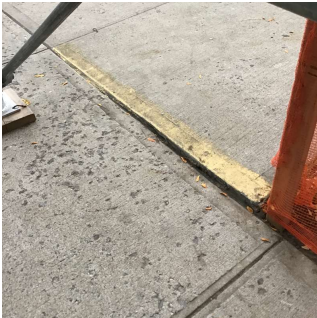
15th Avenue 51273
Violations	
Deficiency	DAMAGED/DETERIORATED/MISSING SECTIONS
Deficiency Location/Instance	15th Avenue, 72nd Street
Deficiency Quantity	700
Quantity Uom	S.F.
Potential Action	REPLACE
Urgency of Action	PRIORITY 4
Purpose of Action	LEVEL 4
Deficiency Photo1	 
	15th Avenue 51273
Violations

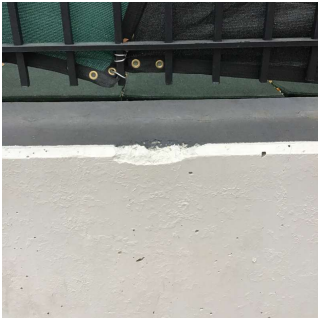
Question	Response
SITE	
RETAINING WALLS	
Violations	No violations recorded.
Deficiency	CAST IN PLACE CONCRETE: CRACKS/SPALLING - MAJOR
Deficiency Location/Instance	72nd Street
Deficiency Quantity	20
Quantity Uom	S.F.
Potential Action	REPLACE
Urgency of Action	PRIORITY 3
Purpose of Action	LEVEL 2
Deficiency Photo1

Violations	72nd Street No violations recorded.
SEATING	Inspected
Benches	Inspected
Concrete	Does not Exist
Metal/Wood/Plastic	Inaccessible
Bleachers	Does not Exist
SITE WALLS (NOT RETAINING WALLS)	Does not Exist
STAIRS/RAMPS: EXTERIOR	Inspected
Railings	Inspected
Condition	2 - Between Good and Fair
Deficiency	No deficiencies recorded
Site Cheek/flank Walls	Inspected
Condition	2 - Between Good and Fair
Deficiency	No deficiencies recorded
Stairs/ramps	Inspected
Condition	3 - Fair
Deficiency	CAST IN PLACE CONCRETE: CRACKS/SPALLING - MAJOR
Deficiency Location/Instance	72nd Street
Deficiency Quantity	50
Quantity Uom	S.F.
