NYC Department of Education
Building Condition Assessment Survey 2023 - 2024

Architectural Inspection

Asset: I.S. 113 - BROOKLYN, 300 ADELPHI STREET, New York, 11205

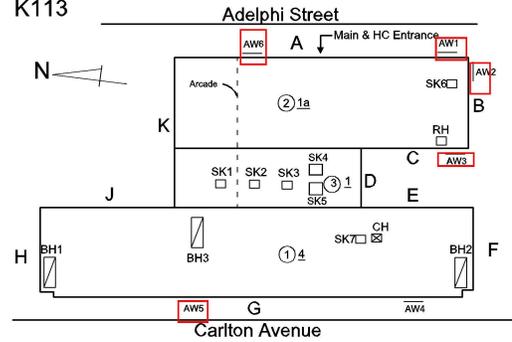
AREAWAY WALLS: CRACKS AND SPALLING

REPLACE

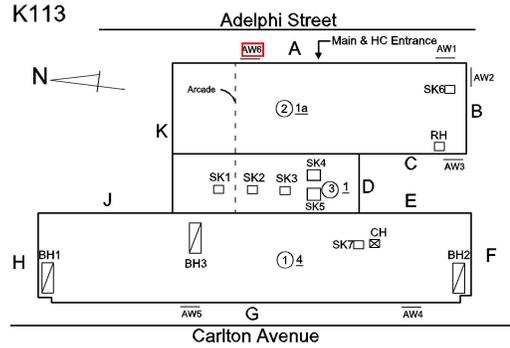
AW6
No violations recorded.

AREAWAY STAIRS: DETERIORATED TREADS/RISERS/NOSINGS

10
S.F.
REPLACE
PRIORITY 4
LEVEL 2

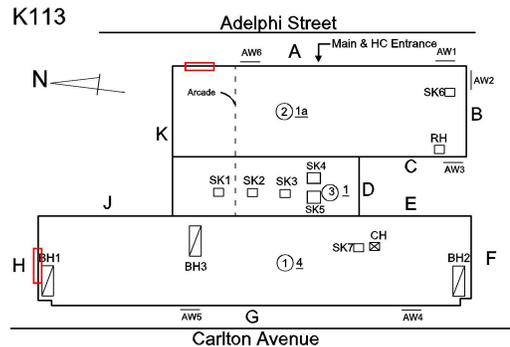
METAL: DETERIORATED DOOR - MINOR DETERIORATION

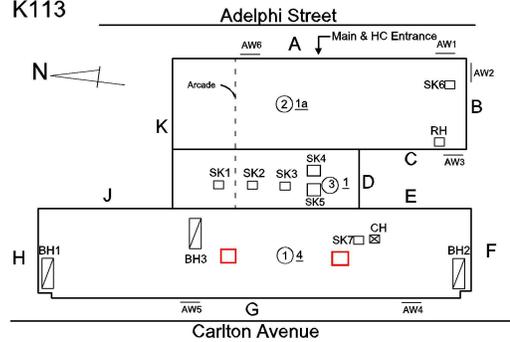
DETERIORATED

REPLACE

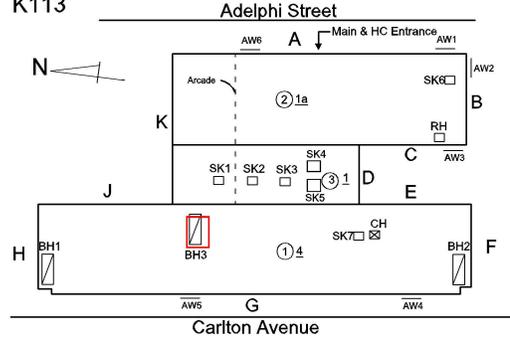
BH3
No violations recorded.

BULKHEAD/PENTHOUSE WALLS/INTERIOR: GLAZED BLOCK
CRACKS/SPALLING

10
S.F.
REPLACE
PRIORITY 4
LEVEL 2

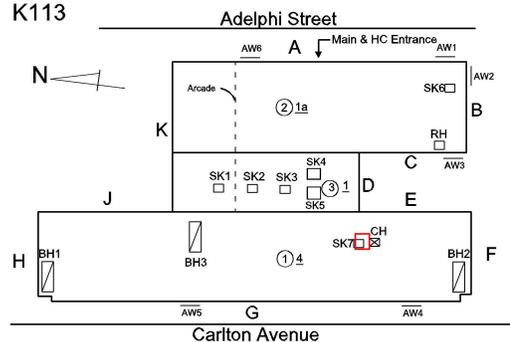
BROKEN GLASS

20
S.F.
MAINTENANCE

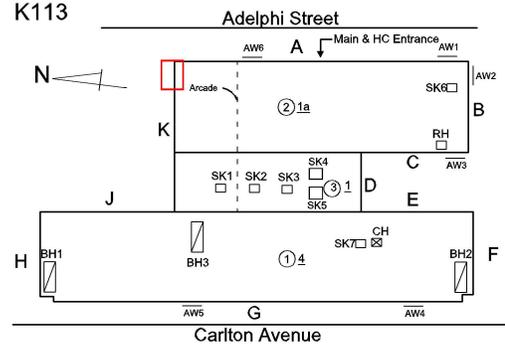
MISSING RAILING

20
L.F.
REPLACE
PRIORITY 5
LEVEL 6

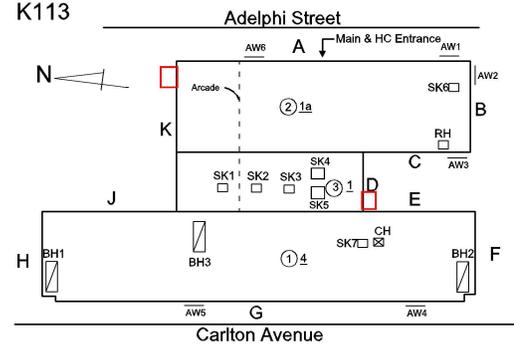
CONCRETE: CRACKS/SPALLING - MAJOR

REPLACE

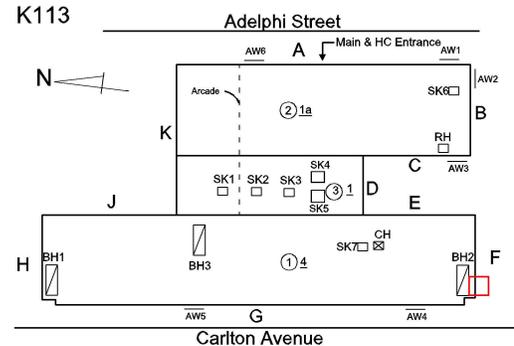
CONCRETE: WORN-OUT TREAD/RISER/NOSING

REPLACE

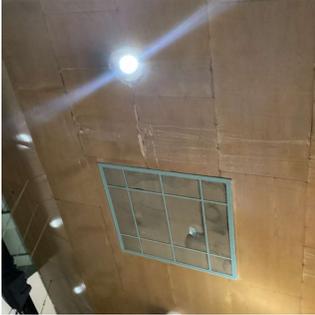
Question	Response
INTERIOR	
AUDITORIUM	
Ceiling	
Instance on 1st Floor (650 Seats)	Inspected
Condition	4 - Between Fair and Poor
Deficiency	WOOD: DAMAGED/DETERIORATED
Deficiency Location/Instance	Near Stage
Deficiency Quantity	80
Quantity Uom	S.F.
Potential Action	REPLACE
Urgency of Action	PRIORITY 3
Purpose of Action	LEVEL 2
Deficiency Photo1

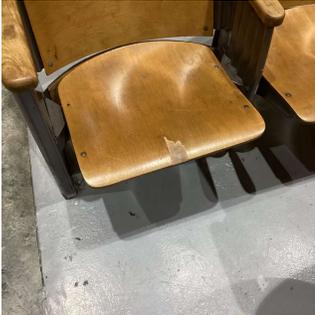
Question	Response
INTERIOR	
AUDITORIUM	
Fixed Seating	
Deficiency	DAMAGED/BROKEN/INOPERABLE
Deficiency Location/Instance	Seats B/101, C/1, 112, E/114, H/1, and others
Deficiency Quantity	21
Quantity Uom	EACH
Potential Action	REPLACE
Urgency of Action	PRIORITY 3
Purpose of Action	LEVEL 2
Deficiency Photo1

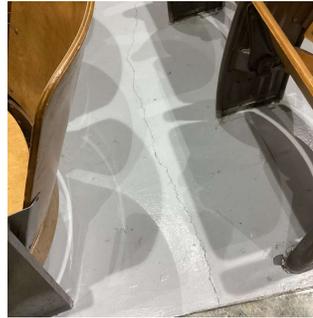
Violations	Seat L/14 No violations recorded.
Floor Finish	
Instance on 1st Floor (650 Seats)	Inspected
Condition	3 - Fair
Deficiency	CONCRETE: CRACKS
Deficiency Location/Instance	Near Seat L/2
Deficiency Quantity	40
Quantity Uom	S.F.
Potential Action	REPLACE
Urgency of Action	PRIORITY 3
Purpose of Action	LEVEL 2

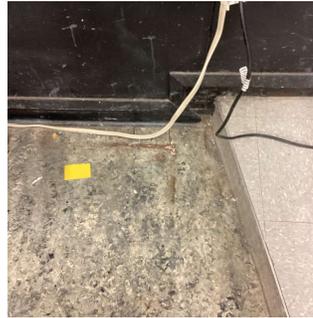
Room 424
Violations	No violations recorded.
Floor Finish	Inspected
Condition	2 - Between Good and Fair
Deficiency	SHEET VINYL: BROKEN/DETERIORATED
Deficiency Location/Instance	Room 201
Deficiency Quantity	40
Quantity Uom	S.F.
Potential Action	REPLACE
Urgency of Action	PRIORITY 3
Purpose of Action	LEVEL 2

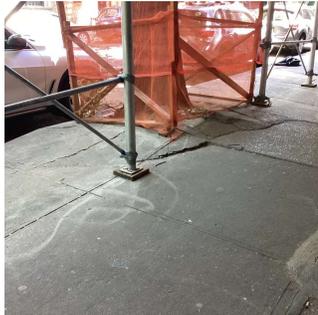
Near Soffit
Violations	No violations recorded.
Pavers	Does not Exist
DOT Sidewalk	Inspected
Asphalt	Does not Exist
Concrete	Inspected
Condition	4 - Between Fair and Poor
Deficiency	HEAVING
Deficiency Location/Instance	Adelphi Street
Deficiency Quantity	250
Quantity Uom	S.F.
Potential Action	REPLACE
Urgency of Action	PRIORITY 5
Purpose of Action	LEVEL 6
Deficiency Photo1
