**NYC Department of Education**  
**Building Condition Assessment Survey 2023 - 2024**

Architectural Inspection

**Asset:** P.S. 116 - BROOKLYN, 515 KNICKERBOCKER AVENUE, New York, 11237

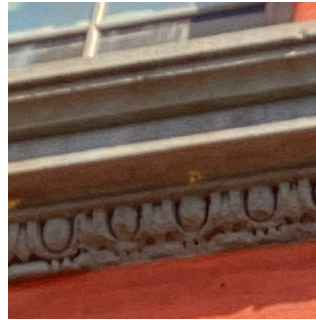
Facade A

Question	Response
<b>Architectural</b>	
<b>EXTERIOR</b>	Inspected
<b>AREAWAY</b>	Does not Exist
<b>AWNINGS AND CANOPIES</b>	Does not Exist
<b>CHIMNEY</b>	Inspected
Material Type(s)	Masonry
Condition	2 - Between Good and Fair
Deficiency	No deficiencies recorded
<b>COPING</b>	Does not Exist
<b>CORNICE</b>	Inspected
Condition	3 - Fair
Deficiency	TERRA COTTA: MINOR CRACKS, SPALLING

30  
S.F.  
REPAIR  
PRIORITY 3  
LEVEL 2

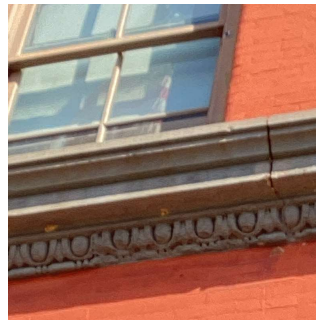
Facade A

TERRA COTTA: DETERIORATED JOINTS

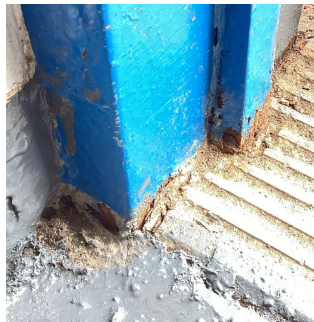
Facade D  
No violations recorded.

METAL CLAD: DETERIORATED DOOR AND FRAME - MAJOR DETERIORATION

4  
EACH  
REPLACE  
PRIORITY 4  
LEVEL 2

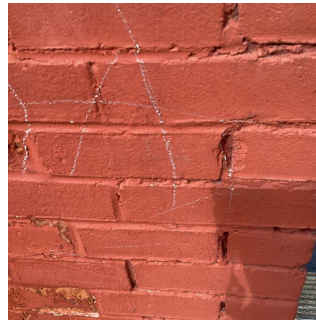
Facade D

BRICK: DETERIORATED JOINTS

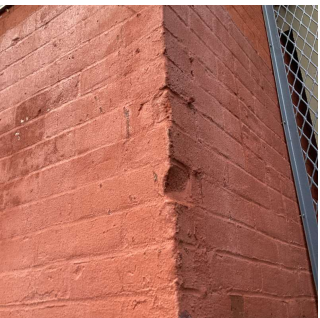
Question	Response
<b>EXTERIOR</b>	
<b>EXTERIOR WALLS</b>	
Violations	No violations recorded.
Deficiency	BRICK: CRACKS/DISPLACED/SPALLED BRICK AT BUILDING CORNERS
Roof Plan reference	K116
Elevation

Deficiency Quantity	60
Quantity Uom	S.F.
Potential Action	REMOVE AND REBUILD
Urgency of Action	PRIORITY 4
Purpose of Action	LEVEL 2
Deficiency Photo1

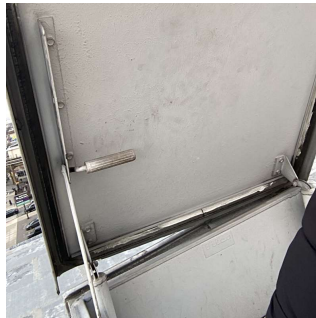
RH2  
 No violations recorded.

Deficiency	DETERIORATED
------------	--------------

1  
 EACH  
 REPLACE  
 PRIORITY 4  
 LEVEL 2

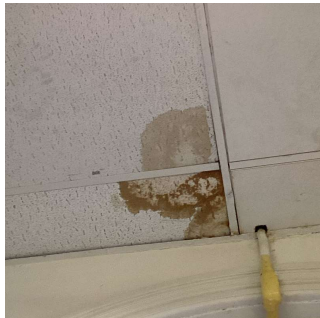
Roof 1 - Corridor near Gymnasium (Shown), In Room 408, Roof 2 - Room 405
Violations	No violations recorded.
<b>ROOFING DRAINS</b>	Does not Exist
<b>Specialties</b>	Inspected
<b>BULKHEAD/PENTHOUSE</b>	Does not Exist

Roof 2
Instance Quantity	12,000
Instance Quantity Uom	S.F.
Does the roof have major mechanical equipment sitting on Dunnage Steel less than 18" above the Roofing?	No
Does this roof instance have a Sustainable Roof System?	No
Do solar panels exist on these roofs?	No
Is/Are the roof(s) suitable for Solar Panel installation?	No
Installation Year	2000
Source of Installation	Custodial Staff
Deficiency	METAL: ROOFING: MAJOR ACTIVE ROOF LEAKS IN INSTRUCTIONAL SPACE
Roof Plan reference	<p>K116</p>

Deficiency Quantity	300
Quantity Uom	S.F.
Potential Action	REPLACE
Urgency of Action	PRIORITY 5
Purpose of Action	LEVEL 2
Deficiency Photo1

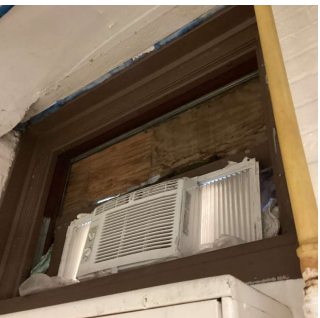
Instance on Aluminum - Other: Roof, Basement, Facades B, F	Inspected
Instance Condition	3 - Fair
Instance Quantity	300
Instance Quantity Uom	S.F.
Are these windows insulated	No
Installation Year	2000
Source of Installation	Custodial Staff
Deficiency	ALUMINUM - OTHER: BROKEN PANE

Deficiency Quantity	30
Quantity Uom	S.F.
Potential Action	MAINTENANCE
Urgency of Action	PRIORITY 3
Purpose of Action	LEVEL 2
Deficiency Photo1

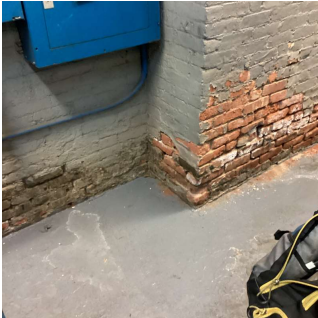
Violations	Boiler Room 35671973L
Deficiency	BRICK: WATER INFILTRATION IN NON- INSTRUCTIONAL SPACE
Deficiency Location/Instance	Basement - Boiler Room
Deficiency Quantity	100
Quantity Uom	S.F.
Potential Action	INSTALL WATERPROOFING
Urgency of Action	PRIORITY 5
Purpose of Action	LEVEL 5
Deficiency Photo1

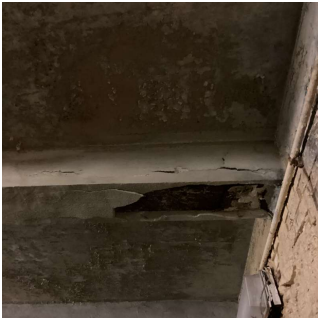
Vault near Oil Tank Room
Violations	35671973L
<b>Slab Structure</b>	Inspected
Condition	4 - Between Fair and Poor
Deficiency	STEEL COLUMNS/BEAMS: MAJOR RUSTING
Deficiency Location/Instance	Basement - Oil Tank Room
Deficiency Quantity	10
Quantity Uom	S.F.
Potential Action	REPLACE
Urgency of Action	PRIORITY 4
Purpose of Action	LEVEL 5
Deficiency Photo1

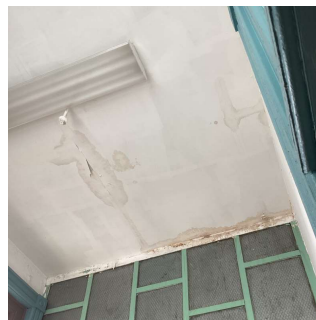
In Room 408

GYPSUM BOARD: DAMAGED/DETERIORATED - ACTIVE LEAK

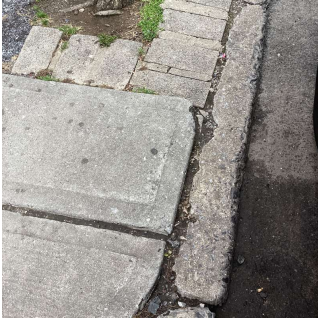
<b>Question</b>	<b>Response</b>
<b>SITE</b>	
<b>PAVING</b>	
<b>DOT Sidewalk</b>	Inspected
<b>Asphalt</b>	Does not Exist
<b>Concrete</b>	Inspected
Condition	4 - Between Fair and Poor
Deficiency	HEAVING
Deficiency Location/Instance	Knickerbocker Avenue
Deficiency Quantity	100
Quantity Uom	S.F.
Potential Action	REPLACE
Urgency of Action	PRIORITY 5
Purpose of Action	LEVEL 6
Deficiency Photo1

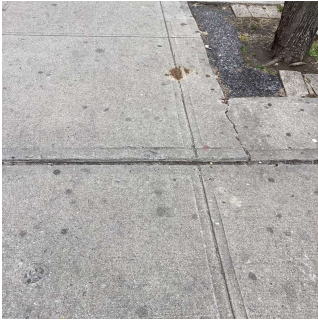
Violations	Knickerbocker Avenue No violations recorded.
Deficiency	HEAVING
Deficiency Location/Instance	Knickerbocker Avenue, Menahan Street
Deficiency Quantity	75
Quantity Uom	S.F.
Potential Action	REPLACE
Urgency of Action	PRIORITY 3
Purpose of Action	LEVEL 2
Deficiency Photo1
