**NYC Department of Education**  
**Building Condition Assessment Survey 2023 - 2024**

Architectural Inspection

**Asset:**        **I.S. 117 - BROOKLYN, 300 WILLOUGHBY AVENUE, New York, 11205**

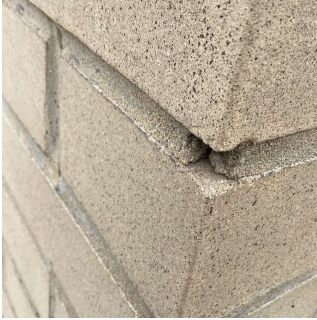
Deficiency Quantity	20
Quantity Uom	S.F.
Potential Action	REPOINT
Urgency of Action	PRIORITY 4
Purpose of Action	LEVEL 2
Deficiency Photo1

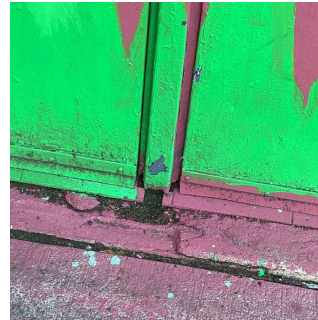
Facade D - Exit 6

METAL: DETERIORATED DOOR AND FRAME - MINOR DETERIORATION

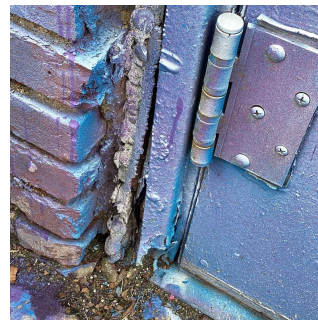
Facade C - Near AW1

**METAL CLAD: DETERIORATED DOOR AND FRAME - MAJOR DETERIORATION**

1  
EACH  
REPLACE  
PRIORITY 4  
LEVEL 2

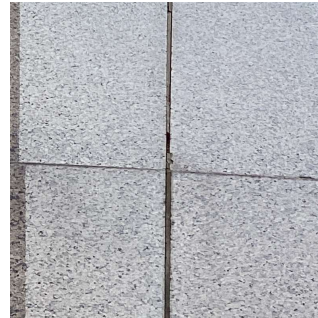
Facade A - Near Main Entrance

STONE: DETERIORATED JOINTS

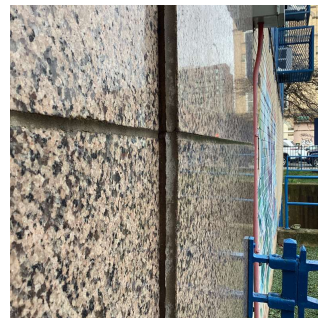
STONE: CHIPPED/SPALLED/BROKEN PIECES - MAJOR

Facade A - Near Main Entrance (bulging stone)

REPLACE

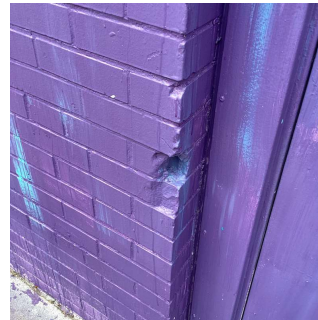
Facade C - Near Universal Waste/ Florescent Lamp Storage Entrance

**BRICK: MAJOR / THRU CRACKS**

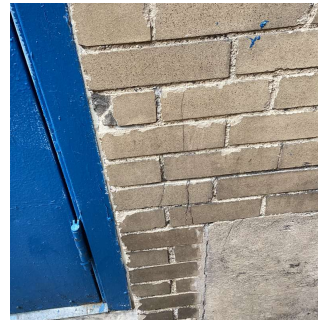
Facade G - Near Exit 9

**BRICK: MINOR CRACKS AND SPALLING**

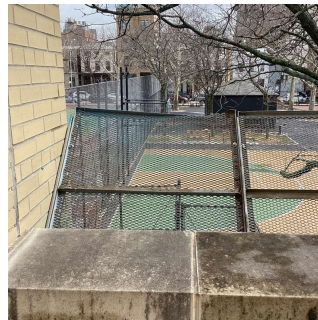
Roof 3 - Facade F

Deficiency	No deficiencies recorded
<b>ROOF BARRIER/FENCE</b>	Inspected
Condition	3 - Fair
Deficiency	RAILINGS/PANELS: DETERIORATED, MAJOR RUSTING

20  
S.F.  
REPLACE  
PRIORITY 4  
LEVEL 2

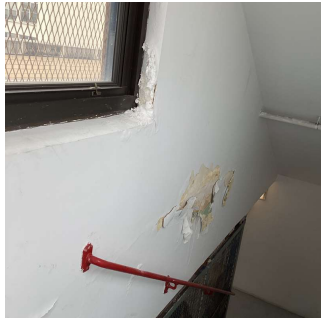
**BULKHEAD/PENTHOUSE WALLS/INTERIOR: PLASTER  
CRACKS/SPALLING**

100  
S.F.  
REPLACE  
PRIORITY 4  
LEVEL 2

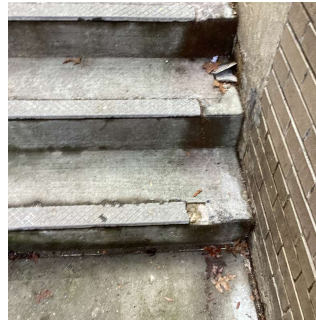
Facade G - Near Roof 7

Violations	BH3 No violations recorded.
<b>CUPOLA/ SPIRES/ TOWERS</b>	Does not Exist
<b>DORMER</b>	Does not Exist
<b>DUNNAGE STEEL</b>	Does not Exist
<b>SKYLIGHT/ROOF VENT</b>	Does not Exist
<b>ROOF/GRAVITY TANK</b>	Does not Exist
<b>STAIRS/RAMPS: EXTERIOR</b>	Inspected
<b>BUILDING CHEEK/FLANK WALLS</b>	Inspected
Condition	2 - Between Good and Fair
Deficiency	No deficiencies recorded
<b>RAILINGS</b>	Inspected
Condition	2 - Between Good and Fair
Deficiency	No deficiencies recorded
<b>STAIRS/RAMPS</b>	Inspected
Condition	4 - Between Fair and Poor
Deficiency	CONCRETE: WORN-OUT TREAD/RISER/NOSING
Roof Plan reference

Deficiency Quantity	10
Quantity Uom	S.F.
Potential Action	REPLACE
Urgency of Action	PRIORITY 4
Purpose of Action	LEVEL 2

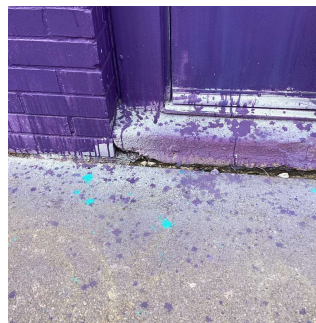
Facade C - Near Universal Waste/ Florescent Lamp Storage Entrance

**CONCRETE: CRACKS/SPALLING - MAJOR**

REPLACE

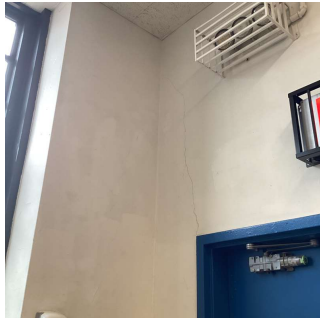
Question	Response
<b>INTERIOR</b>	
<b>CAFETERIA</b>	
<b>Walls</b>	
Deficiency Quantity	30
Quantity Uom	S.F.
Potential Action	REPLACE
Urgency of Action	PRIORITY 3
Purpose of Action	LEVEL 2
Deficiency Photo1

Violations	Near Windows No violations recorded.
<b>Window Curtains/Shades/Blinds</b>	
Instance on Basement	Does not Exist
<b>CLASSROOMS/CORRIDORS/ADMIN SPACES</b>	
<b>Ceiling</b>	
Condition	Inspected
Deficiency	2 - Between Good and Fair
Deficiency Location/Instance	PLASTER: CRACKS/SPALLING
Deficiency Quantity	Room B13
Quantity Uom	50
Potential Action	S.F.
Urgency of Action	REPLACE
Purpose of Action	PRIORITY 3
Deficiency Photo1	LEVEL 2
Violations

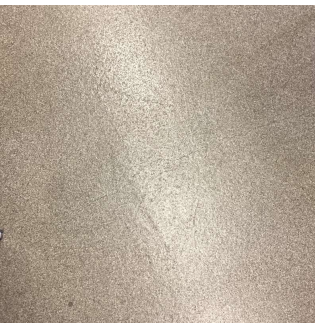
Question	Response
<b>INTERIOR</b>	
<b>CLASSROOMS/CORRIDORS/ADMIN SPACES</b>	
<b>Floor Finish</b>	
Deficiency Photo1           Violations

Room 313  No violations recorded.
Deficiency Deficiency Location/Instance Deficiency Quantity Quantity Uom Potential Action Urgency of Action Purpose of Action Deficiency Photo1           Violations	VINYL TILES: BROKEN/DETERIORATED/MISSING TILES Room B13, B12, Exit 6, Corridor near Room 313, 237, and others 180 S.F. REPLACE PRIORITY 3 LEVEL 2

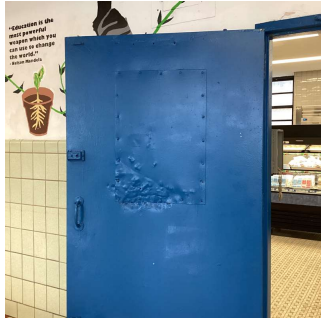
Question	Response
<b>INTERIOR</b>	
<b>KITCHEN</b>	
<b>Door(s)</b>	
Deficiency	METAL: DETERIORATED DOOR
Deficiency Location/Instance	Entrance
Deficiency Quantity	5
Quantity Uom	EACH
Potential Action	MAINTENANCE
Urgency of Action	PRIORITY 3
Purpose of Action	LEVEL 2
Deficiency Photo1

Violations	Entrance No violations recorded.
<b>Floor Finish</b>	
Instance on Basement	Inspected
Condition	4 - Between Fair and Poor
Deficiency	VINYL TILES: BROKEN/DETERIORATED/MISSING TILES
Deficiency Location/Instance	Office
Deficiency Quantity	10
Quantity Uom	S.F.
Potential Action	REPLACE
Urgency of Action	PRIORITY 3
Purpose of Action	LEVEL 2
Deficiency Photo1

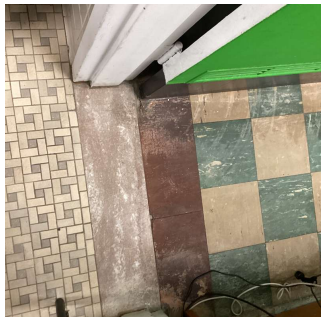
Violations	Office No violations recorded.
Deficiency	CONCRETE: CRACKS
Deficiency Location/Instance	Storage
Deficiency Quantity	20
Quantity Uom	S.F.
Potential Action	REPLACE
Urgency of Action	PRIORITY 3
Purpose of Action	LEVEL 2

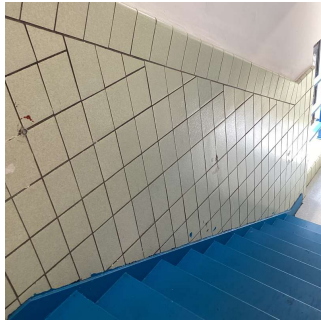
Question	Response
<b>INTERIOR</b>	
<b>STAIRS/RAMPS: INTERIOR</b>	
<b>Door(s)</b>	Inspected
Condition	2 - Between Good and Fair
Deficiency	No deficiencies recorded
<b>Partition</b>	Does not Exist
<b>Railings</b>	Inspected
Condition	3 - Fair
Deficiency	METAL: MISSING
Deficiency Location/Instance	Exit 5, Stair EF/3
Deficiency Quantity	15
Quantity Uom	L.F.
Potential Action	REPLACE
Urgency of Action	PRIORITY 5
Purpose of Action	LEVEL 6
Deficiency Photo1	No photo recorded

Stair EF/3
Violations	No violations recorded.
<b>Stairs and Landings</b>	Inspected
Condition	3 - Fair
Deficiency	VINYL TILES: DETERIORATED SUBSTRATE
Deficiency Location/Instance	Stair AB/Basement, EF/Basement
Deficiency Quantity	20
Quantity Uom	S.F.
Potential Action	REPLACE
Urgency of Action	PRIORITY 3
Purpose of Action	LEVEL 2
Deficiency Photo1

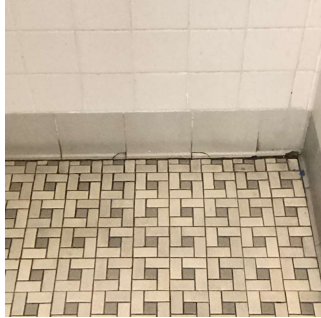
Question	Response
<b>INTERIOR</b>	
<b>TOILET ROOMS - STUDENTS</b>	
<b>Walls</b>	
Urgency of Action	PRIORITY 3
Purpose of Action	LEVEL 2
Deficiency Photo1

Room 327
Violations	No violations recorded.
<b>LIFE SAFETY</b>	Inspected
<b>F.D. HOLDING AREA</b>	Does not Exist
<b>STEEL STAIRS</b>	Does not Exist
<b>SITE</b>	Inspected
<b>CONTAINERIZATION</b>	Does not Exist
<b>Drainage System for Asphalt</b>	Does not Exist
<b>Drainage System for Concrete</b>	Inspected
<b>Catch Basins/Manhole - Surrounded by concrete</b>	Inspected
Condition	2 - Between Good and Fair
Deficiency	No deficiencies recorded
<b>Culverts - Concrete Covering</b>	Does not Exist
<b>Drainage System for Soil</b>	Inspected
<b>Catch Basins/Manhole - Surrounded by Soil</b>	Inspected
Condition	2 - Between Good and Fair
Deficiency	No deficiencies recorded
<b>Culverts - Soil Covering</b>	Does not Exist
<b>DRINKING FOUNTAINS</b>	Does not Exist
<b>FENCES</b>	Inspected

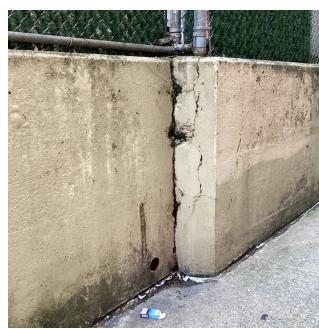
Question	Response
<b>SITE</b>	
<b>RETAINING WALLS</b>	
Purpose of Action	LEVEL 2
Deficiency Photo1

Violations	Near Exit 9 No violations recorded.
<b>SEATING</b>	
<b>SITE WALLS (NOT RETAINING WALLS)</b>	Does not Exist
<b>STAIRS/RAMPS: EXTERIOR</b>	
<b>ARTWORK</b>	Does not Exist
