**NYC Department of Education**  
**Building Condition Assessment Survey 2023 - 2024**

Architectural Inspection

**Asset:** P.S. 119 - BROOKLYN, 3829 AVENUE K, New York, 11210

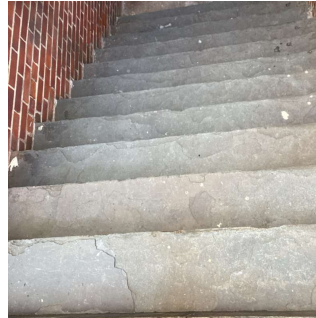
Question	Response
<b>Architectural</b>	
<b>EXTERIOR</b>	Inspected
<b>AREAWAY</b>	Inspected
Instance on AW1	Inspected
Instance Condition	5 - Poor
Instance Quantity	1
Instance Quantity Uom	EACH
Deficiency	AREAWAY STAIRS: DETERIORATED TREADS/RISERS/NOSINGS
Roof Plan reference

Deficiency Quantity	50
Quantity Uom	S.F.
Potential Action	REPLACE
Urgency of Action	PRIORITY 4
Purpose of Action	LEVEL 2
Deficiency Photo1

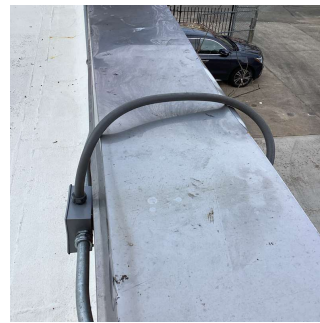
Roof 2

METAL: DETERIORATED

REPLACE-IN-KIND

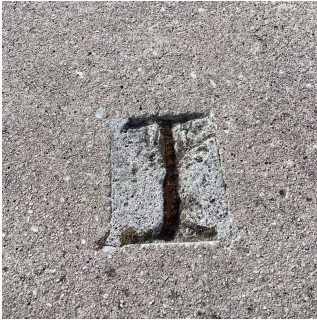
CAST STONE: CRACKED/BROKEN PIECES

REPLACE-IN-KIND

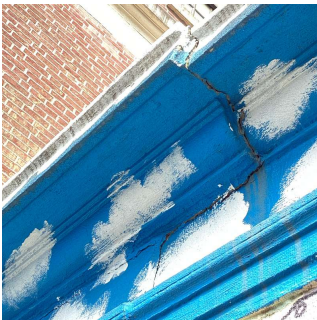
Violations	Roof 1 No violations recorded.
<b>CORNICE</b>	Inspected
Condition	3 - Fair
Deficiency	PRE-CAST CONCRETE: MAJOR CRACKS, SPALLING
Roof Plan reference

Deficiency Quantity	30
Quantity Uom	S.F.
Potential Action	REPLACE
Urgency of Action	PRIORITY 4
Purpose of Action	LEVEL 2
Deficiency Photo1

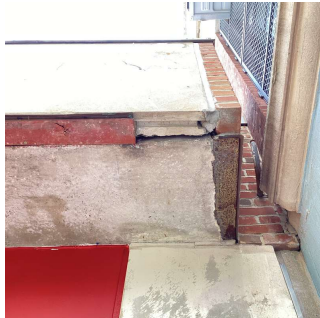
CONCRETE: DETERIORATED

Question	Response
<b>EXTERIOR</b>	
<b>EXTERIOR SOFFITS</b>	
Urgency of Action	PRIORITY 4
Purpose of Action	LEVEL 2
Deficiency Photo1

REPLACE

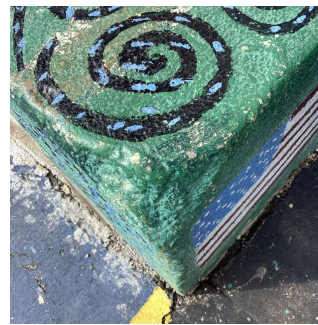
<b>BUILDING CHEEK/FLANK WALLS</b>	Inspected
Condition	4 - Between Fair and Poor
Deficiency	STONE: CRACKS/SPALLING - MAJOR

20  
 S.F.  
 REPLACE  
 PRIORITY 4  
 LEVEL 2

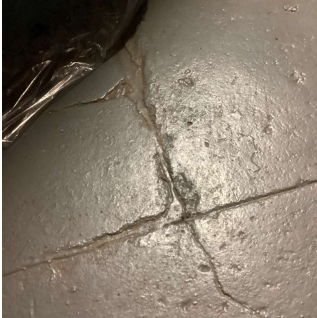
Question	Response
<b>EXTERIOR</b>	
<b>WINDOWS</b>	
<b>WINDOWS</b>	
Elevation	 
Deficiency Quantity	400
Quantity Uom	S.F.
Potential Action	REPLACE WINDOW
Urgency of Action	PRIORITY 4
Purpose of Action	LEVEL 2
Deficiency Photo1	No photo recorded
Violations	No violations recorded.
<b>INTERIOR</b>	
	Inspected
<b>POOLS</b>	
	Does not Exist
<b>STRUCTURAL</b>	
	Inspected
<b>COLUMNS/BEAMS/BEARING WALLS</b>	
Condition	3 - Fair
Deficiency	STEEL COLUMNS/BEAMS: DETERIORATED MASONRY FIREPROOFING
Deficiency Location/Instance	Basement - Break Room
Deficiency Quantity	30
Quantity Uom	S.F.
Potential Action	REPLACE
Urgency of Action	PRIORITY 3
Purpose of Action	LEVEL 5
Deficiency Photo1	 
	Basement - Break Room
Violations	No violations recorded.
<b>FLOOR STRUCTURE</b>	
	Inspected
Condition	3 - Fair
Deficiency	CONCRETE SLAB ON GRADE: THRU CRACKS
Deficiency Location/Instance	Basement - Boiler Room
Deficiency Quantity	60
Quantity Uom	S.F.
Potential Action	REPLACE

Question	Response
<b>INTERIOR</b>	
<b>STRUCTURAL</b>	
<b>FLOOR STRUCTURE</b>	
Urgency of Action	PRIORITY 4
Purpose of Action	LEVEL 5
Deficiency Photo1

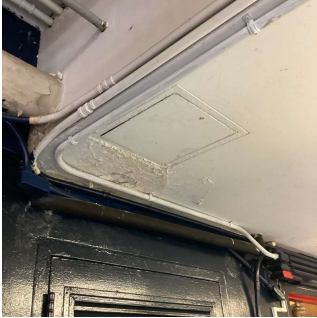
Violations	Basement - Boiler Room No violations recorded.
<b>FOUNDATION WALLS</b>	
Material Type(s)	Inspected Concrete, Masonry
Condition	2 - Between Good and Fair
Deficiency	No deficiencies recorded
<b>ROOF STRUCTURE</b>	
Condition	Inspected 2 - Between Good and Fair
Deficiency	No deficiencies recorded
<b>VAULTS-BUNKERS</b>	
Does not Exist	
<b>AUDITORIUM</b>	
Does not Exist	
<b>CAFETERIA</b>	
Instance on Basement	Inspected Inspected
<b>Ceiling</b>	
Instance on Basement	Inspected
Condition	2 - Between Good and Fair
Deficiency	PLASTER: CRACKS/SPALLING
Deficiency Location/Instance	Near Girls Toilet Room
Deficiency Quantity	10
Quantity Uom	S.F.
Potential Action	REPLACE
Urgency of Action	PRIORITY 3
Purpose of Action	LEVEL 2
Deficiency Photo1

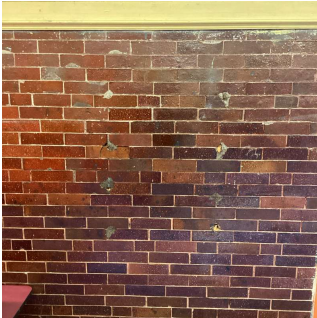
Question	Response
<b>INTERIOR</b>	
<b>CAFETERIA</b>	
<b>Walls</b>	
Deficiency	SALT GLAZED BRICK: CRACKS/SPALLING
Deficiency Location/Instance	Near Room 136, by Stair C, next to Gymnasium
Deficiency Quantity	30
Quantity Uom	S.F.
Potential Action	REPLACE
Urgency of Action	PRIORITY 3
Purpose of Action	LEVEL 2
Deficiency Photo1

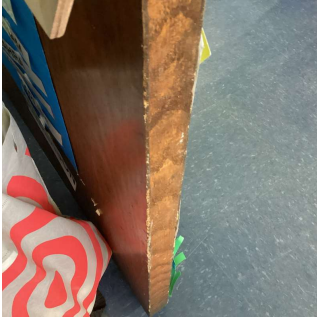
Corridor near Room 308
Violations	No violations recorded.
<b>Door(s)</b>	
Condition	Inspected
Condition	5 - Poor
Deficiency	WOOD: DETERIORATED DOOR

Deficiency Location/Instance	Rooms 103, 107, 108A, 303, 305 and others
Deficiency Quantity	8
Quantity Uom	EACH

Question	Response
<b>INTERIOR</b>	
<b>CLASSROOMS/CORRIDORS/ADMIN SPACES</b>	
<b>Door(s)</b>	
Potential Action	MAINTENANCE
Urgency of Action	PRIORITY 3
Purpose of Action	LEVEL 2
Deficiency Photo1

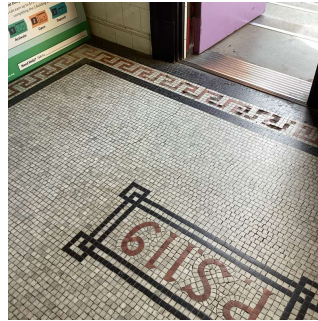
Corridor near Room 102
Violations	No violations recorded.
Deficiency	CERAMIC TILE: BROKEN/MISSING TILES
Deficiency Location/Instance	Main Entrance - Vestibule
Deficiency Quantity	20
Quantity Uom	S.F.
Potential Action	REPLACE
Urgency of Action	PRIORITY 3
Purpose of Action	LEVEL 2

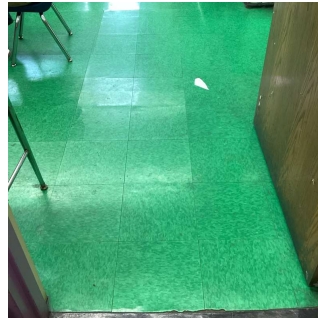
Room 107

Deficiency	VINYL TILES: BROKEN/DETERIORATED/MISSING TILES
Deficiency Location/Instance	Rooms 301, 201, 109, 107, 104 and others
Deficiency Quantity	800
Quantity Uom	S.F.
Potential Action	REPLACE
Urgency of Action	PRIORITY 3
Purpose of Action	LEVEL 2
Deficiency Photo1

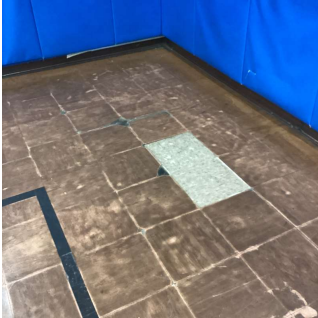
Deficiency	VINYL TILES: BROKEN/DETERIORATED/MISSING TILES

Question	Response
<b>INTERIOR</b>	
<b>GYMNASIUM</b>	
<b>Floor Finish</b>	
Deficiency Location/Instance	Near Room B100, Right and Left Side, near Stage, by Cafeteria
Deficiency Quantity	500
Quantity Uom	S.F.
Potential Action	REPLACE
Urgency of Action	PRIORITY 3
Purpose of Action	LEVEL 2
Deficiency Photo1

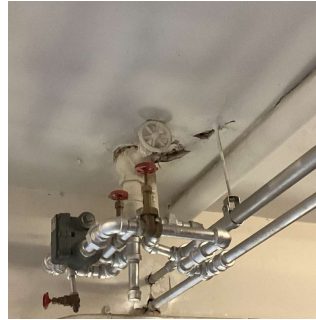
Condition	2 - Between Good and Fair
Deficiency	PLASTER: CRACKS/SPALLING
Deficiency Location/Instance	Servery
Deficiency Quantity	10
Quantity Uom	S.F.
Potential Action	REPLACE
Urgency of Action	PRIORITY 3
Purpose of Action	LEVEL 2
Deficiency Photo1

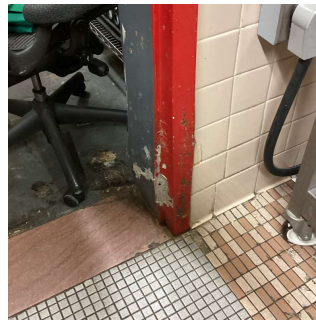
Instance on Basement (300 SF)	Inspected
Condition	3 - Fair
Deficiency	METAL: DETERIORATED DOOR AND FRAME
Deficiency Location/Instance	Office Room
Deficiency Quantity	1
Quantity Uom	EACH
Potential Action	MAINTENANCE
Urgency of Action	PRIORITY 3
Purpose of Action	LEVEL 2
Deficiency Photo1

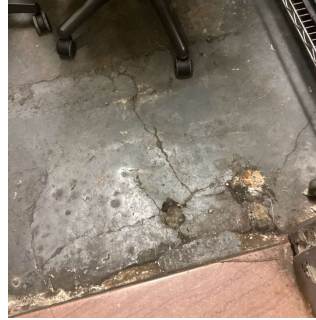
Instance on Basement (300 SF)	Inspected
Condition	5 - Poor
Deficiency	CONCRETE: CRACKS
Deficiency Location/Instance	Office Room
Deficiency Quantity	20
Quantity Uom	S.F.

Potential Action	REPLACE
Urgency of Action	PRIORITY 3
Purpose of Action	LEVEL 2
Deficiency Photo1

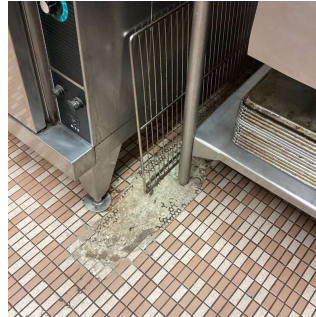
Preparation Area

Deficiency	CERAMIC TILE: BROKEN/MISSING TILES
Deficiency Location/Instance	Preparation Area, by Office Room, next to sink
Deficiency Quantity	40
Quantity Uom	S.F.
Potential Action	REPLACE
Urgency of Action	PRIORITY 3
Purpose of Action	LEVEL 2
Deficiency Photo1

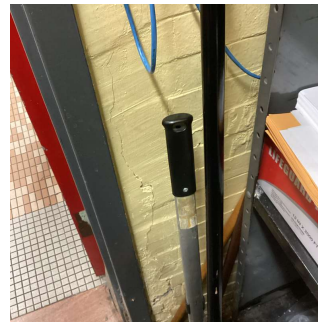
Instance on Basement (300 SF)	Inspected
Condition	3 - Fair
Deficiency	BRICK: CRACKS/SPALLING
Deficiency Location/Instance	Office Room
Deficiency Quantity	10
Quantity Uom	S.F.
Potential Action	REPLACE
Urgency of Action	PRIORITY 3
Purpose of Action	LEVEL 2

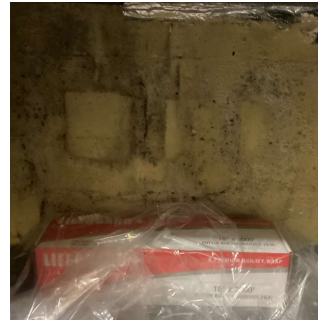
Office Room

PLASTER: CRACKS/SPALLING

REPLACE

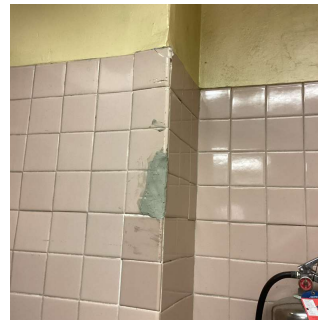
Near sink

CERAMIC TILE: BROKEN/ MISSING

REPLACE

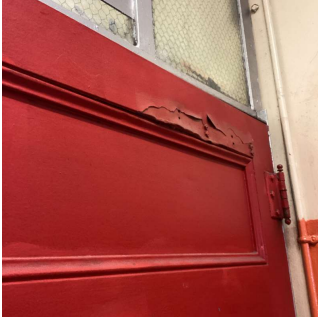
Deficiency	METAL CLAD WOOD: DETERIORATED DOOR

Question	Response
<b>INTERIOR</b>	
<b>STAIRS/RAMPS: INTERIOR</b>	
<b>Door(s)</b>	
Deficiency Location/Instance	Stairs A/1, C/1
Deficiency Quantity	2
Quantity Uom	EACH
Potential Action	MAINTENANCE
Urgency of Action	PRIORITY 3
Purpose of Action	LEVEL 2
Deficiency Photo1

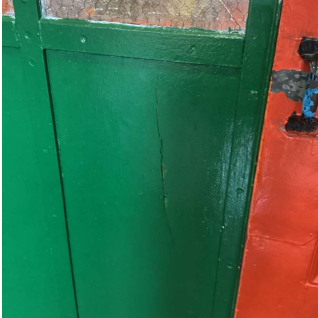
Stair A/1
Violations	No violations recorded.
<b>Partition</b>	Inspected
Condition	2 - Between Good and Fair
Deficiency	METAL PANEL: DAMAGED/DETERIORATED
Deficiency Location/Instance	Stair C/3
Deficiency Quantity	10
Quantity Uom	S.F.
Potential Action	REPLACE
Urgency of Action	PRIORITY 3
Purpose of Action	LEVEL 2
Deficiency Photo1

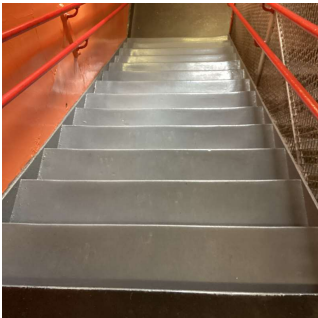
Violations	Stair B/Basement No violations recorded.
Deficiency	STONE: WORN-OUT TREAD/NOSINGS
Deficiency Location/Instance	Stairs A/1, C/1, 2, D/1, 2 and others
Deficiency Quantity	210
Quantity Uom	S.F.
Potential Action	REPLACE
Urgency of Action	PRIORITY 3
Purpose of Action	LEVEL 2
Deficiency Photo1

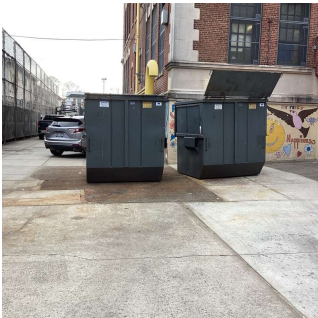
Violations	E 39th Street No violations recorded.
Deficiency	FENCING MISSING
Deficiency Location/Instance	E 39th Street
Deficiency Quantity	1,050
Quantity Uom	S.F.
Potential Action	INSTALL NEW
Urgency of Action	PRIORITY 3
Purpose of Action	LEVEL 2
Deficiency Photo1
